## CERTIFIED ARBORIST REPORT

11810, 11818, 11820, 11824, 11828, 11838 90 Ave, Delta

May 8, 2025

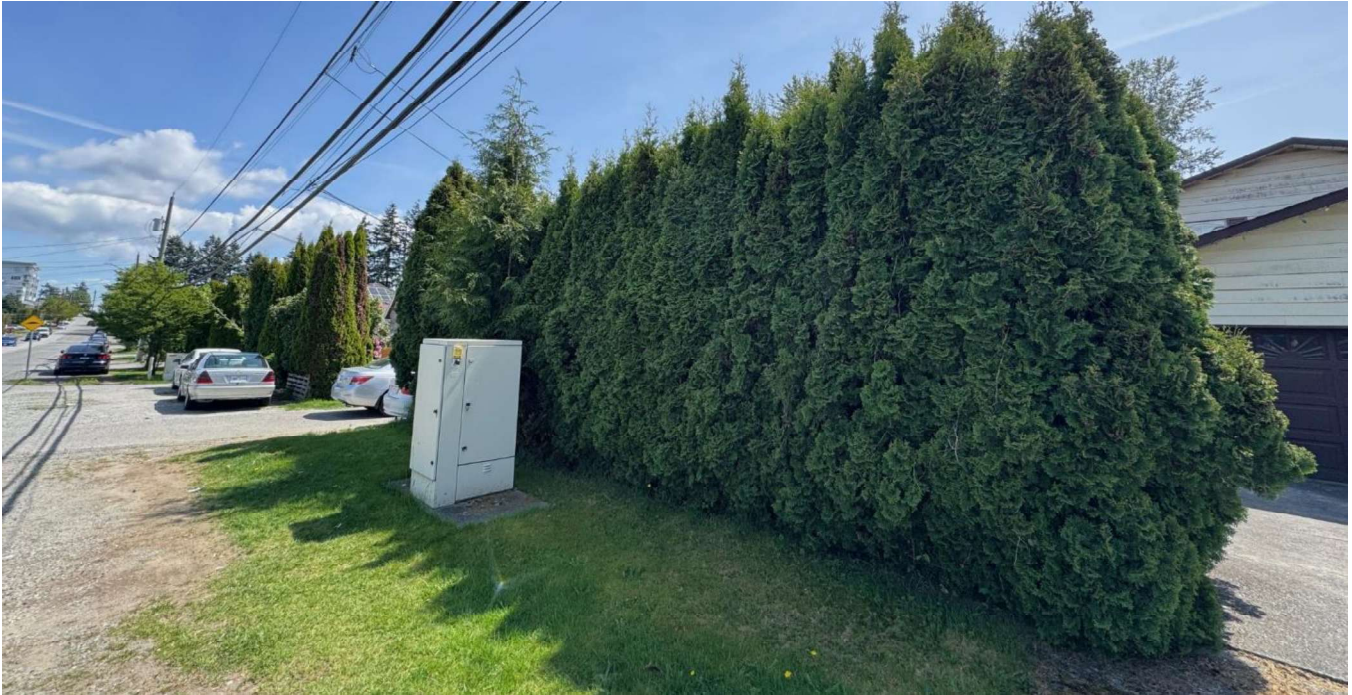
Photo 1 - Facing towards the frontage of the property and looking at the non bylaw sized hedges

**All section of on-site hedging** in direct conflict with the proposed development is recommended to be removed. As sections of the hedging would fall towards the edge or would be in direct conflict with the required site access or would fall within an area requiring high disturbances related to the construction works occurring along the frontage of the site (*all off-site sections of hedging have been proposed to be left intact*).

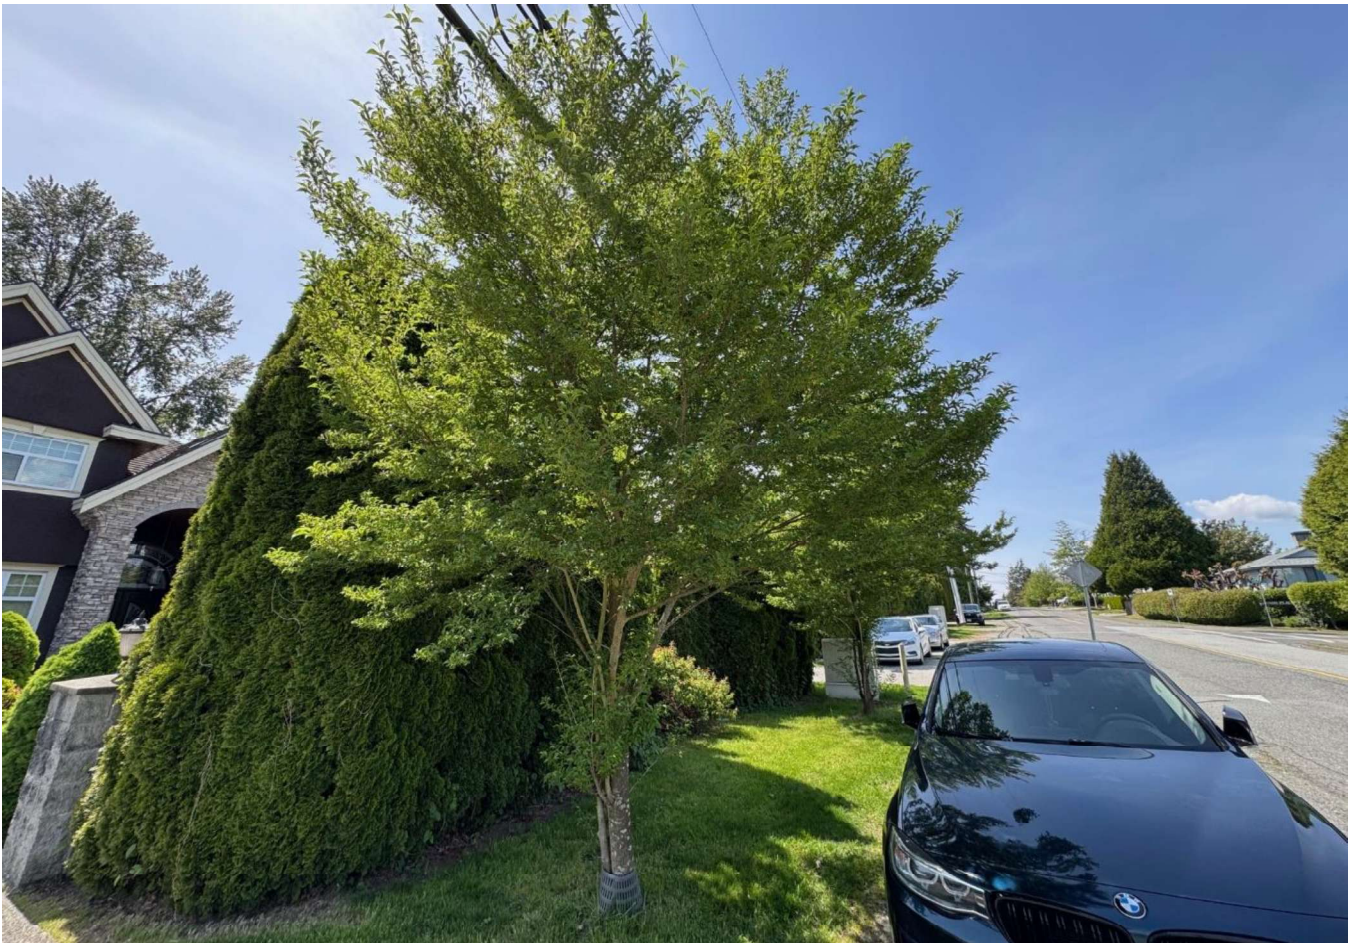
| Table 3 - City Tree Inventory | | | | | | | | | | | | |
|---|---|---|---|---|---|---|---|---|---|---|---|---|
| C1 | Yes | City | Cornelian<br>cherry | <i>Cornus mas</i> | 12 | 65 | 5 | Smaller diameter Juvenilia city tree. The overall growth of the tree was observed to have a single stemmed structured development. The overall growth of the crown was observed to have developed in common with its species. No other major defects and or signs of stress were to be examined. Subject tree is in good condition. | Subject tree will be in direct conflict with the proposed development, proposed boulevard works, off-site civil requirements, and will be within the zone of the heaviest construction & site disturbance related activities.<br><b>The city's authorization will be required for its removal.</b> | Suitable | Remove | 1.2 |

Photo 2 - Facing towards the frontage of the property and looking at city tree #C1

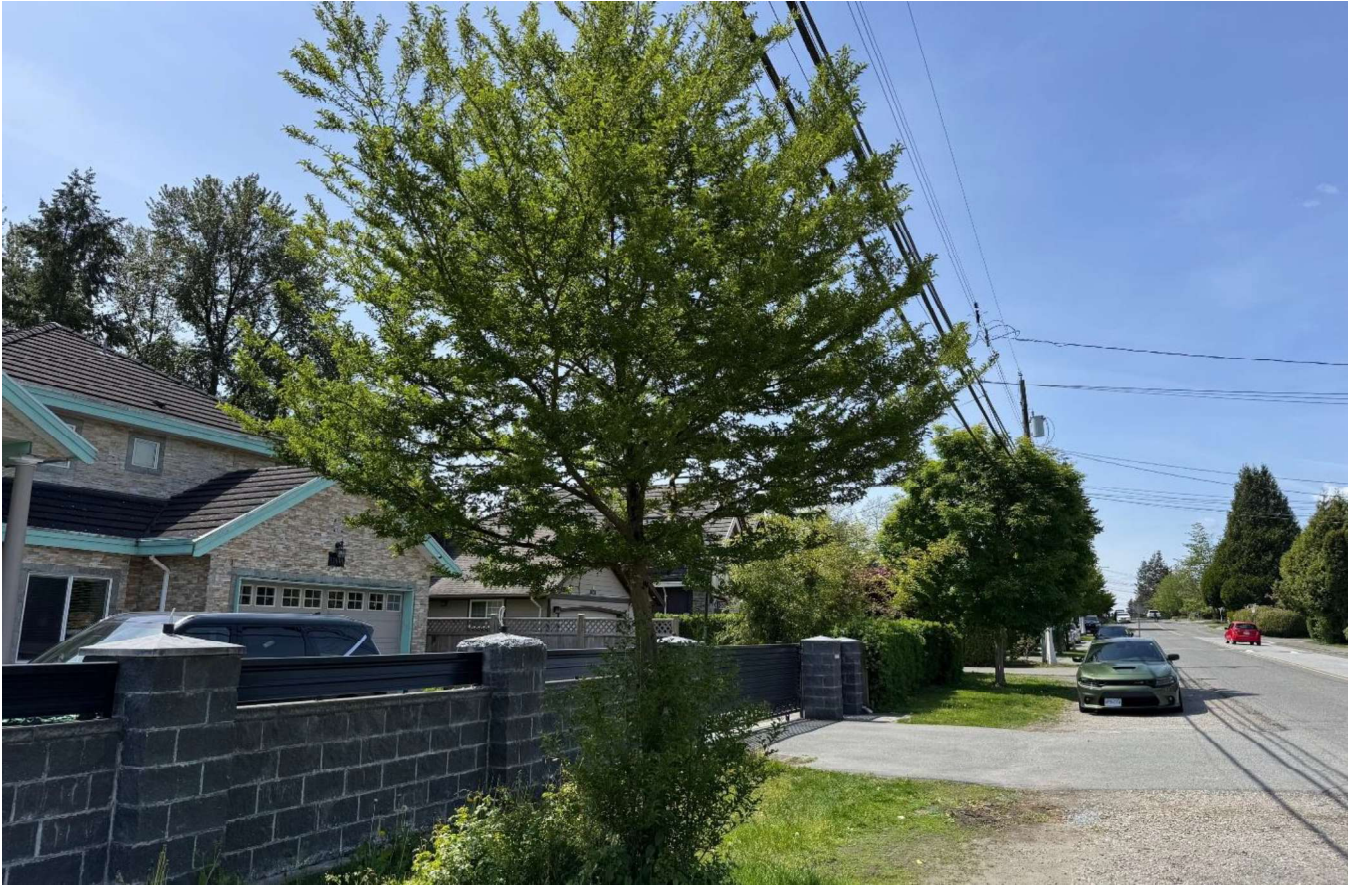
| Table 3 - City Tree Inventory | | | | | | | | | | | | |
|---|---|---|---|---|---|---|---|---|---|---|---|---|
| C2 | Yes | City | Cornelian<br>cherry | <i>Cornus mas</i> | 11/6/5 | 65 | 5 | Juvenillie city tree. The overall growth of the tree was observed to have a multi stemmed structured development. The overall growth of the crown was observed to have developed in common with its species. No other major defects and or signs of stress were to be examined. Subject tree is in good condition. | Subject tree will be in direct conflict with the proposed development, proposed boulevard works, off-site civil requirements, and will be within the zone of the heaviest construction & site disturbance related activities.<br><b>The city's authorization will be required for its removal.</b> | Suitable | Remove | 1.4 |
| C3 | Yes | City | Green ash | <i>Fraxinus pennsylvanica</i> | 18 | 75 | 6 | Juvenillie city tree. The overall growth of the tree was observed to have a single stemmed structured development. The overall growth of the crown was observed to have developed in common with its species. No other major defects and or signs of stress were to be examined. Subject tree is in good condition. | Subject tree will be in direct conflict with the proposed development, proposed boulevard works, off-site civil requirements, and will be within the zone of the heaviest construction & site disturbance related activities.<br><b>The city's authorization will be required for its removal.</b> | Suitable | Remove | 1.2 |

**Photo 3 - Facing towards the frontage of the property and looking at city trees #C2 and #C3**

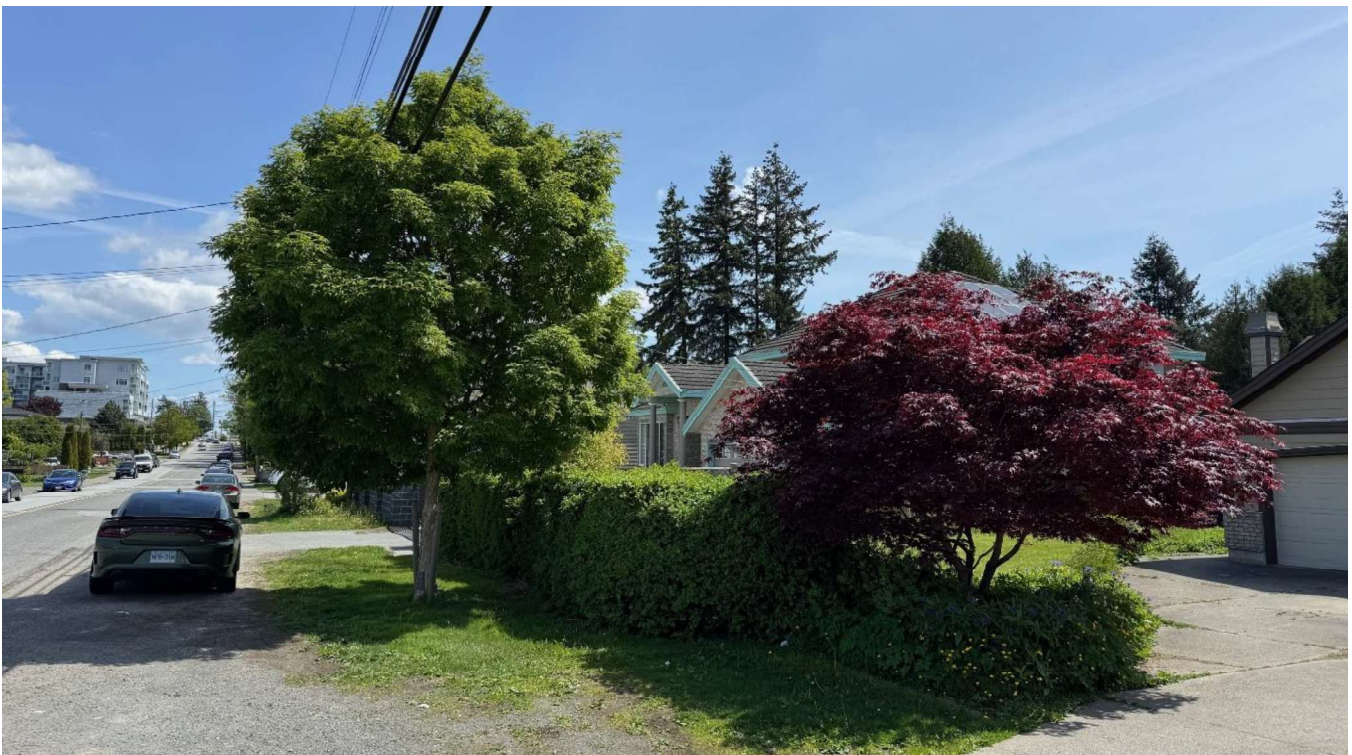
**Photo 4 - Facing towards the frontage of the property and looking at city tree #C3**

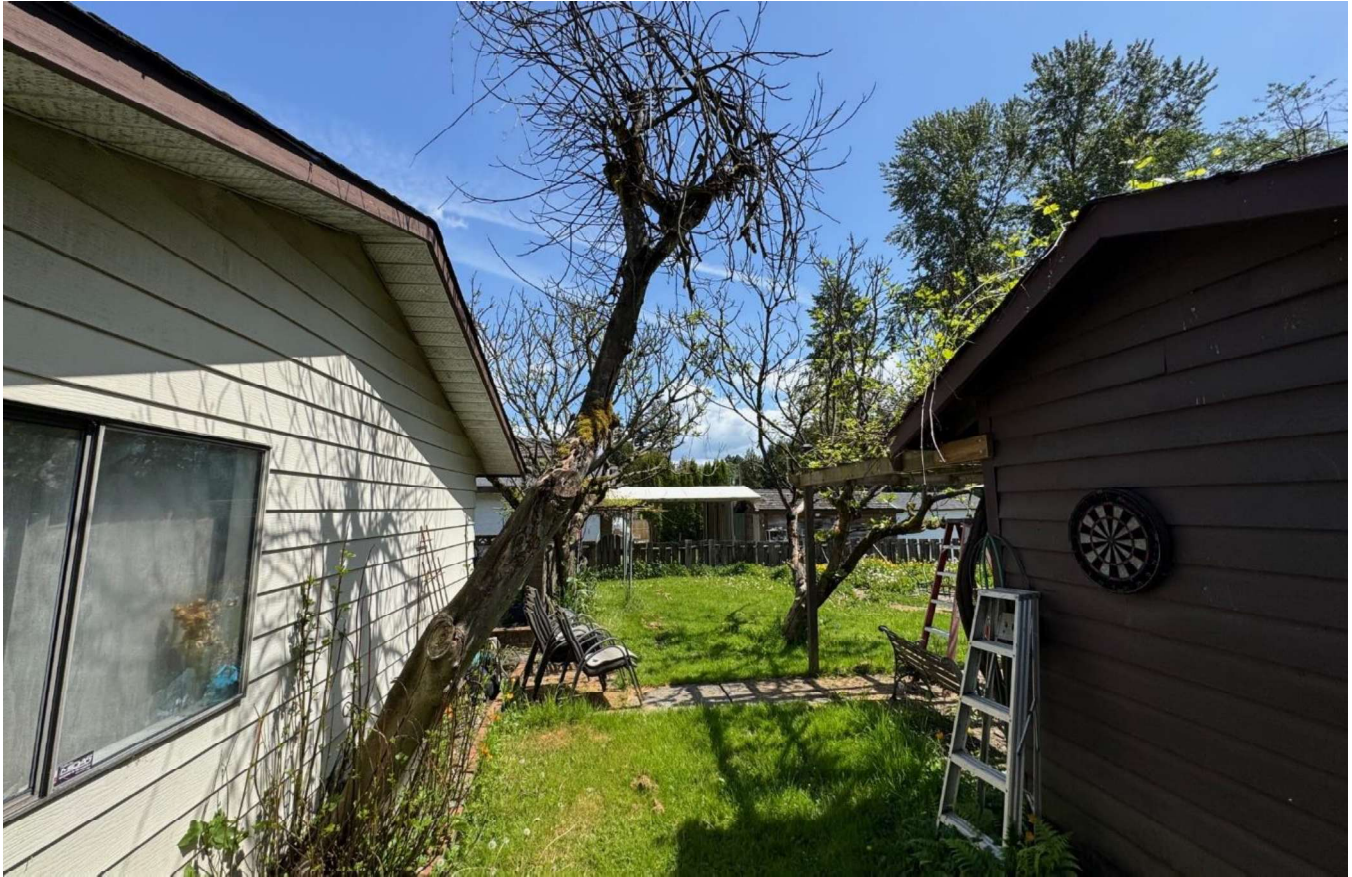
| ID# | Surveyed<br>Y/N | On-site (ON)<br>Off-site (OFF) | City (C) | Common name | Botanical name | DBH (cm) | LCR (%) | Canopy (Dia. M) | Condition | Comments | Retention<br>Suitability | Retain /<br>Remove | TPZ<br>(m) |
|---|---|---|---|---|---|---|---|---|---|---|---|---|---|
| 83 | Yes | On-site | | Common fig | <i>Ficus carica</i> | 28 | 35 | 5 | Fruiting species. The overall growth of the tree was examined to have a single stemmed structured growth form with a ornamental crown spread. The overall development of the subject tree was examined to have sections of exposed deadwood and extensive decay. Subject tree is in fair to poor condition. | Subject tree will be in direct conflict with the proposed development area ( <i>building footprint, lot excavation requirements, site layout</i> ) and will be within the zone of the heaviest site disturbance & construction related activities occurring on-site. | Unsuitable | Remove | 1.7 |
| 84 | Yes | On-site | | Common fig | <i>Ficus carica</i> | 14/14<br>/23 | 35 | 6 | Fruiting species. The overall growth of the tree was examined to have a single stemmed structured growth form with a ornamental crown spread. The overall development of the subject tree was examined to have sections of exposed deadwood and extensive decay. Subject tree is in fair to poor condition. | Subject tree will be in direct conflict with the proposed development area ( <i>building footprint, lot excavation requirements, site layout</i> ) and will be within the zone of the heaviest site disturbance & construction related activities occurring on-site. | Unsuitable | Remove | 3.1 |
| 85 | Yes | On-site | | Common fig | <i>Ficus carica</i> | 19/19<br>/21 | 30 | 5 | Fruiting species. The overall growth of the tree was examined to have a single stemmed structured growth form with a ornamental crown spread. The overall development of the subject tree was examined to have sections of exposed deadwood and extensive decay. Subject tree is in fair to poor condition. | Subject tree will be in direct conflict with the proposed development area ( <i>building footprint, lot excavation requirements, site layout</i> ) and will be within the zone of the heaviest site disturbance & construction related activities occurring on-site. | Unsuitable | Remove | 3.6 |

Photo 5 - Facing towards on-site trees #83, #84, and #85

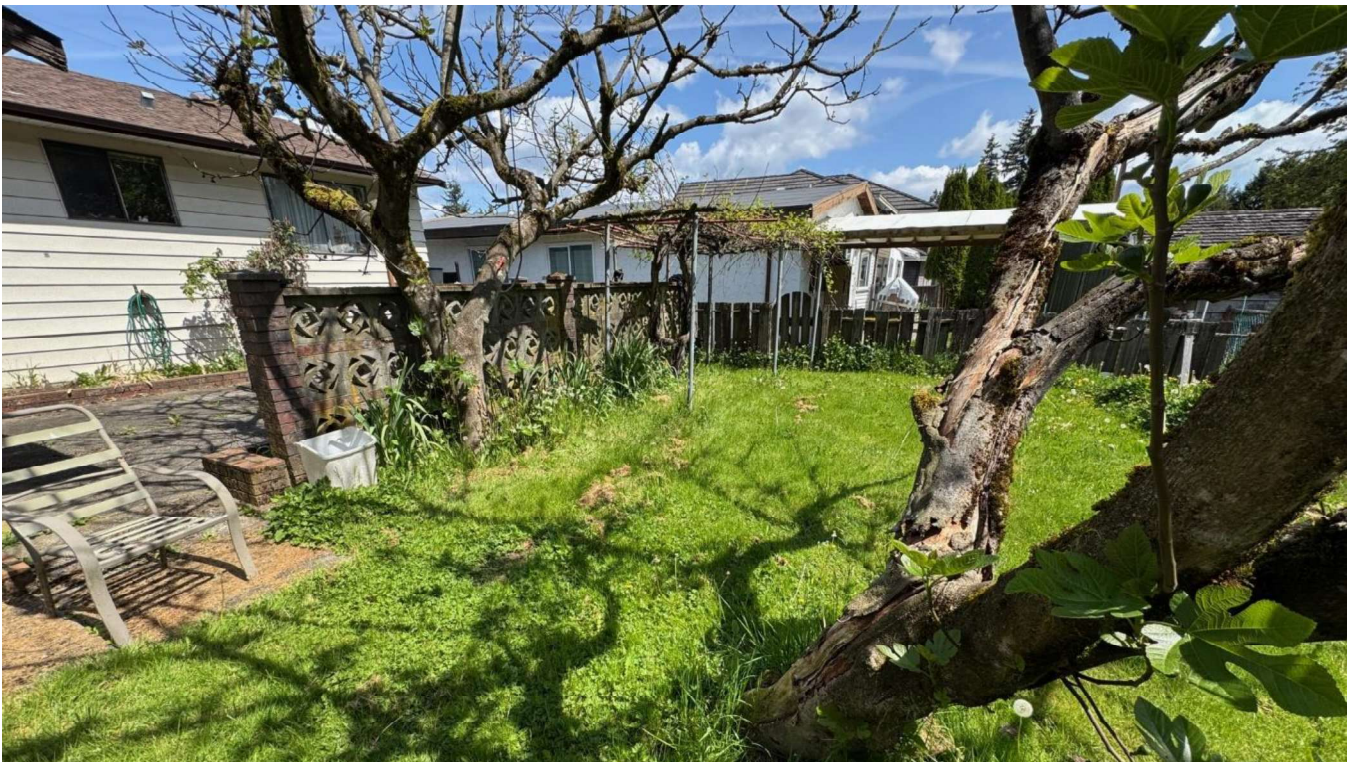
Photo 6 - Facing towards the lower trunks of on-site trees #84 and #85

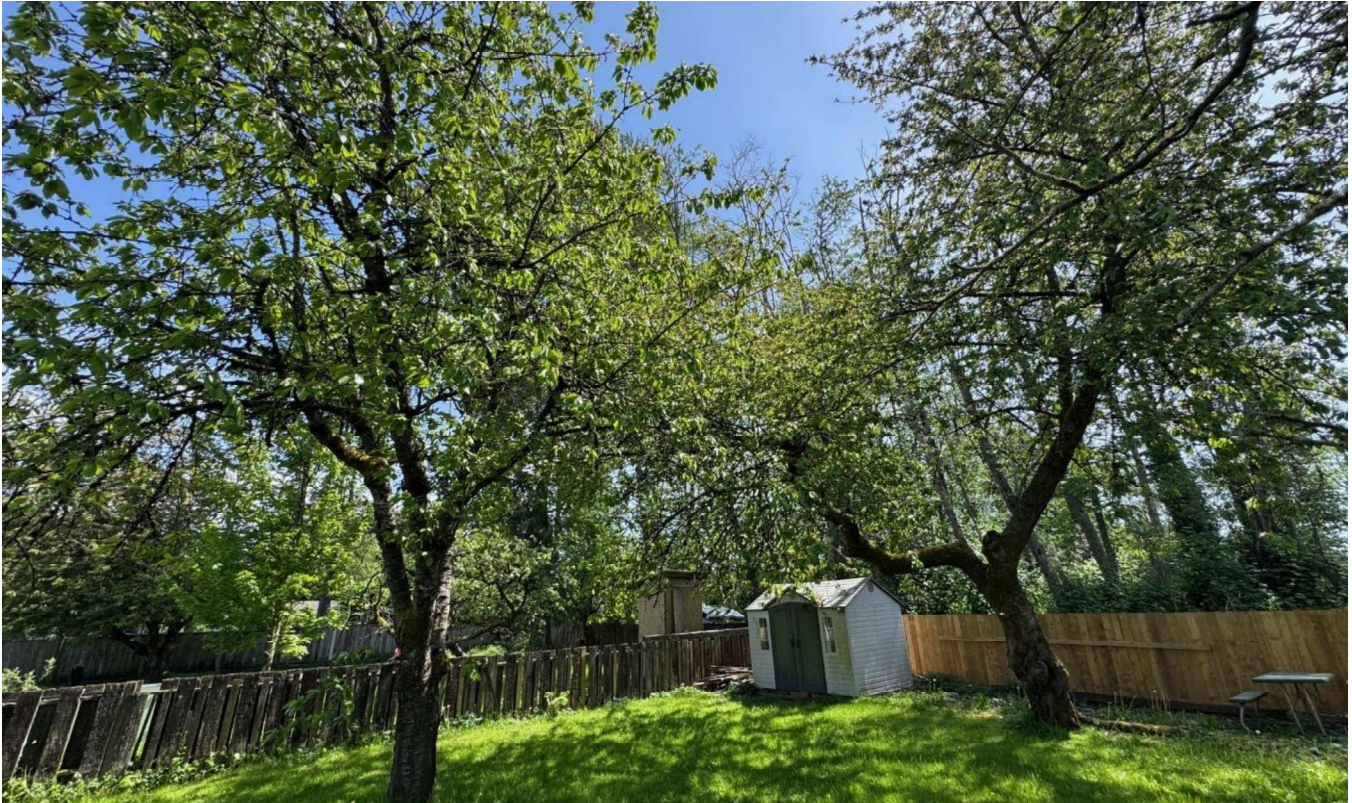
| Table 1 - On-site Tree Inventory | | | | | | | | | | | | |
|---|---|---|---|---|---|---|---|---|---|---|---|---|
| 80 | Yes | On-site | Common cherry | <i>Prunus</i> Sp. | 32/26 | 65 | 8 | Mature deciduous fruiting tree. Subject tree was examined to have developed a co dominant stemmed structured overall growth form and further develops into multiple stems. The overall development of the crown was examined to have been pruned in other past. The overall growth of the crown was observed to be healthy. Subject tree is in fair condition. | Subject tree will be in direct conflict with the proposed development area ( <i>building footprint, lot excavation requirements, site layout</i> ) and will be within the zone of the heaviest site disturbance & construction related activities occurring on-site. | Marginal | Remove | 3.5 |
| 81 | Yes | On-site | Common cherry | <i>Prunus</i> Sp. | 51 | 60 | 8 | Mature fruiting tree with a multi stemmed structured growth form. Subject tree was examined to have been previously pruned in the past and several larger scaffold stems was observed to have been removed. The overall development of the subject tree was examined to have several callus wounds. Dominant and healthy overall growth form. Subject tree is in fair condition. | Subject tree will be in direct conflict with the proposed development area ( <i>building footprint, lot excavation requirements, site layout</i> ) and will be within the zone of the heaviest site disturbance & construction related activities occurring on-site. | Marginal | Remove | 3.1 |

Photo 7 - Facing towards on-site trees #80 and #81

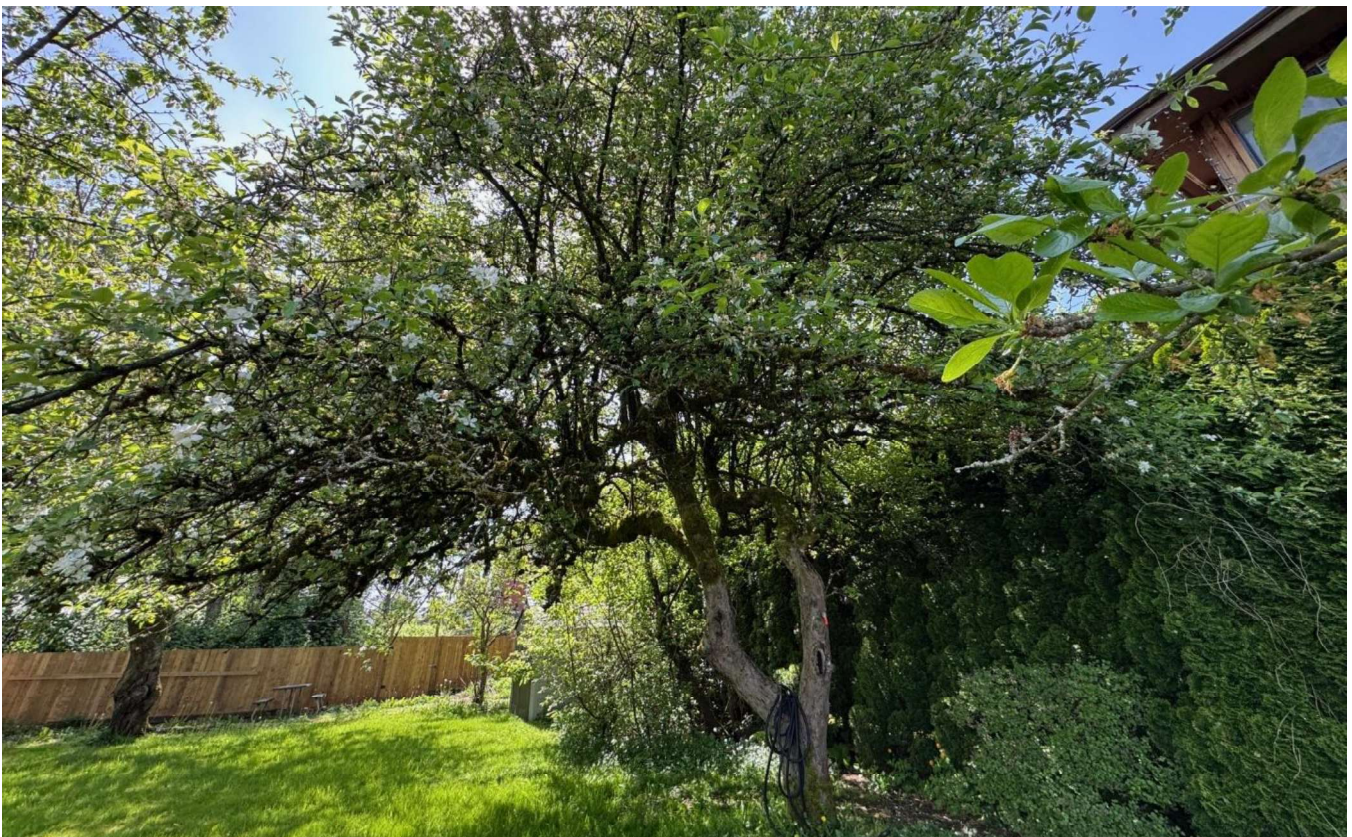
| Table 1 - On-site Tree Inventory | | | | | | | | | | | | |
|---|---|---|---|---|---|---|---|---|---|---|---|---|
| 82 | Yes | On-site | Common apple | <i>Malus domestica</i> | 24/29 | 45 | 7 | Fruiting tree with a typical species growth form. Subject tree was examined to have been previously pruned in the past and several larger scaffold stems was observed to have been removed. The overall development of the subject tree was examined to have several callus wounds. Subject tree is in fair condition. | Subject tree will be in direct conflict with the proposed development area ( <i>building footprint, lot excavation requirements, site layout</i> ) and will be within the zone of the heaviest site disturbance & construction related activities occurring on-site. | Marginal | Remove | 3.1 |

Photo 8 - Facing towards on-site tree #82

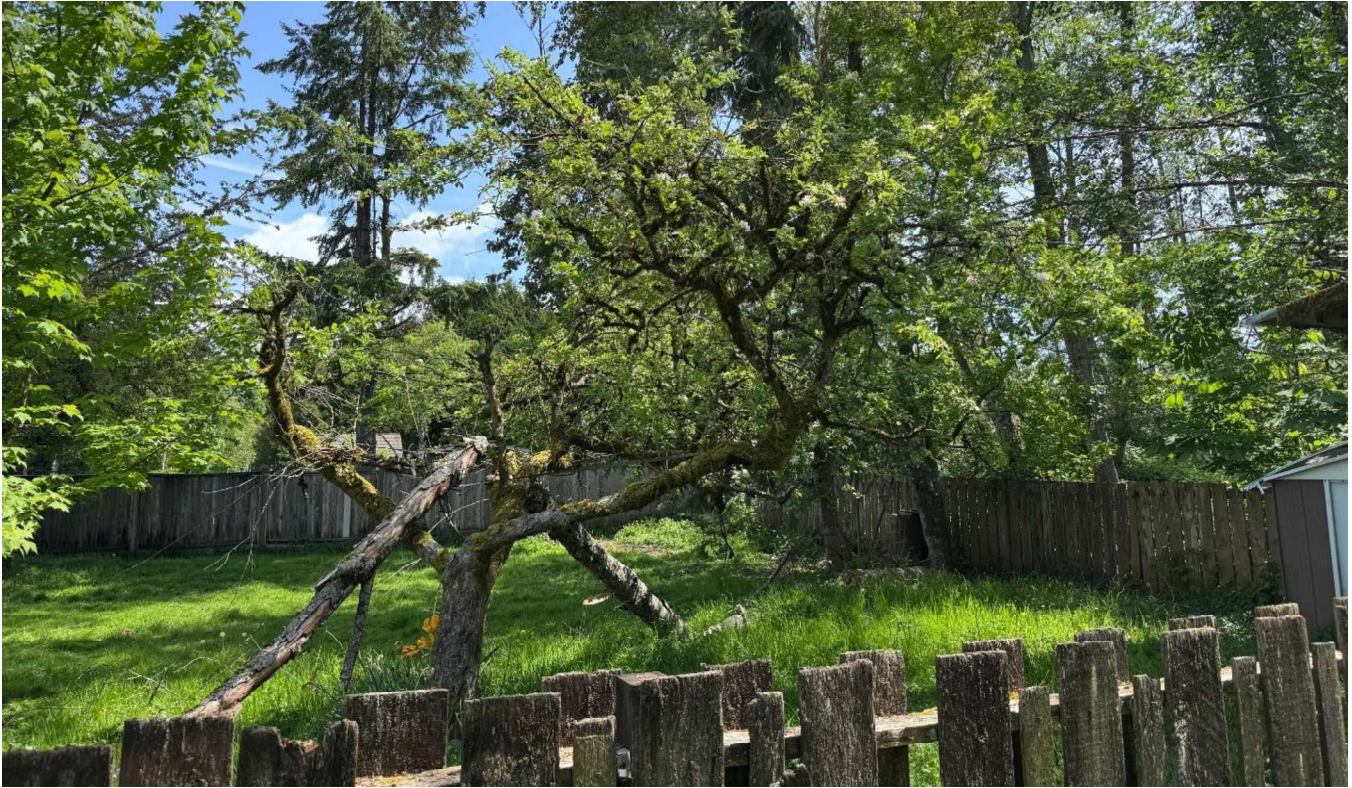
| Table 1 - On-site Tree Inventory | | | | | | | | | | | | |
|---|---|---|---|---|---|---|---|---|---|---|---|---|
| 79 | No | On-site | Common apple | <i>Malus domestica</i> | 20/23 /18 | 65 | 9 | Fruiting tree with a multi stemmed structured growth form. Larger section of the tree was observed to be dead with a decayed overall structure. Main leader had failed in the past. Subject tree was examined to have been previously pruned in the past and several larger scaffold stems was observed to have been removed. Subject tree is in poor condition. | Subject tree will be in direct conflict with the proposed development area ( <i>building footprint, lot excavation requirements, site layout</i> ) and will be within the zone of the heaviest site disturbance & construction related activities occurring on-site. | Unsuitable | Remove | 3.7 |

| ID# | Surveyed<br>Y/N | On-site (ON)<br>Off-site (OFF) | City (C) | Common name | Botanical name | DBH (cm) | LCR (%) | Canopy (Dia. M) | Condition | Comments | Retention<br>Suitability | Retain /<br>Remove | TPZ<br>(m) |
|---|---|---|---|---|---|---|---|---|---|---|---|---|---|
| 87 | Yes | On-site | | Red alder | <i>Alnus rubra</i> | 30 | 65 | 8 | Native deciduous tree with a phototropic growth form. Single stemmed structured. The overall growth of the canopy was examined to be suppressed by the growth of surrounding trees. Main stem was observed to have a phototropic lean. Subject tree is in fair TO poor condition. | Subject tree will be in direct conflict with the proposed development area ( <i>building footprint, lot excavation requirements, site layout</i> ) and will be within the zone of the heaviest site disturbance & construction related activities occurring on-site. | Unsuitable | Remove | 1.8 |

Photo 9 - Facing towards the southwestern section of the property and looking at on-site trees #79 and #87

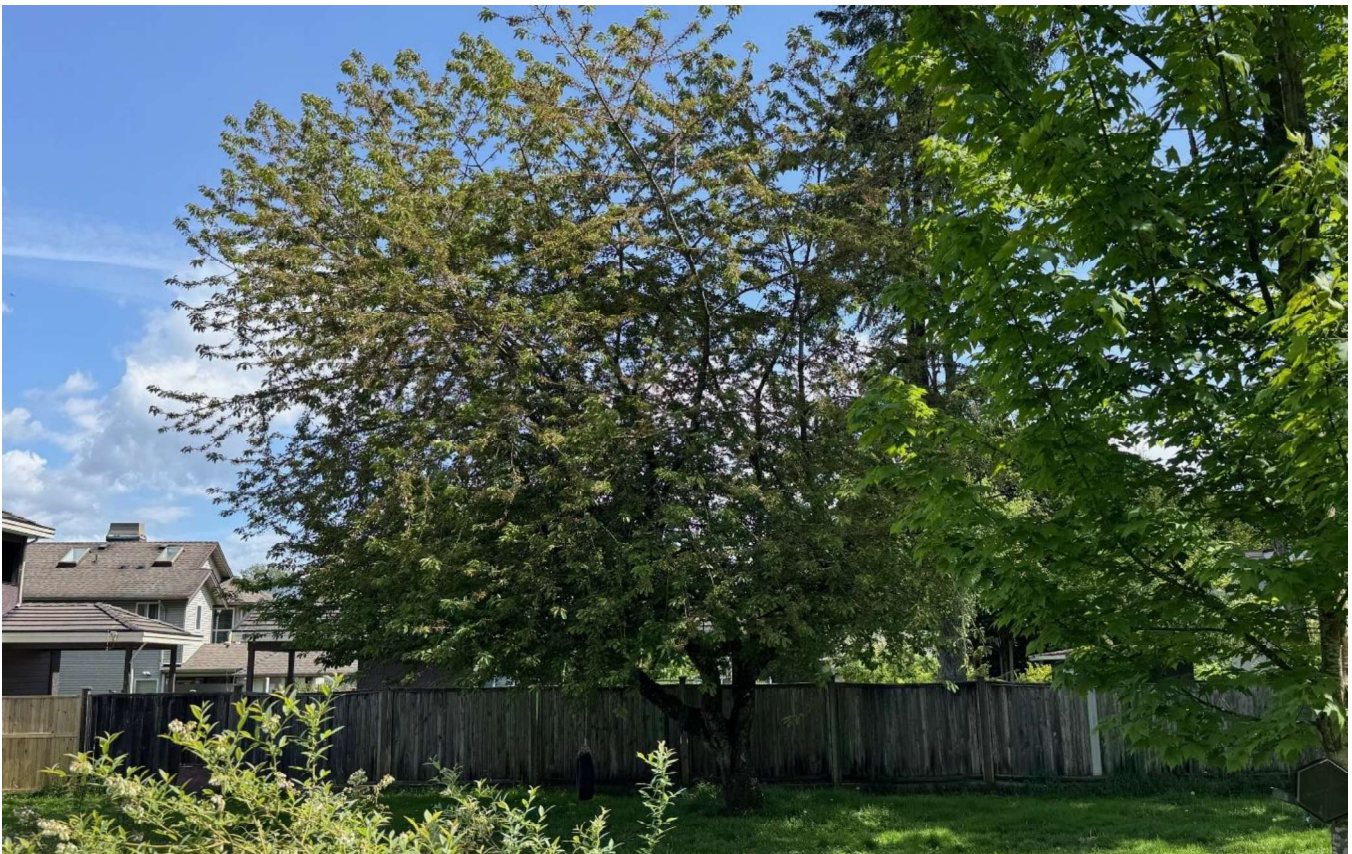
| ID# | Surveyed<br>Y/N | On-site (ON)<br>Off-site (OFF) | City (C) | Common name | Botanical name | DBH (cm) | LCR (%) | Canopy (Dia. M) | Condition | Comments | Retention<br>Suitability | Retain /<br>Remove | TPZ<br>(m) |
|---|---|---|---|---|---|---|---|---|---|---|---|---|---|
| 86 | Yes | On-site | | Common cherry | <i>Prunus</i> Sp. | 53 | 70 | 8 | Fruiting tree with a multi stemmed structured growth form. Subject tree was examined to have been previously pruned in the past and several larger scaffold stems was observed to have been removed. The overall development of the subject tree was examined to have several callus wounds along with open cavities. Subject tree is in fair condition. | Subject tree will be in direct conflict with the proposed development area ( <i>building footprint, lot excavation requirements, site layout</i> ) and will be within the zone of the heaviest site disturbance & construction related activities occurring on-site. | Marginal | Remove | 3.2 |

Photo 10 - Facing towards on-site tree #86

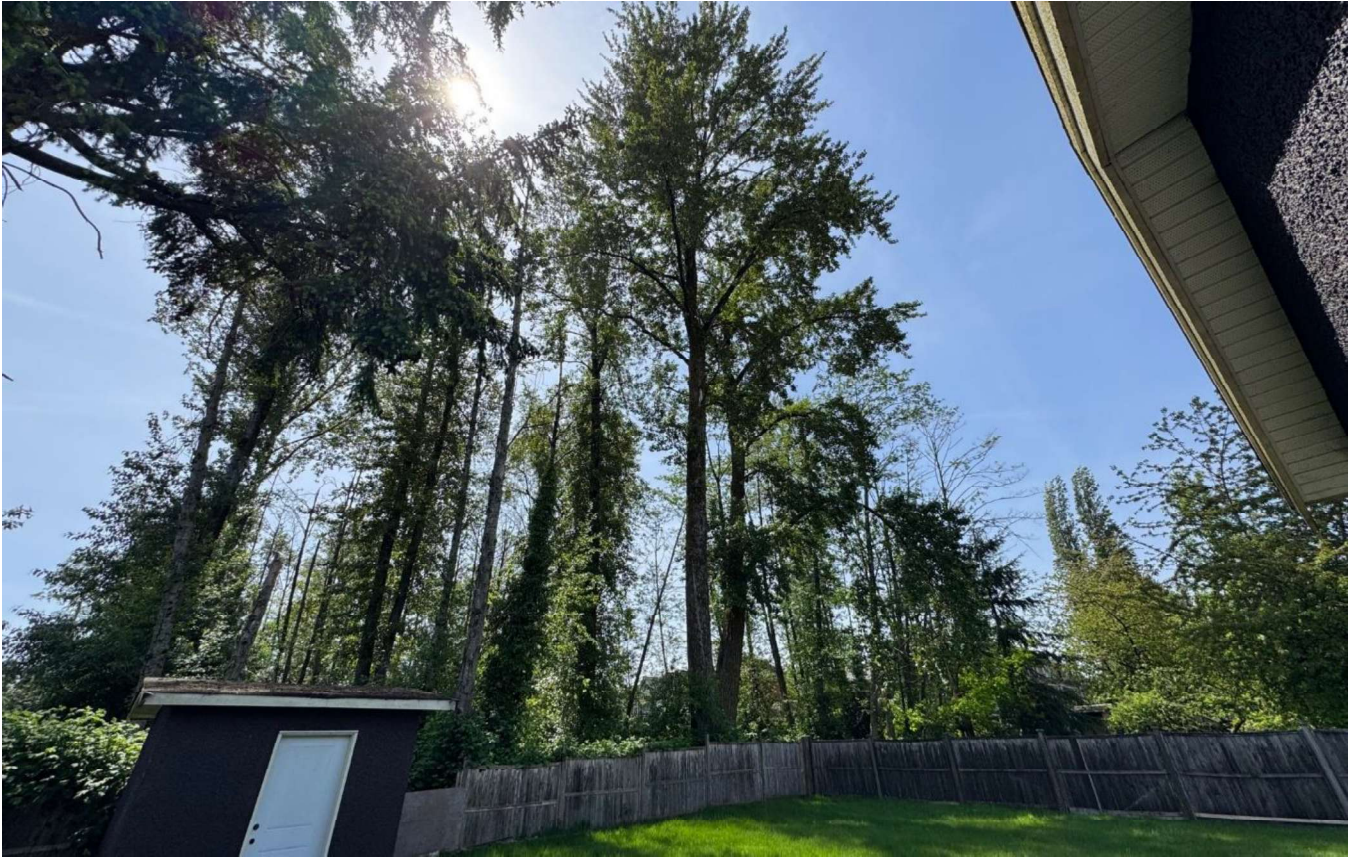
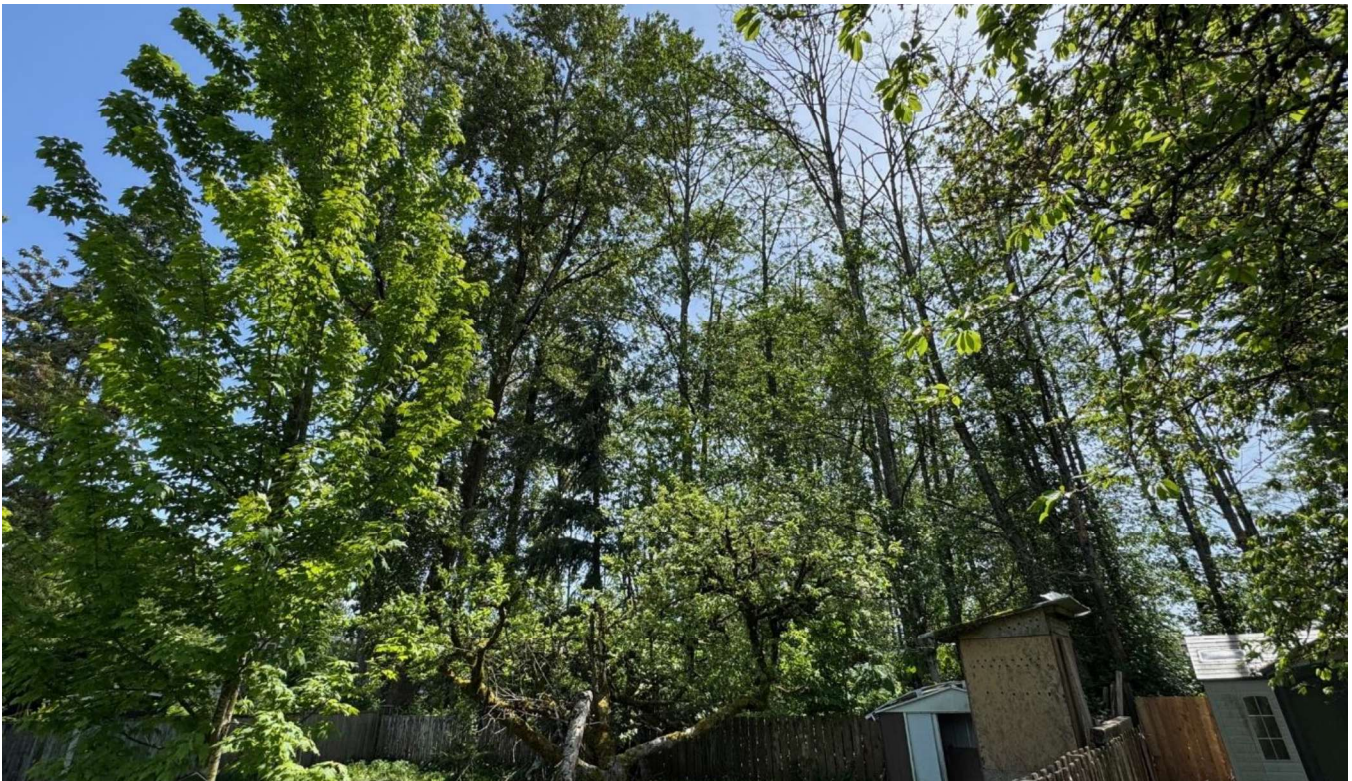
| Table 2 - Off-site Tree Inventory | | | | | | | | | | | | | |
|---|---|---|---|---|---|---|---|---|---|---|---|---|--|
| OS1 | Yes | Off-site | Red alder | <i>Alnus rubra</i> | 41<br>(Surveyed) | 65 | 8 | Native deciduous tree with a phototropic growth form. Single stemmed structured. The overall growth of the canopy was examined to be suppressed by the growth of surrounding trees. Main stem was observed to have a phototropic lean. Subject tree is in fair condition. | Subject tree will be in direct conflict with the proposed development area ( <i>building footprint, lot excavation requirements, site layout</i> ) and will be within the zone of the heaviest site disturbance & construction related activities occurring within the limits of the site. <b><i>The neighbor's authorization will be required for its removal.</i></b> | Marginal | Remove | 2.5 | |
| OS2 | Yes | Off-site | Eastern cottonwood | <i>Populus deltoides</i> | 90/90<br>(Surveyed) | 70 | 12 | Mature, larger diameter native deciduous tree with a phototropic growth form. Co dominant stemmed structured growth form. The overall growth of the canopy was examined to be influenced by the growth of surrounding trees. Main stems were observed to have a basal lean. Subject tree is in fair condition. | Subject tree will be in direct conflict with the proposed development area ( <i>building footprint, lot excavation requirements, site layout</i> ) and will be within the zone of the heaviest site disturbance & construction related activities occurring within the limits of the site. <b><i>The neighbor's authorization will be required for its removal.</i></b> | Marginal | Remove | 10.8 | |

Photo 11 - Facing towards the southern section of the property and looking at off-site trees #OS1 and #OS2

Photo 12 - Facing towards the southern section of the property and looking at off-site trees #OS1 and #OS2

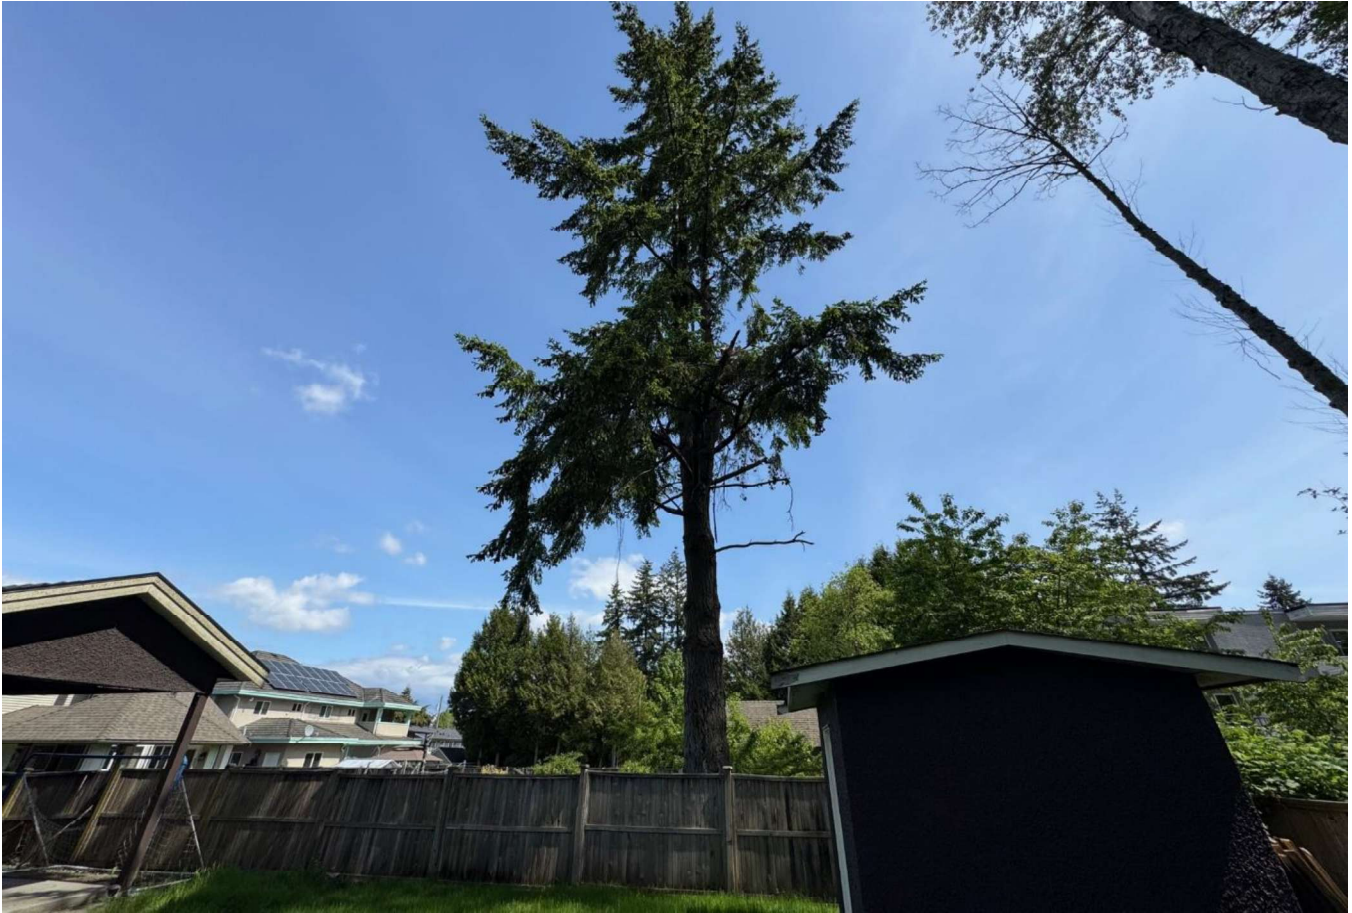
| ID# | Surveyed<br>Y/N | On-site (ON)<br>Off-site (OFF) | City (C) | Common name | Botanical name | DBH (cm) | LCR (%) | Canopy (Dia. M) | Condition | Comments | Retention<br>Suitability | Retain /<br>Remove | TPZ<br>(m) |
|---|---|---|---|---|---|---|---|---|---|---|---|---|---|
| 333 | Yes | On-site | | Douglas fir | <i>Pseudotsuga menziesii</i> | 96 | 65 | 10 | Mature coniferous tree with a larger diameter trunk. The overall growth of the subject tree was examined to have developed a single stemmed structured overall growth form and had developed a split top. The overall crown was observed to have a dominant overall crown spread. Subject tree is in fair condition. | Subject tree will be in direct conflict with the proposed development area ( <i>building footprint, lot excavation requirements, site layout</i> ) and will be within the zone of the heaviest site disturbance & construction related activities occurring on-site. | Marginal | Remove | 5.8 |

**Photo 13 - Facing towards on-site tree #333**

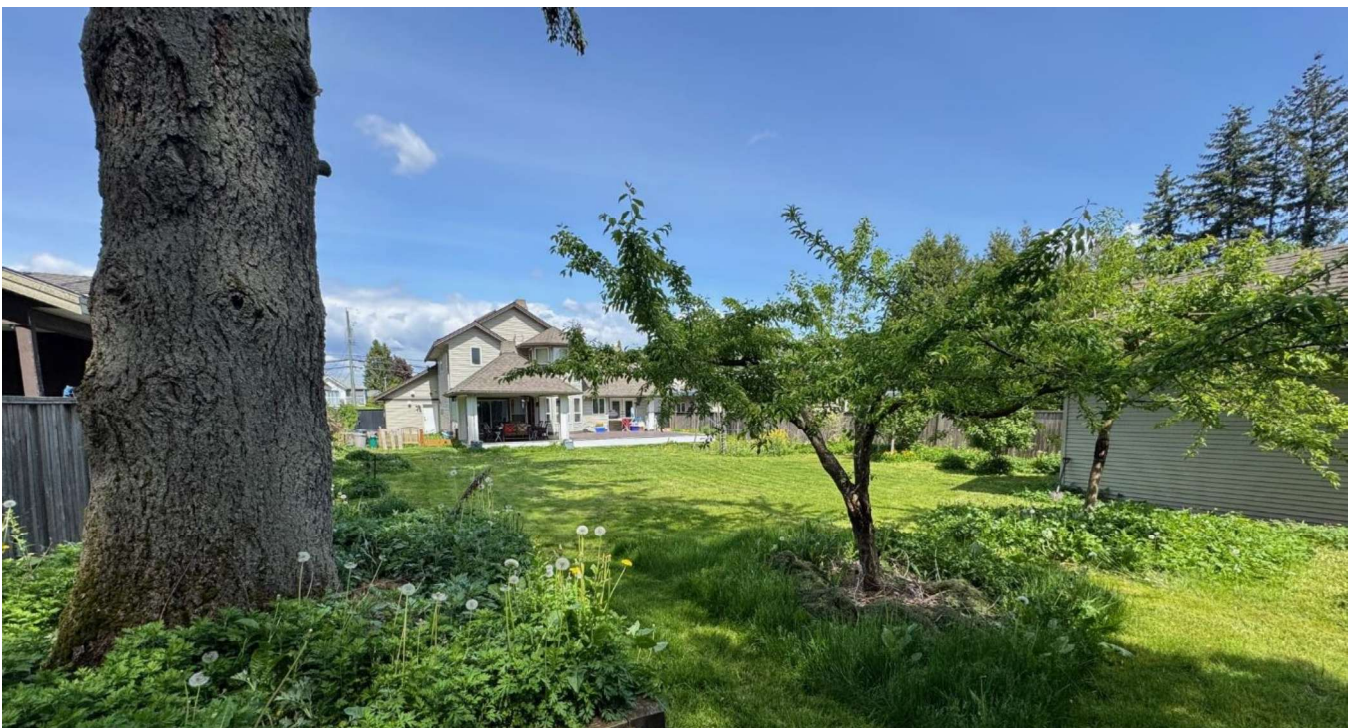
| ID# | Surveyed<br>Y/N | On-site (ON)<br>Off-site (OFF) | City (C) | Common name | Botanical name | DBH (cm) | LCR (%) | Canopy (Dia. M) | Condition | Comments | Retention<br>Suitability | Retain /<br>Remove | TPZ<br>(m) |
|---|---|---|---|---|---|---|---|---|---|---|---|---|---|
| 332 | No | On-site | | Common plum | <i>Prunus domestica</i> | 9/8/11/8 | 55 | 4 | Smaller sized fruiting species. The overall growth of the subject tree was examined to have developed a multi stemmed structured overall growth form. The overall crown was observed to have developed in common with its species. Crown was examined to have been shaped. Subject tree is in fair to good condition. | Subject tree will be in direct conflict with the proposed development area ( <i>building footprint, lot excavation requirements, site layout</i> ) and will be within the zone of the heaviest site disturbance & construction related activities occurring on-site. | Suitable | Remove | 1.7 |

**Photo 14 - Facing towards the lower trunk of on-site trees #333 and #332**

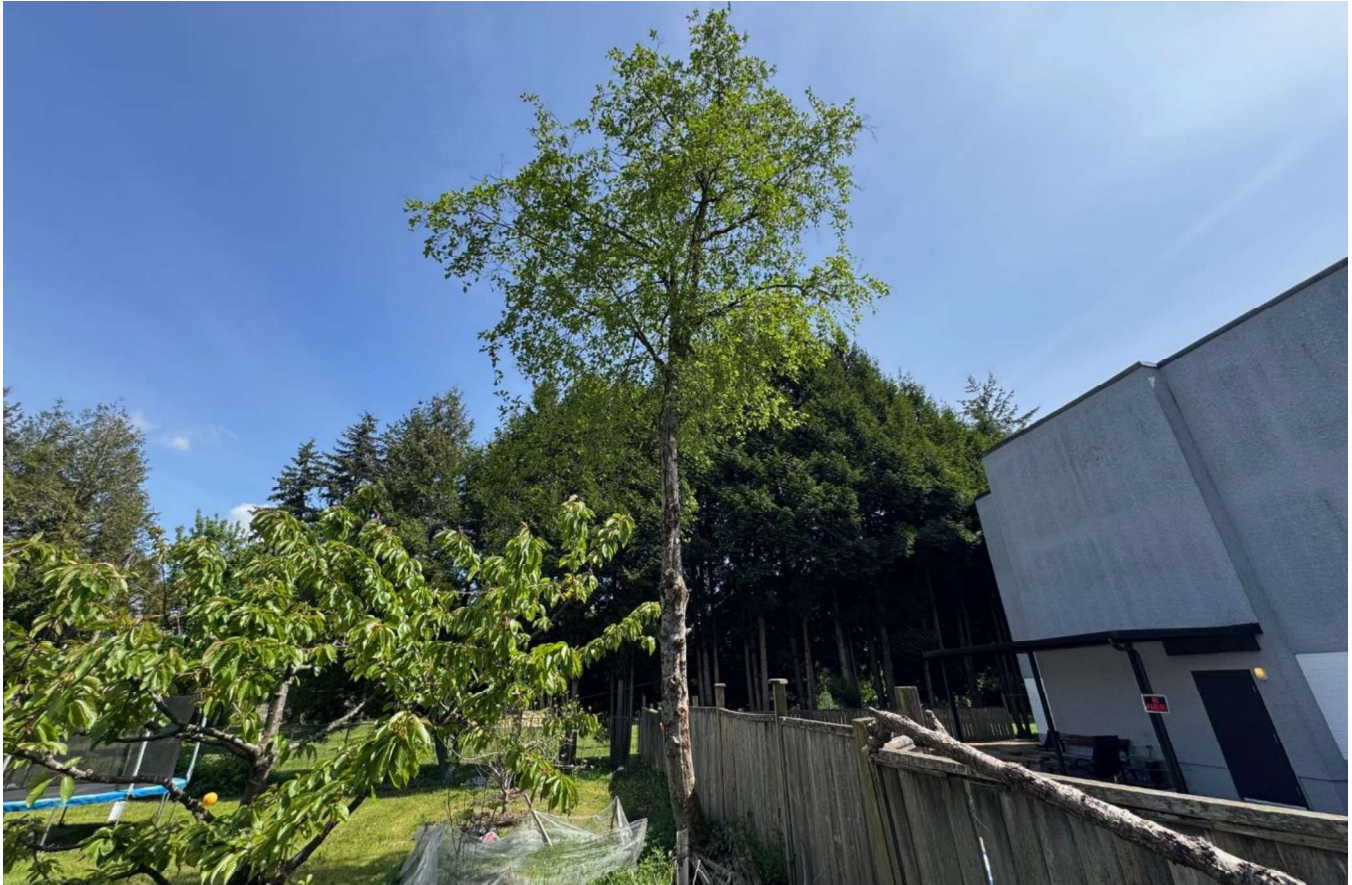
| ID# | Surveyed<br>Y/N | On-site (ON)<br>Off-site (OFF) | City (C) | Common name | Botanical name | DBH (cm) | LCR (%) | Canopy (Dia. M) | Condition | Comments | Retention<br>Suitability | Retain /<br>Remove | TPZ<br>(m) |
|---|---|---|---|---|---|---|---|---|---|---|---|---|---|
| 334 | Yes | On-site | | Red alder | <i>Alnus rubra</i> | 35 | 65 | 8 | Native deciduous tree with a phototropic growth form. Single stemmed structured. The overall growth of the canopy was examined to be suppressed by the growth of surrounding trees. Main stem was observed to have a phototropic lean. Subject tree is in fair TO poor condition. | Subject tree will be in direct conflict with the proposed development area ( <i>building footprint, lot excavation requirements, site layout</i> ) and will be within the zone of the heaviest site disturbance & construction related activities occurring on-site. | Marginal | Remove | 2.1 |

**Photo 15 - Facing towards the south eastern section of the property and looking at on-site tree #334**

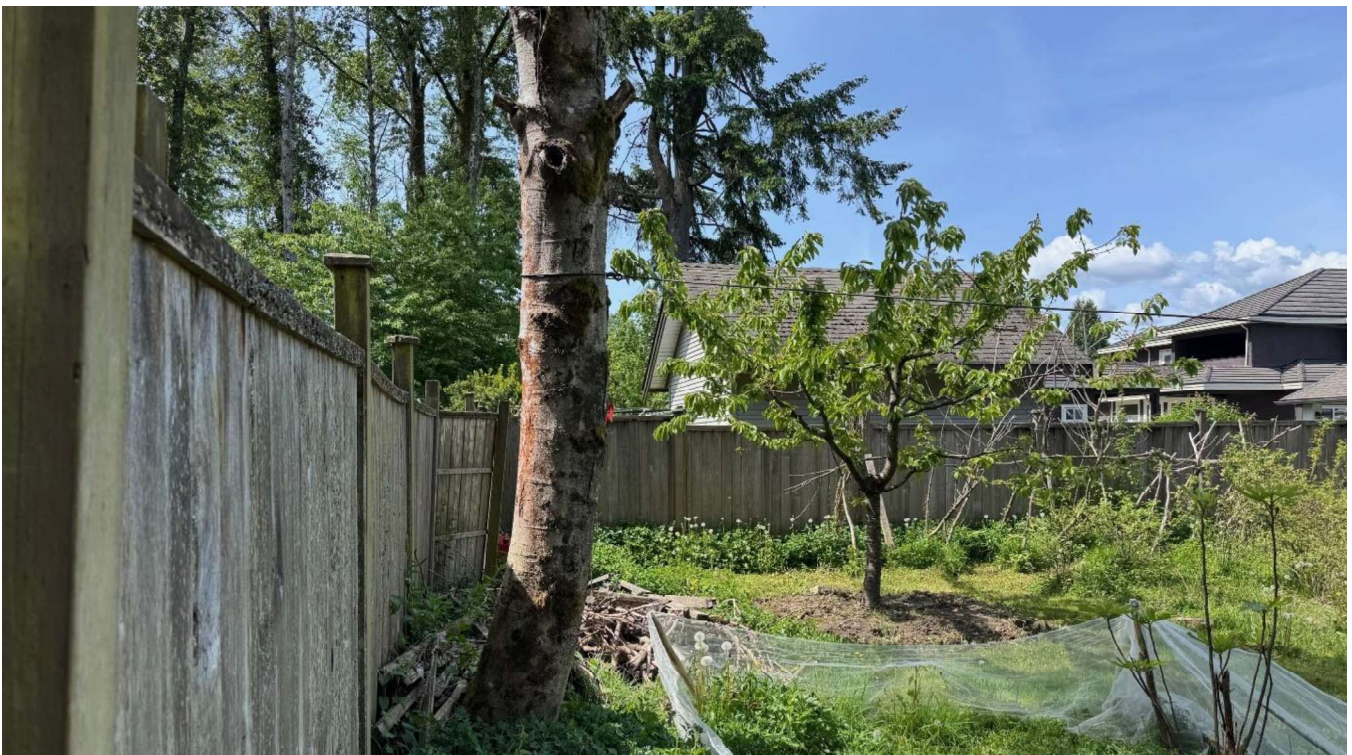
**Photo 16 - Facing towards the lower trunk of on-site tree #334**
