## CERTIFIED ARBORIST REPORT

11810, 11818, 11820, 11824, 11828, 11838 90 Ave, Delta

May 8, 2025

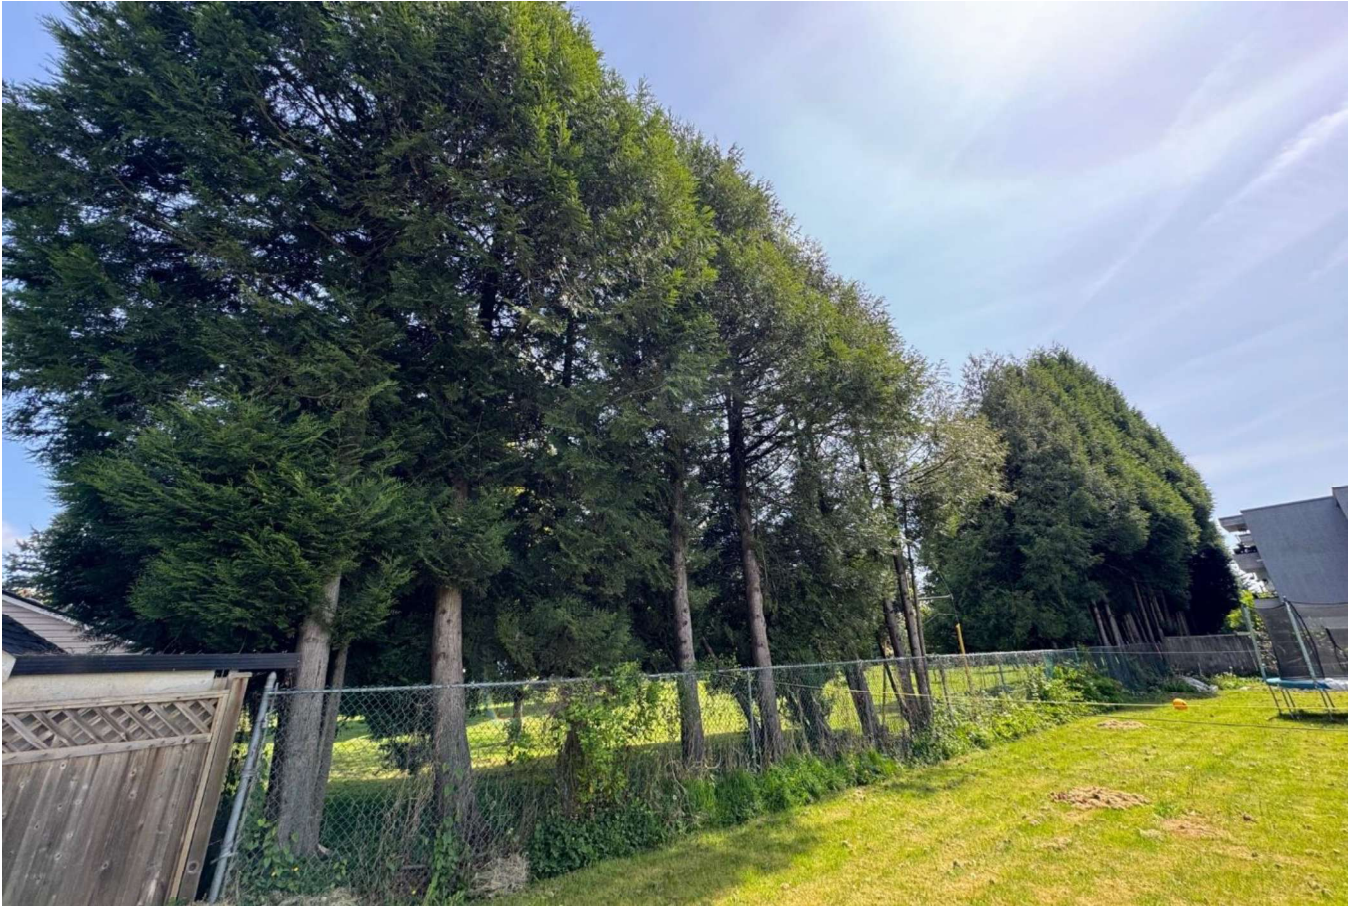
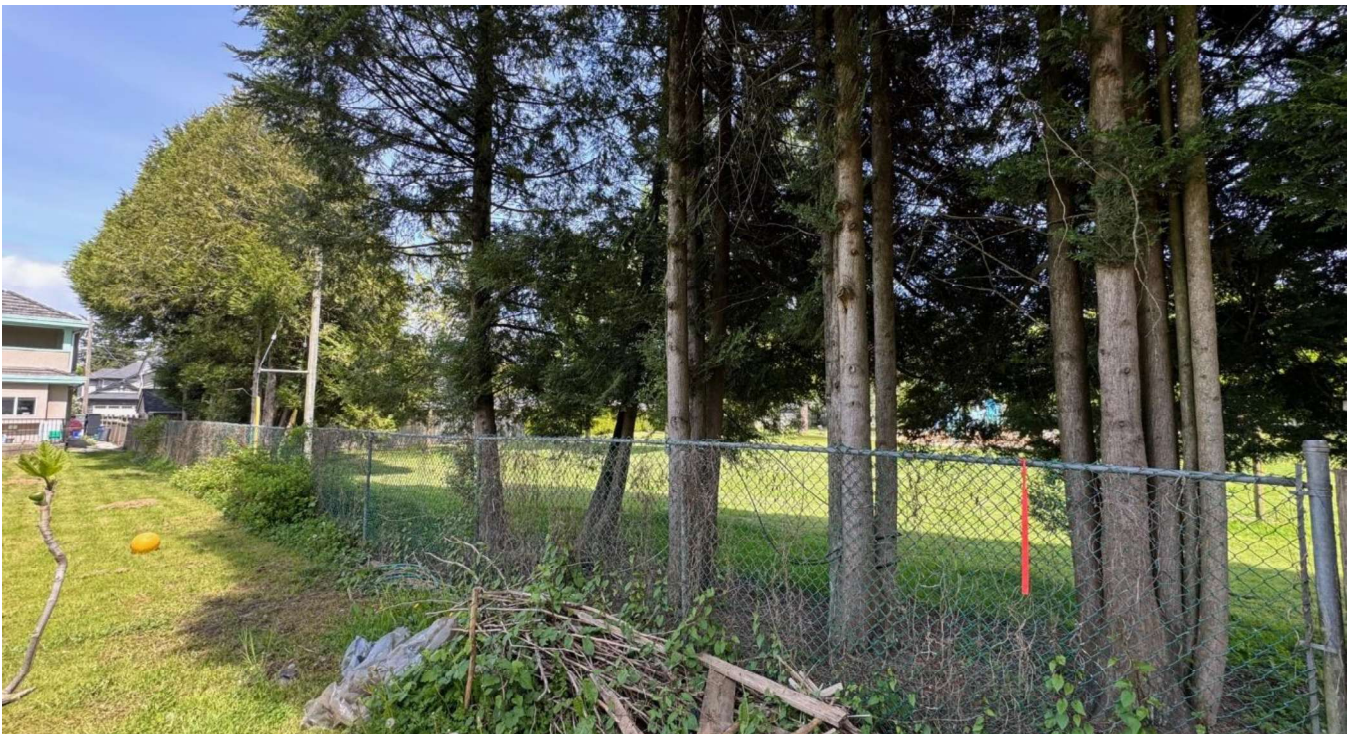
Photo 17 - Facing towards city trees #C5 - #C17

Photo 18 - Facing towards city trees #C5 - #C17

**City trees #C5, #C6, #C7, #C8, #C9, #C10, #C11, #C12, #C13, #C14, #C15, #C16, and #C17** has been recommended to be retained as part of the proposed apartment development project. As the protected trees were examined to be situated near the limits of the proposed construction, lot grading, site servicing related activities occurring on-site, the subject trees will require the placement of Tree Protection Barriers in order to protect their trunks, roots, and structures. The placement of Tree Protection Barriers would be required to be placed along their drip lines or to their specified measurements as outlined within the Tree Inventory (*TPZ Column*) or as per the attached Tree Management Plan and left throughout the duration of the development project.
