**Froggers Creek  
Tree Consultants Ltd.**

Re: 4501 Arthur Drive, Delta BC

## **Tree Preservation Report**

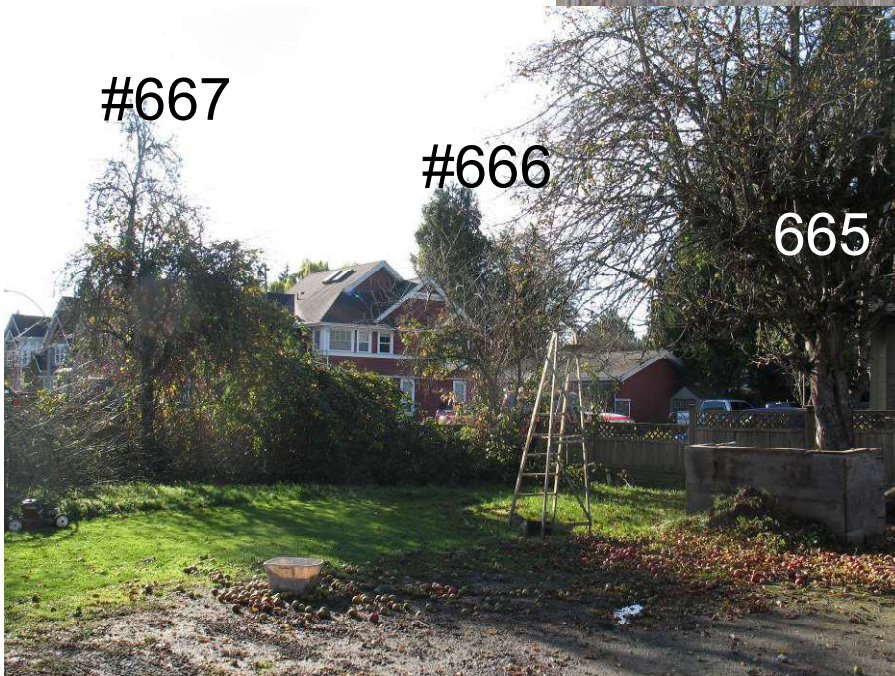
#666

| # | Type | LOC | Action | Reason | VAL | DBH | MPZ | Ht | CR | Health | Structural Condition |
|---|---|---|---|---|---|---|---|---|---|---|---|
| 666 | Apple | Onsite | Remove | Too close building | Low | 28cm | 1.7m | 4m | 3m | Poor | Poor, major decay in the trunk |

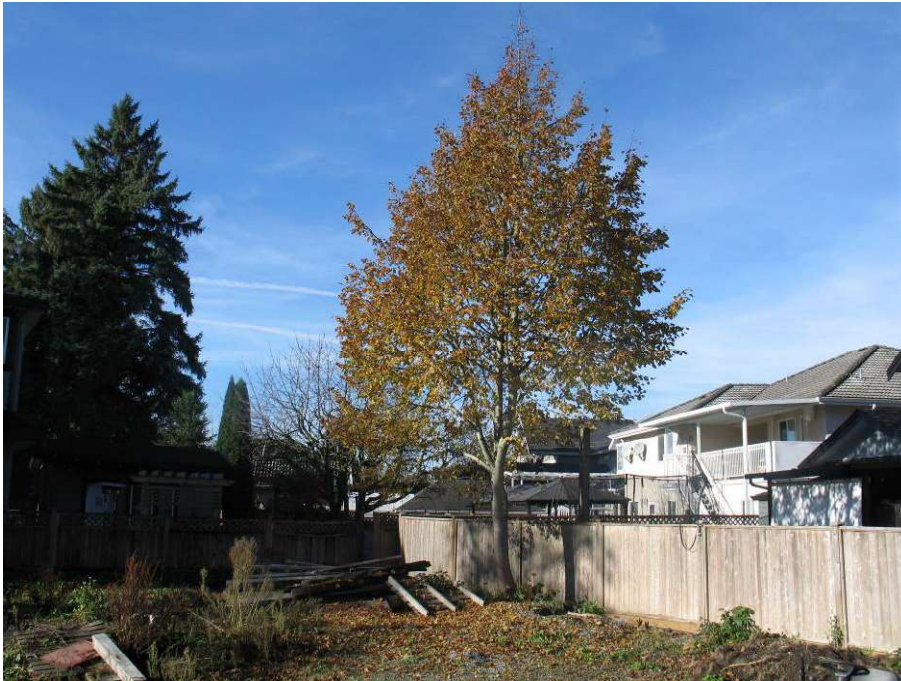
Tree 709

| # | Type | LOC | Action | Reason | VAL | DBH | MPZ | Ht | CR | Health | Structural Condition |
|---|---|---|---|---|---|---|---|---|---|---|---|
| 709 | Linden | Onsite | Remove | Inside building | Mod | 30cm | 1.8m | 10m | 4m | Fair | Covered in black berry, can't assess trunk |

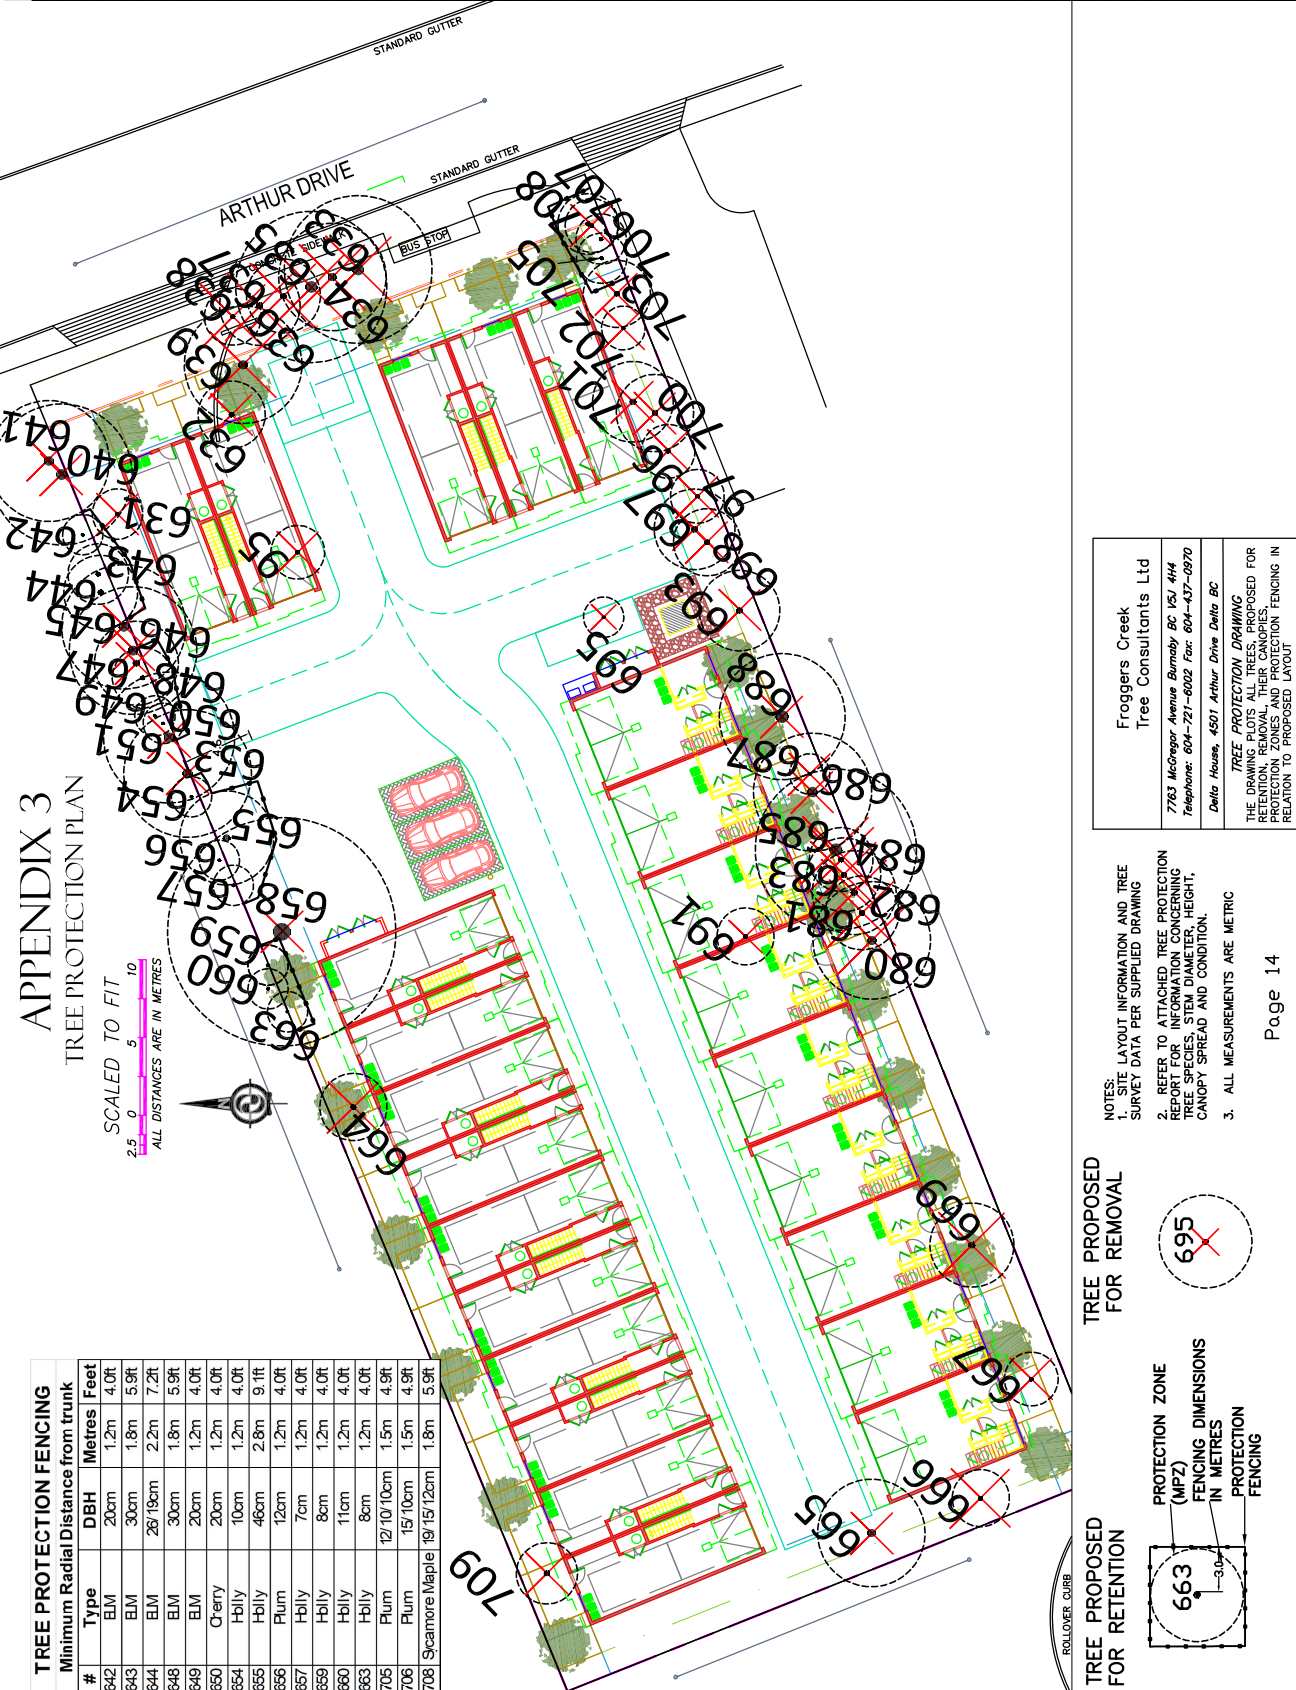
**TREE PROTECTION DRAWING**

THE DRAWING PLOTS ALL TREES, PROPOSED FOR RETENTION, REMOVAL AND PROTECTION FENCING IN RELATION TO PROPOSED LAYOUT
