## Arboricultural Assessment Report

Project File No.: 19-032

Date of Report: **November 16, 2023**

Project Name: Ladner Willows  
5625 Ladner Trunk Road  
Delta, BC.

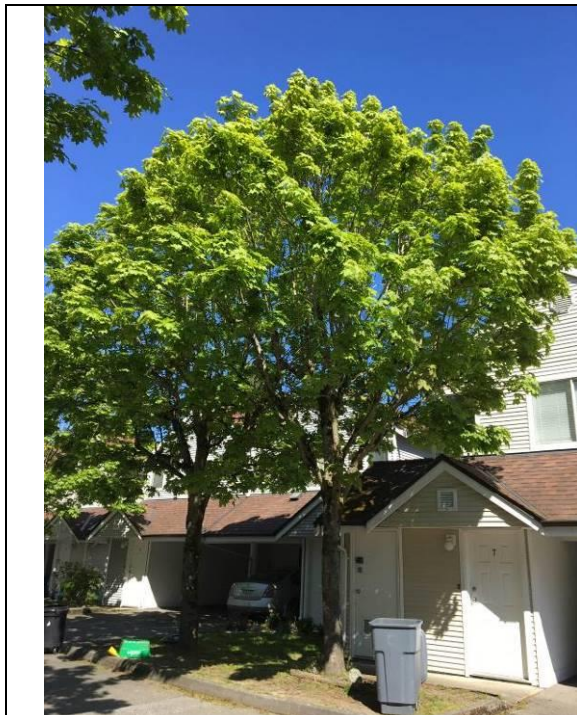
Photo 1: Tree #5152/5156 (Remove), Norway maples; typ. growing condition for all on-site Norway maples (on top of curb, in turf with compacted soil, within restricted growing area).

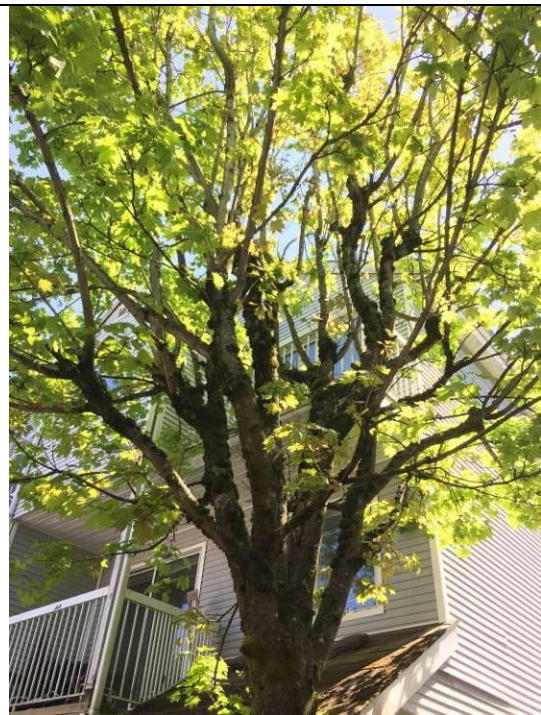
Photo 2: Tree #5155 (Remove), Norway maple; Canopy reduced, some stubs remaining, some dead wood; typ. of all on-site Norway maples.

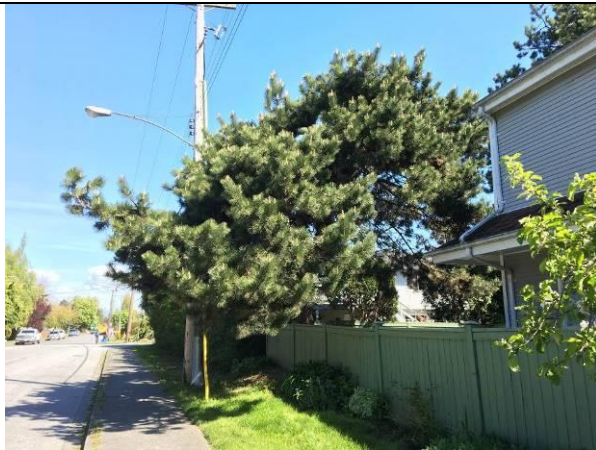
Photo 3: Tree #5153 (Remove), Scots pine; topped at 7m and clearance pruned at west side for Hydro.

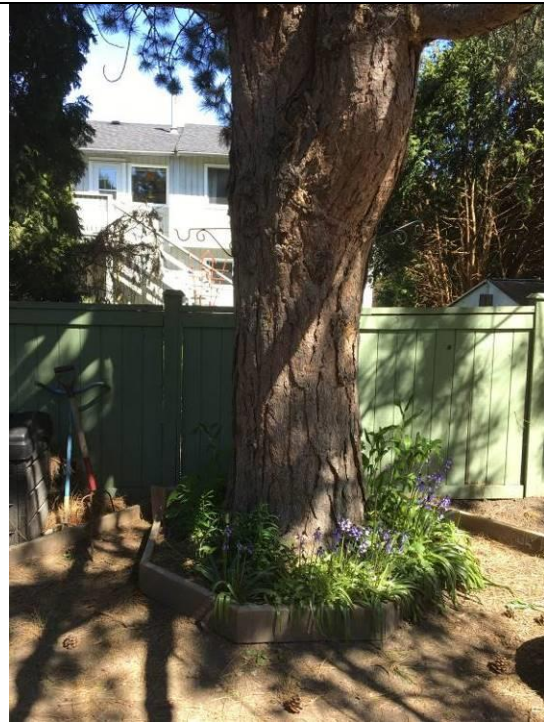
Photo 4: Tree #5136 (Remove), Scots pine; base within small perennial garden with wooden edge.

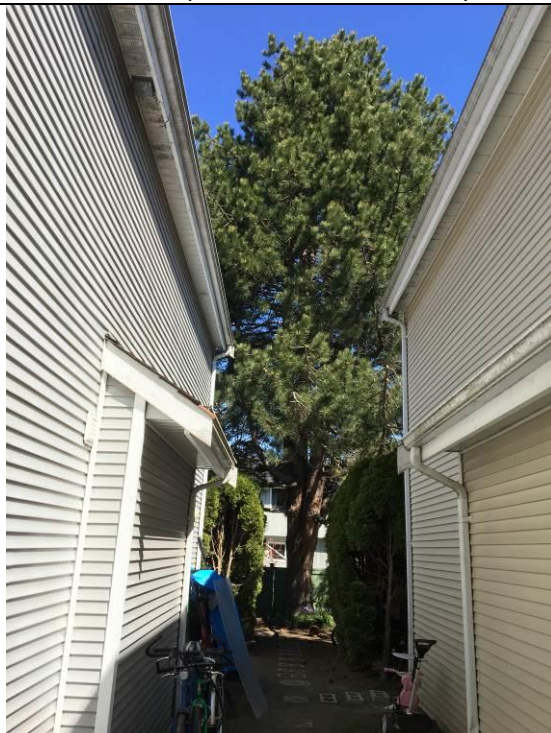
Photo 5: Tree #5136 (Remove), Scots pine; in back yards, in good condition.

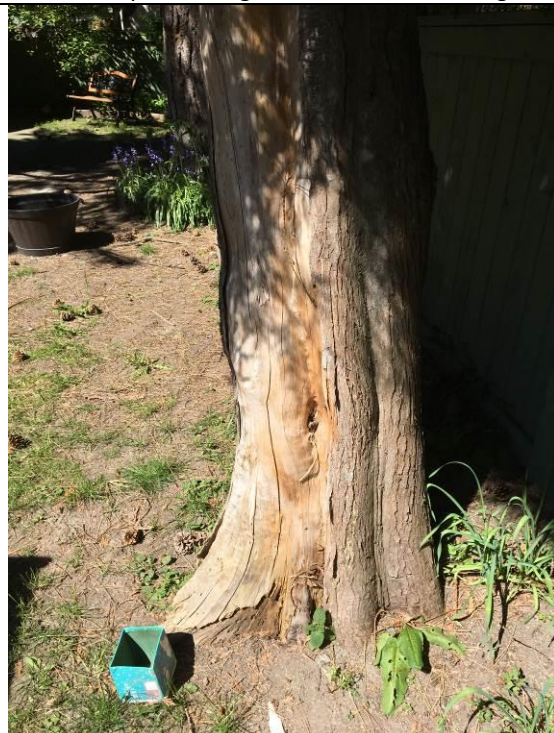
Photo 6: Tree #5151 (Remove), Lawson's cypress; stripped bark on south-side to 4m; previously topped at 5m; very poor condition.

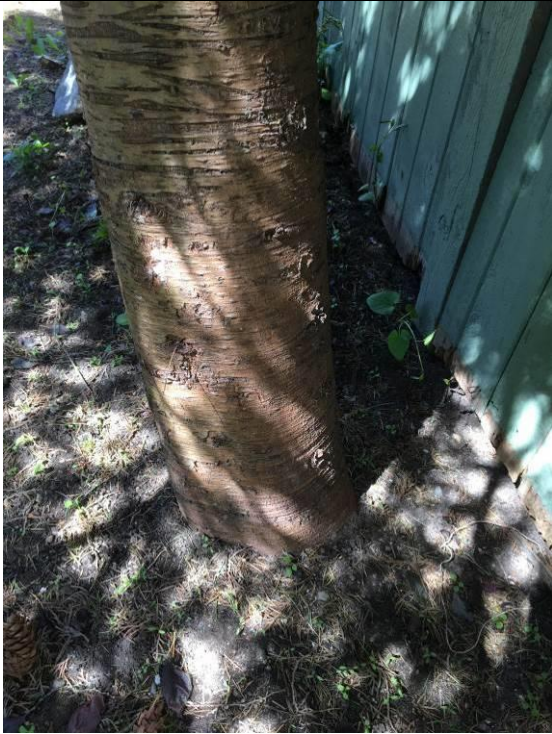
Photo 7: Tree #353 (Remove), Douglas-fir; trunk flair buried.

| Tree ID # | Botanical Name | Common Name | On Survey Y/N | Location: On, off, Shared, City | DBH (cm) | LCR (%) | Canopy (dia.) | Condition (Structure, Health, TRAQ rating) | Comments | Retention Suitability | Retain/ Remove | Tree Protection Zone (TPZ) |
|---|---|---|---|---|---|---|---|---|---|---|---|---|
| 353 | <i>Pseudotsuga menziesii</i> | Douglas-fir | N | On | 24 | 90 | 8m | Moderate condition; poor-moderate structure; interior pruning required; slight lean to south (away from fence); trunk flair buried; suppressed | Conflicts with new road | p | Remove | |

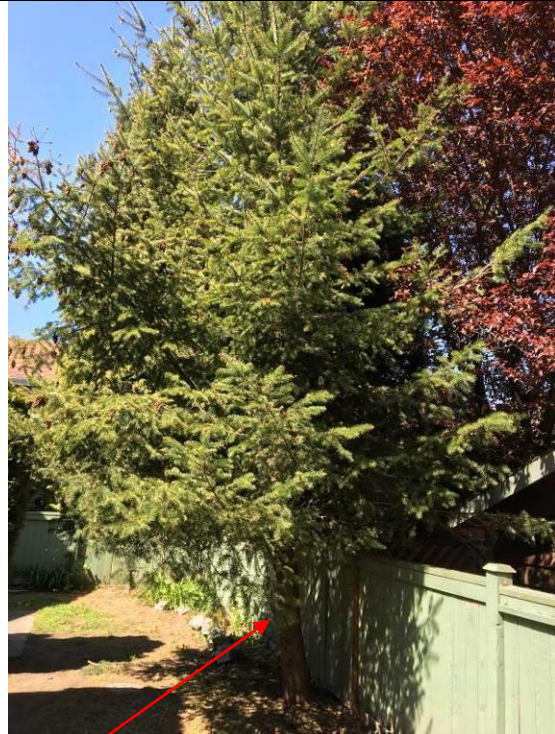
Photo 8: Tree #353 (Remove), Douglas-fir; poor-moderate branch structure.

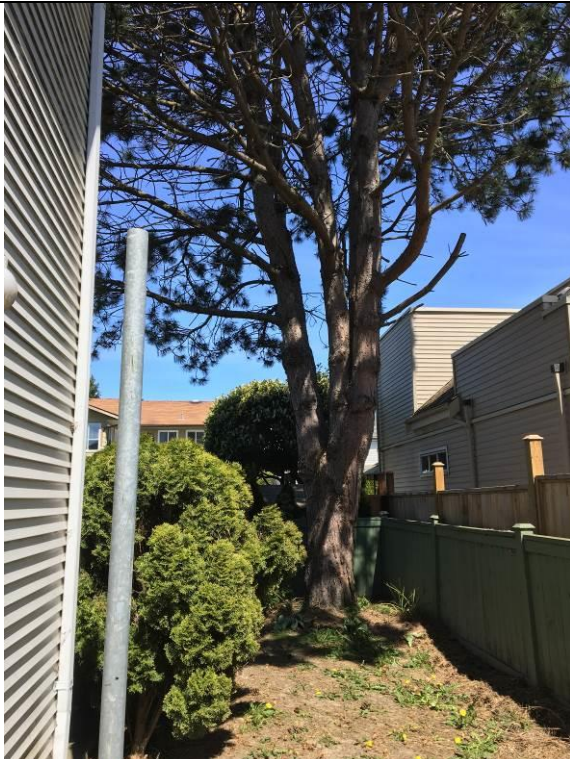
Photo 9: Tree #5138 (Remove); Scots pine; moderate-good condition

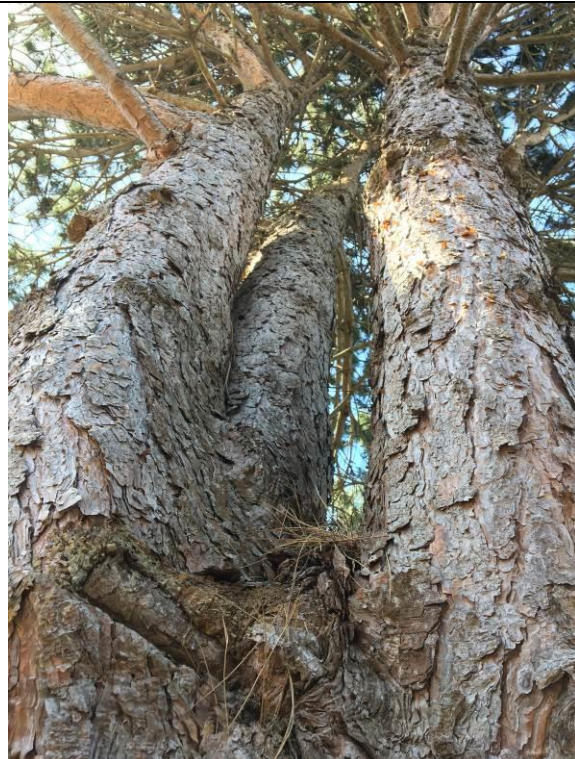
Photo 10: Tree #5138 (Remove), Scots pine; codominant stem attachment at 3m.

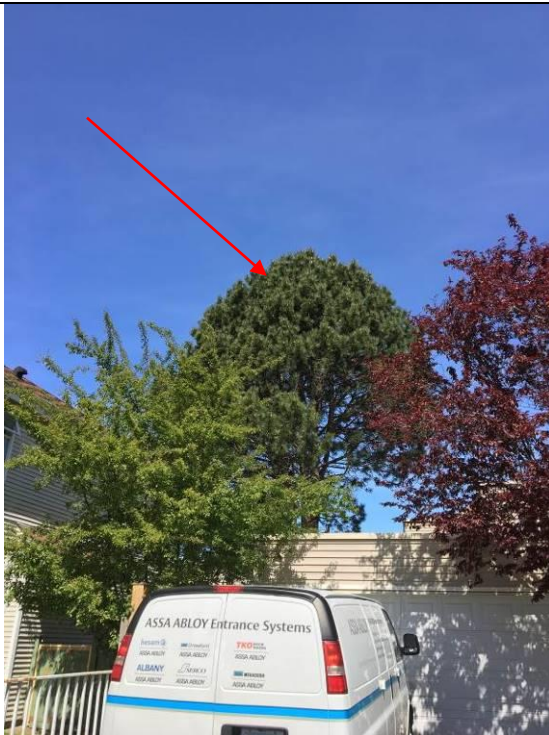
Photo 11: Tree #5138 (Remove), Scots pine; round form.

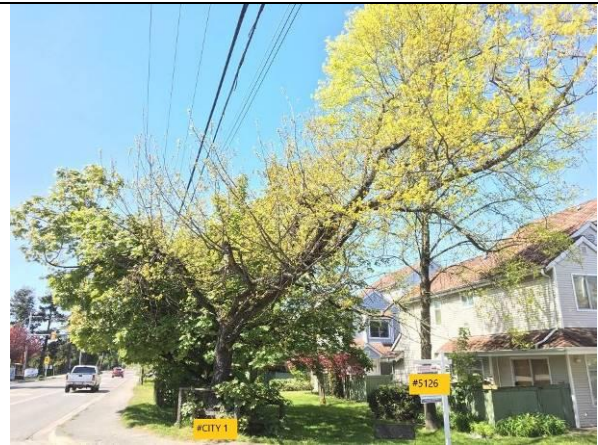
Photo 12: Tree #5126 (Remove), and Tree #CITY1 (Remove), English oak.

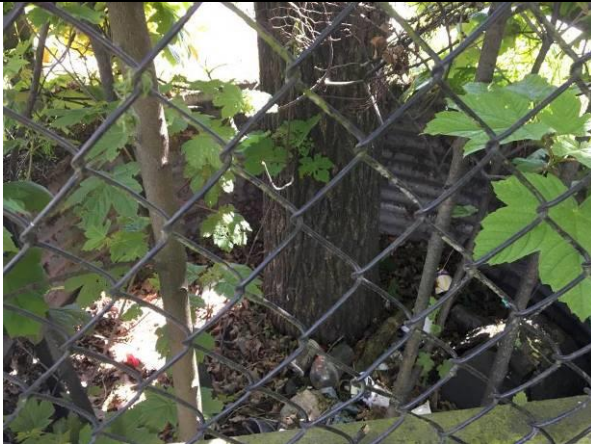
Photo 13: Tree #CITY1 (Remove), English oak; poor structure and condition; trunk flair buried, grade is 1m lower than road/sidewalk to south; growing beside a corrugated metal retaining wall, and within a fenced area.

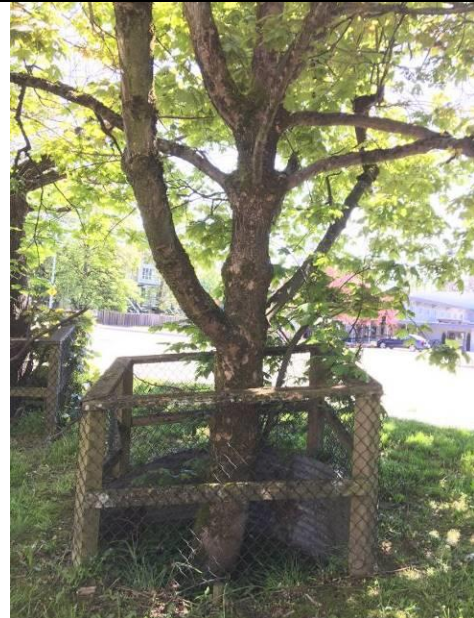
Photo 14: Tree #CITY2 (Remove), Red maple; poor to moderate condition; prolific dead wood, in decline.

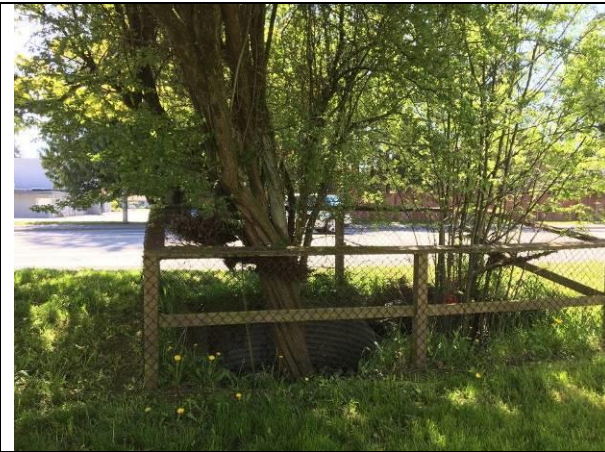
Photo 15: Tree #CITY3 (Remove), Hawthorn; growing in depression (1m lower than road) with sumac shrub at right. Hawthorn leaning to east with poor structure.

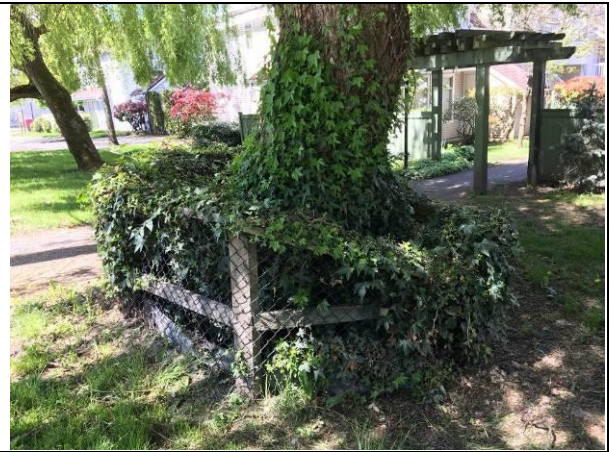
Photo 16: Tree CITY6 5107 (Remove), Weeping willow; trunk flair not visible – covered in ivy; growing within depression surrounded by corrugated metal retaining wall.

| Tree ID # | Botanical Name | Common Name | On Survey Y/N | Location: On, off, Shared, City | DBH (cm) | LCR (%) | Canopy (dia.) | Condition (Structure, Health, TRAQ rating) | Comments | Retention Suitability | Retain/ Remove | Tree Protection Zone (TPZ) |
|---|---|---|---|---|---|---|---|---|---|---|---|---|
| CITY 6 5107 | <i>Salix babylonica</i> | Weeping willow | Y | City | 81 | 65 | 20m | Moderate condition; large/mature; canopy biased to north; clearance pruned (stubbed) on south side for Hydro; torn branch (historical event) on north-east side at 0.5m - decay noted; broken branches; base not visible/covered in ivy; growing in grate (depression with corrugated steel metal retaining wall); grade is lower than road | Conflict with proposed sidewalk | g | Remove | 5.4m |

According to the latest site plan received on June 17, 2021, tree #5106 and #5107 conflict with proposed sidewalk and access walkway. Both two trees are recommended to be removed.

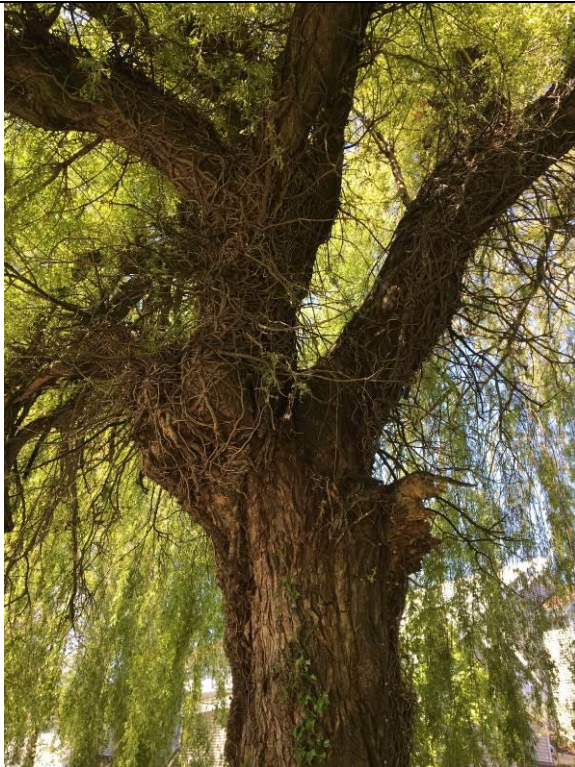
Photo 17: Tree CITY6 5107 (Remove), Weeping willow; covered in old ivy; clearance pruned on south side, for Hydro; canopy biased to north; some dead wood present; pruning to remove dead wood and stubs (due to poor pruning and torn branch) is required.

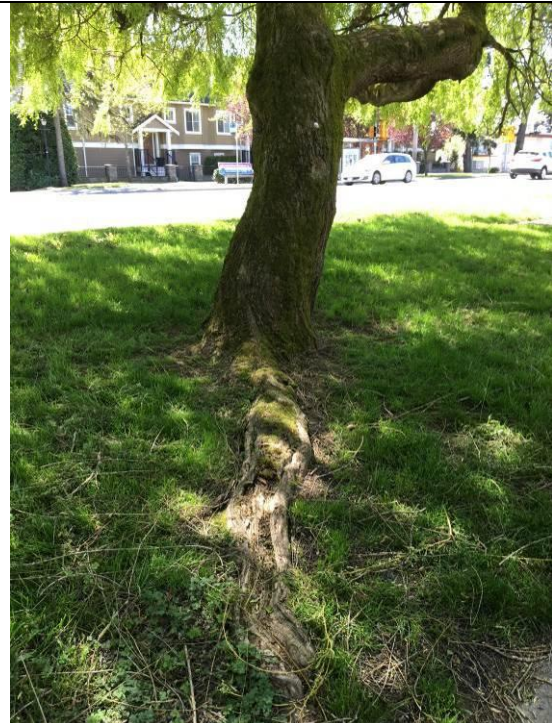
Photo 18: Tree CITY5 5106 (Remove), Weeping willow; large structural root visible above grade; branch attachment good at west side (90 degrees);

| Tree ID # | Botanical Name | Common Name | On Survey Y/N | Location: On, off, Shared, City | DBH (cm) | LCR (%) | Canopy (dia.) | Condition (Structure, Health, TRAQ rating) | Comments | Retention Suitability | Retain/ Remove | Tree Protection Zone (TPZ) |
|---|---|---|---|---|---|---|---|---|---|---|---|---|
| CITY 5 5106 | <i>Salix babylonica</i> | Weeping willow | Y | City | 68 | 80 | 22m | Moderate condition; biased to south; trunk curves / leans to south-west; dead scaffold branches; good attachment (90 degrees) on large 45cm dia. lower limb (2.5m above ground); structural roots exposed and damaged by maintenance equipment (lawn mowers); clearance pruned for Hydro, at south side | Conflict with proposed walkway | g | Remove | 3.9m |

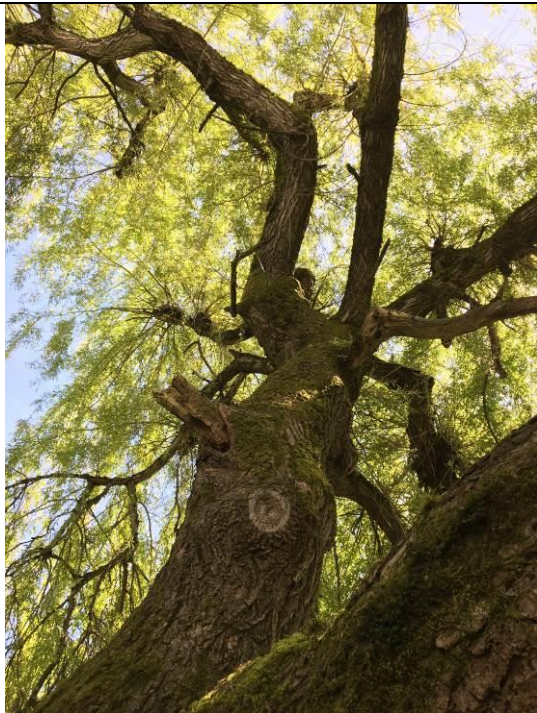
Photo 19: Tree CITY5 5106 (Remove), Weeping willow; pruning to remove dead wood and stubs is required.

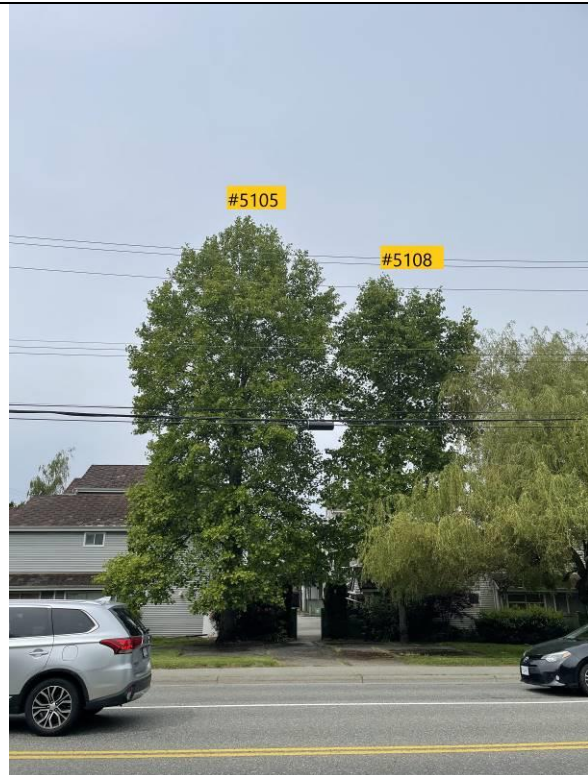
Photo 20: Tree #5105 (Remove), #5108 (Remove), Tulip tree; good condition and form;

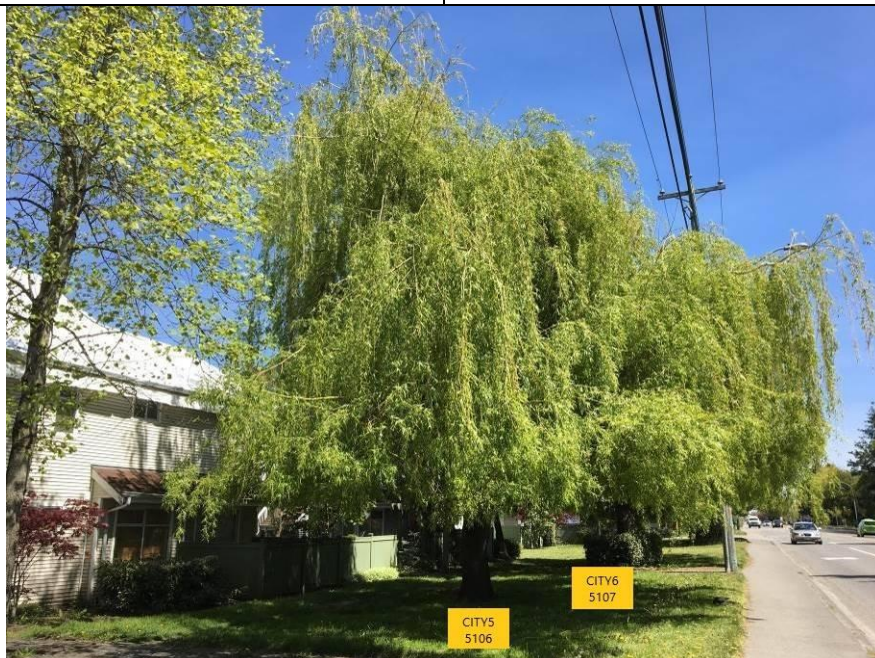
Photo 21: Tree CITY5 5106 (Remove) and CITY6 5107 (Remove), Weeping willows; view from west, looking east along Ladner Trunk Road. Both trees have been clearance pruned at south side for Hydro.

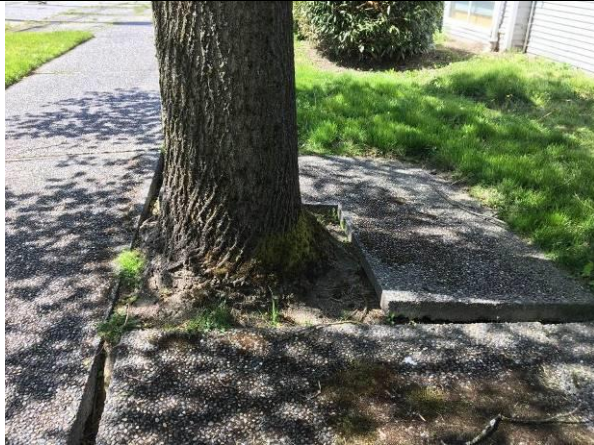
Photo 22: Tree #5105 (Remove), Tulip tree; structural roots pushing up concrete walkway.

| Tree ID # | Botanical Name | Common Name | On Survey Y/N | Location: On, off, Shared, City | DBH (cm) | LCR (%) | Canopy (dia.) | Condition (Structure, Health, TRAQ rating) | Comments | Retention Suitability | Retain/ Remove | Tree Protection Zone (TPZ) |
|---|---|---|---|---|---|---|---|---|---|---|---|---|
| 5105 | <i>Liriodendron tulipifera</i> | Tulip tree | Y | On | 55 | 90 | 10m | Moderate condition and structure; codominant at 5m; included bark; possible girdling roots (twisting); growing in area surrounded by concrete slabs; roots pushing up concrete | Conflicts with development | p | Remove | |

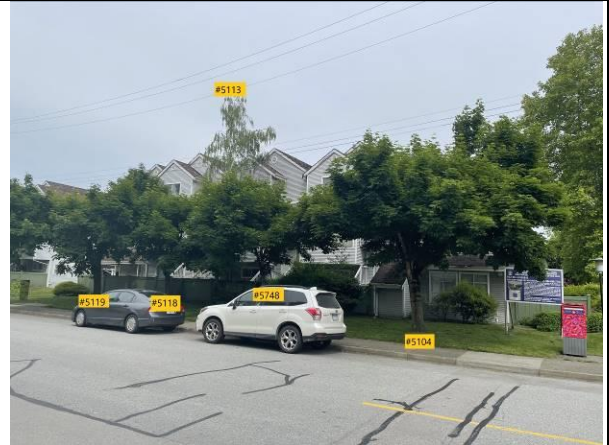
Photo 23: Tree CITY7 5118 (Retain), CITY8 5119 (Remove), CITY13 5748 (Retain) and #5113 (Remove), CITY4 5104 (Retain); Norway maples along 55B Street; canopies reduced at 5-6m to be kept at small size; growth suppressed.

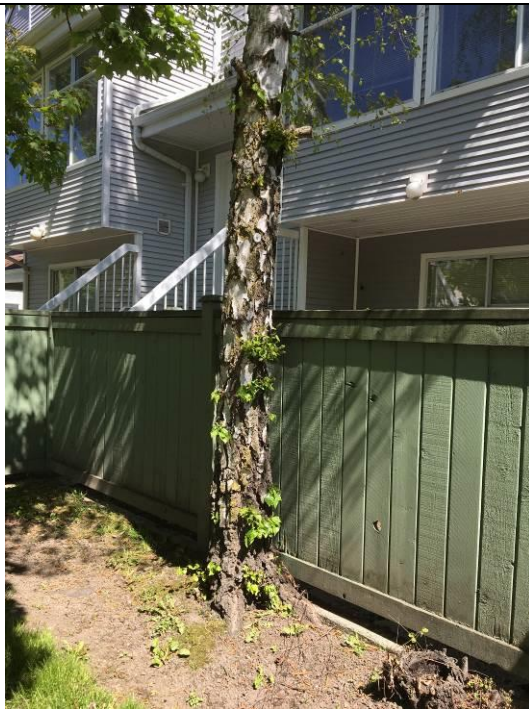
Photo 24: Tree #5113 (Remove), Paper birch; epicormics growth on trunk; stressed; poor structure in canopy; concrete pad and fence directly at east side.

| Tree ID # | Botanical Name | Common Name | On Survey Y/N | Location: On, off, Shared, City | DBH (cm) | LCR (%) | Canopy (dia.) | Condition (Structure, Health, TRAQ rating) | Comments | Retention Suitability | Retain/ Remove | Tree Protection Zone (TPZ) |
|---|---|---|---|---|---|---|---|---|---|---|---|---|
| 5113 | <i>Betulus papyrifera</i> | Paper birch | Y | On | 25 | 45 | 5m | Poor condition; poor structure; epicormic growth; stubbed/dead branches; top curves to east; stressed; concrete pad and fence immediately at base, on east side of trunk | Will be critically impacted by underground parking excavation.<br><b>Arborist to supervise the removal of tree #5113, stump to be removed by stump grinder only.</b> | p | Remove | |

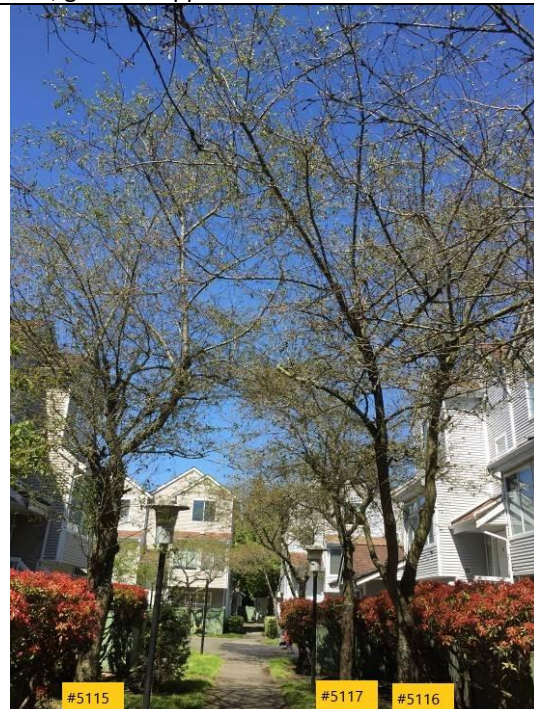
Photo 25: Tree #5115 (Remove), #5116 (Remove), #5117 (Remove), Flowering cherry trees; poor pruning in past; root collars exposed above grade; decay noted at old pruning wounds.

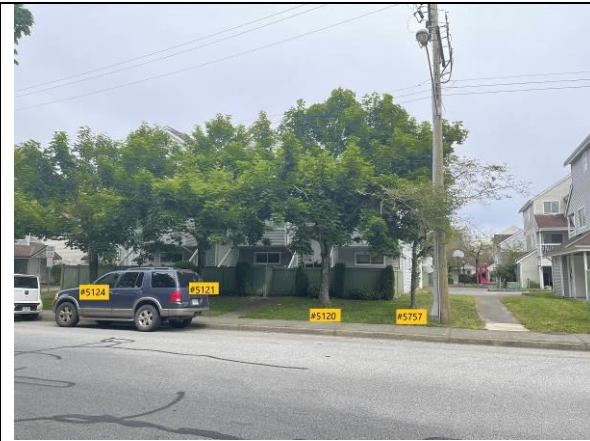
Photo 26: Tree CITY14 5757 (Remove), CITY9 5120 (Remove), CITY10 5124 (Remove) and CITY11 5124 (Retain); Norway maples along 55B Street; canopies reduced at 5-6m to be kept at small size; growth suppressed.

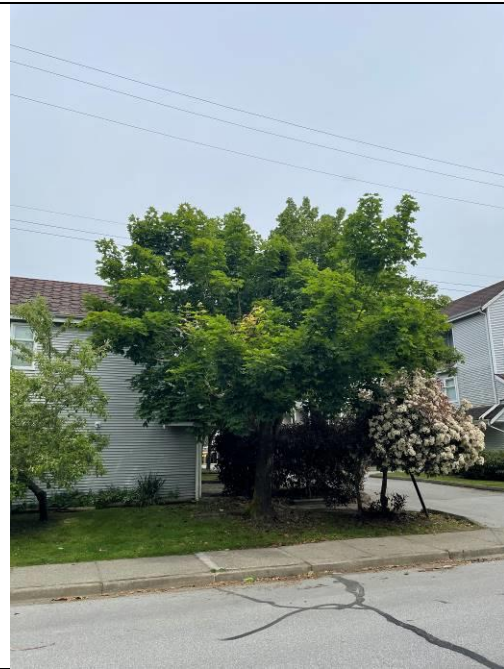
Photo 27: Tree CITY12 5125 (Remove), Norway maples along 55B Street; canopies reduced at 5-6m to be kept at small size; growth suppressed.

| Tree ID # | Botanical Name | Common Name | On Survey Y/N | Location: On, off, Shared, City | DBH (cm) | LCR (%) | Canopy (dia.) | Condition (Structure, Health, TRAQ rating) | Comments | Retention Suitability | Retain/ Remove | Tree Protection Zone (TPZ) |
|---|---|---|---|---|---|---|---|---|---|---|---|---|
| CITY 12 5125 | <i>Acer platanoides</i> | Norway maple | Y | City | 40 | 45 | 9m | Poor condition; included bark; previously topped at approx. 4m; poor pruning in past (and stubs remaining); leaders removed/canopy reduced; decay noted where three main stems removed at 3.5m; raised up on curb; in turf; curb at 1.0m to south | Will be critically impacted by proposed walkway installation | p | Remove | |

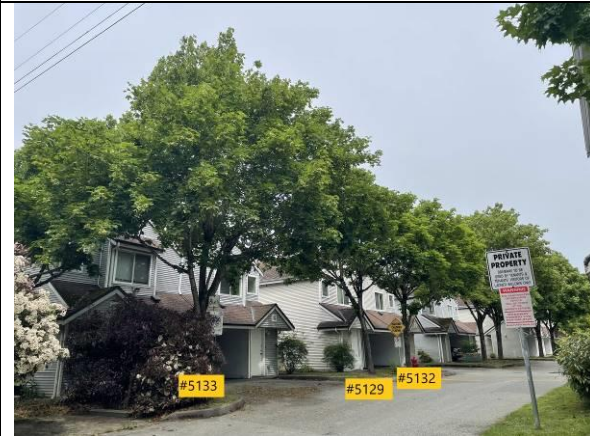
Photo 28: Tree #5133 (Remove), #5129 (Remove), #5132 (Remove), Norway maple; typ. growing condition for all on-site Norway maples (on top of curb, in turf with compacted soil, within restricted growing area).

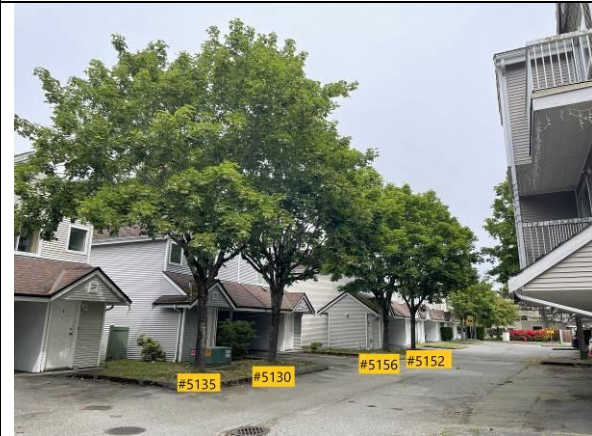
Photo 29: Tree #5135 (Remove), #5130 (Remove), #5156 (Remove), #5152 (Remove), Norway maple; typ. growing condition for all on-site Norway maples (on top of curb, in turf with compacted soil, within restricted growing area).

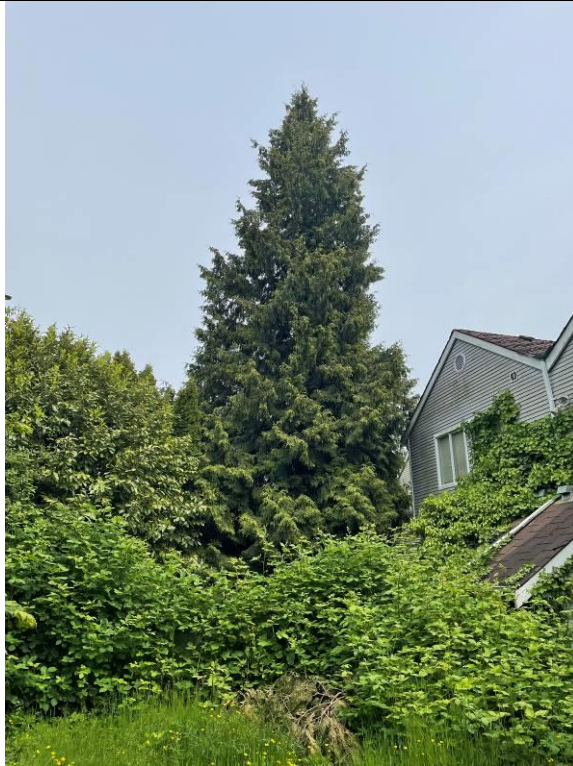
Photo 30: Tree #5150 (Remove), Western redcedar, moderate condition, recovering from previous drought stress, retaining wall observed on north side of trunk, also, grade on north is much lower than the subject site, limited roots on northern property, proposed new road will significantly impact the tree stability and health.

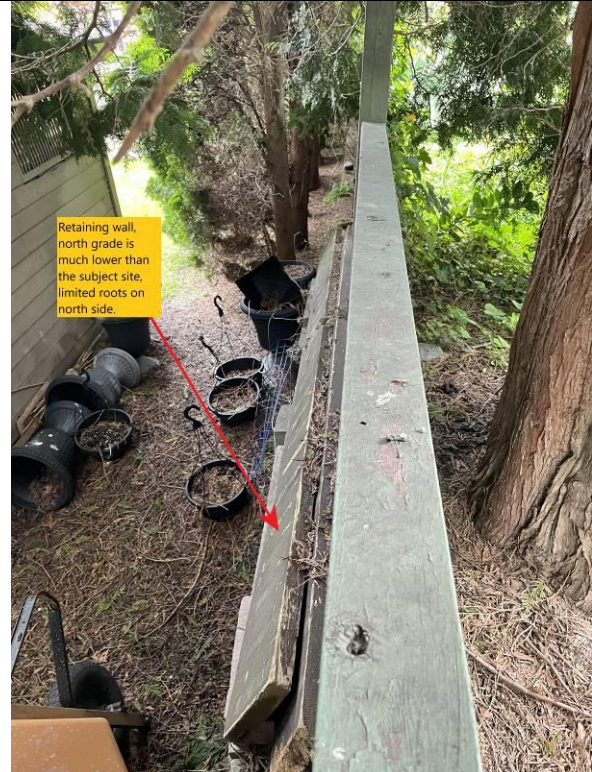
Photo 31: Retaining wall on north side of trunk, limited roots on neighbour's property.

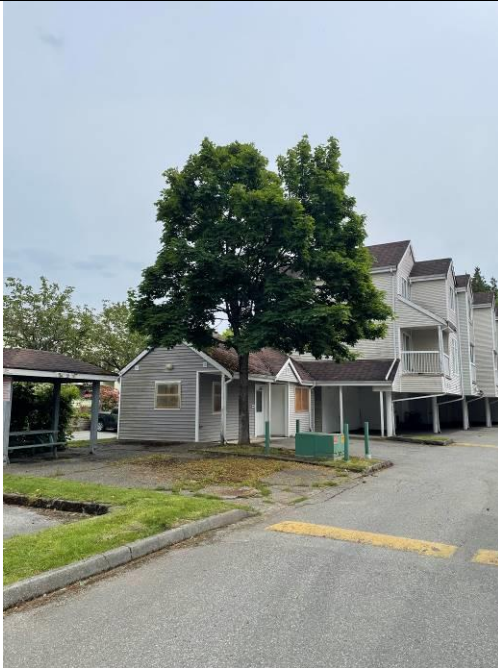
Photo 32: Tree #5114 (Remove), Norway maple; typ. growing condition for all on-site Norway maples (on top of curb, in turf with compacted soil, within restricted growing area).

| Tree ID # | Botanical Name | Common Name | On Survey Y/N | Location: On, off, Shared, City | DBH (cm) | LCR (%) | Canopy (dia.) | Condition (Structure, Health, TRAQ rating) | Comments | Retention Suitability | Retain/ Remove | Tree Protection Zone (TPZ) |
|---|---|---|---|---|---|---|---|---|---|---|---|---|
| 5114 | <i>Acer platanoides</i> | Norway maple | Y | On | 29 | 60 | 12m | Moderate condition; round shape; structural roots exposed above grade; located in median with utility box; compacted soil (foot traffic); soil dry; otherwise surrounded by asphalt | Conflicts with development | p | Remove | |

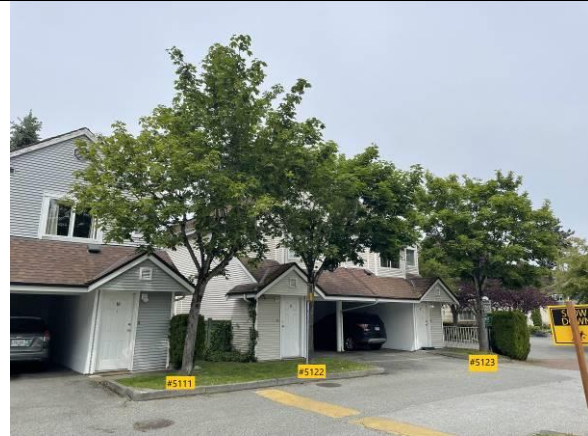
Photo 33: Tree #5111 (Remove), #5122 (Remove), #5123 (Remove); Norway maple; typ. growing condition for all on-site Norway maples (on top of curb, in turf with compacted soil, within restricted growing area).

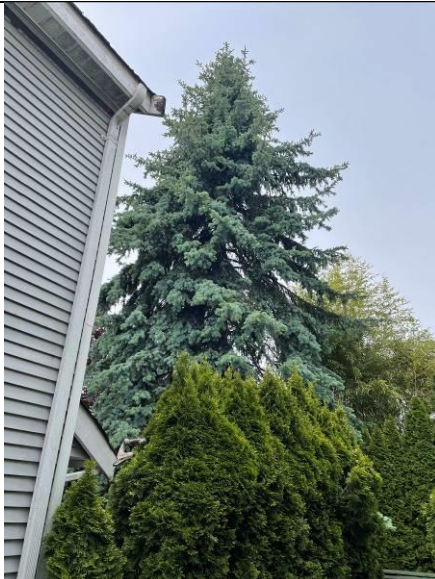
Photo 34: Tree #5134 (Remove), Blue spruce; Moderate to good condition; moderate structure; leader intact; sparse on north side; slight curve to south.

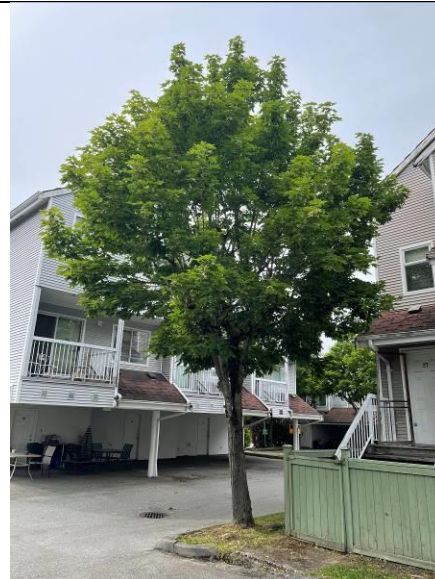
Photo 35: Tree #5112 (Remove), Norway maple; typ. growing condition for all on-site Norway maples (on top of curb, in turf with compacted soil, within restricted growing area).

| Tree ID # | Botanical Name | Common Name | On Survey Y/N | Location: On, off, Shared, City | DBH (cm) | LCR (%) | Canopy (dia.) | Condition (Structure, Health, TRAQ rating) | Comments | Retention Suitability | Retain/ Remove | Tree Protection Zone (TPZ) |
|---|---|---|---|---|---|---|---|---|---|---|---|---|
| 5112 | <i>Acer platanoides</i> | Norway maple | Y | On | 28 | 55 | 8m | Poor to moderate condition and structure; codominant at 3.5m (4 stems); structural roots exposed above grade; growing in turf median; curb located at 0.5m to west and east; compacted soil conditions | | p | Remove | |

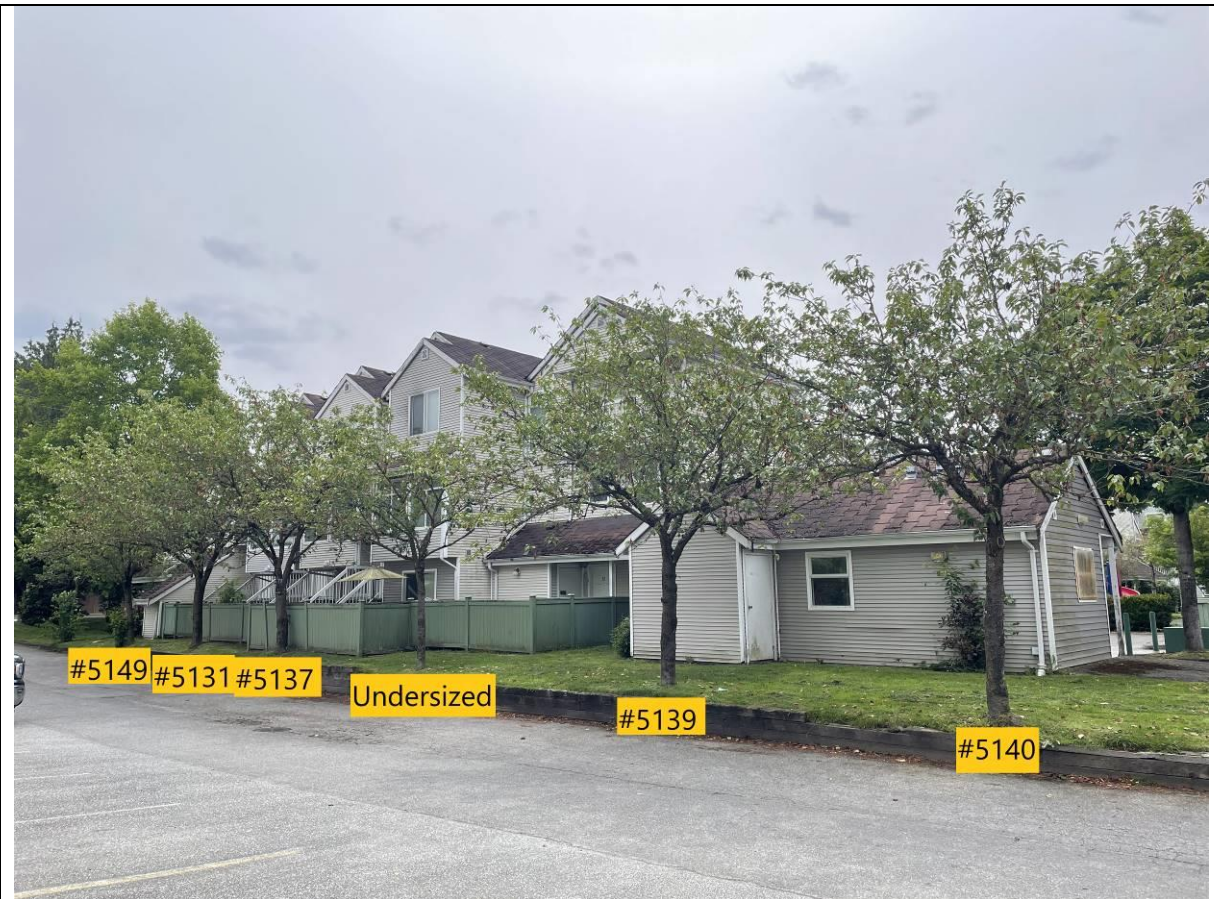
Photo 36: Tree #5140 (Remove), #5139 (Remove), #5137 (Remove), #5131 (Remove), #5149 (Remove), Cherry; Poor to moderate health condition, poorly pruned, roots on the east limited by wood retaining wall.

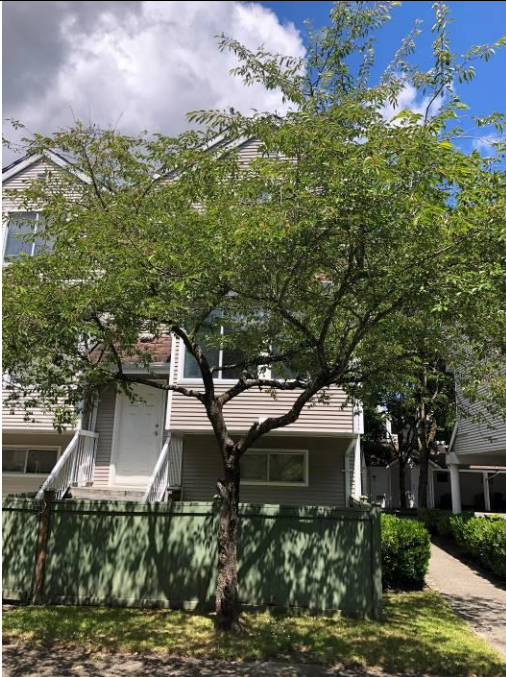
Photo 37: Tree #5714 (Remove), cherry; Flowering cherry tree; poor pruning in past; decay noted at old pruning wounds.

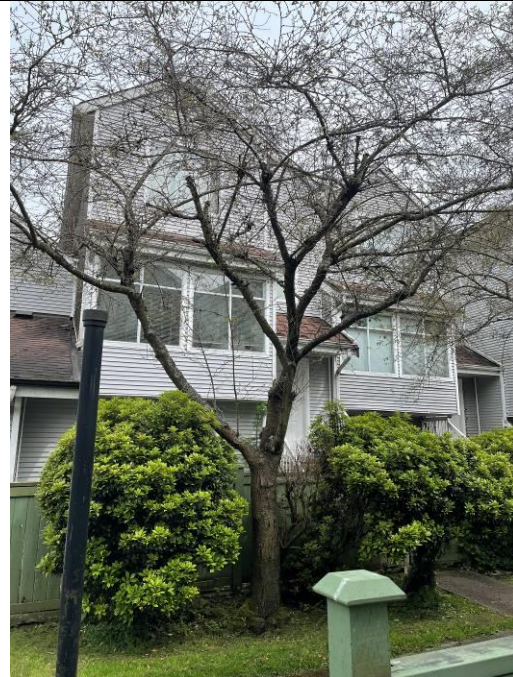
Photo 38: Tree #354 (Remove), Cherry; Flowering cherry tree; poor pruning in past; root collars exposed above grade; decay noted at old pruning wounds.

| Tree ID # | Botanical Name | Common Name | On Survey Y/N | Location: On, off, Shared, City | DBH (cm) | LCR (%) | Canopy (dia.) | Condition (Structure, Health, TRAQ rating) | Comments | Retention Suitability | Retain/ Remove | Tree Protection Zone (TPZ) |
|---|---|---|---|---|---|---|---|---|---|---|---|---|
| 354 | <i>Prunus</i> spp. | Flowering cherry | N | On | 26 | 35 | 8m | Poor condition; slight curve to west, self-correcting at 1m; exposed structural roots; bulging root collar; poor canopy structure; poor condition; poor pruning in past (stubs remaining); decay noted; long stub remaining at 3m | | p | Remove | |

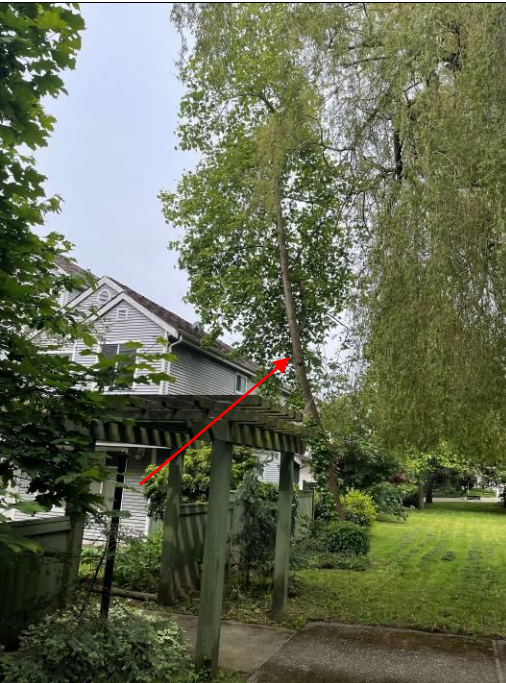
Photo 39: Tree #5109 (Removed), Tulip tree; Phototropic leaning north, suppressed by neighbouring trees, no obvious leader.

On November 16, 2023, project Arborist was notified of the removal of tree #5109. It was found uprooted due to recent storm.

| Tree ID # | Botanical Name | Common Name | On Survey Y/N | Location: On, off, Shared, City | DBH (cm) | LCR (%) | Canopy (dia.) | Condition (Structure, Health, TRAQ rating) | Comments | Retention Suitability | Retain/ Remove | Tree Protection Zone (TPZ) |
|---|---|---|---|---|---|---|---|---|---|---|---|---|
| 5109 | <i>Liriodendron tulipifera</i> | Tulip tree | Y | On | 31 | 65 | 6m | Poor to moderate condition; lean to north, curve to north; no leader visible; thin canopy; decayed stub present at 7m on north side; decayed branch (on lower limb) on east side; surrounded by ivy | Removed due to hazardous condition | p | Removed | |

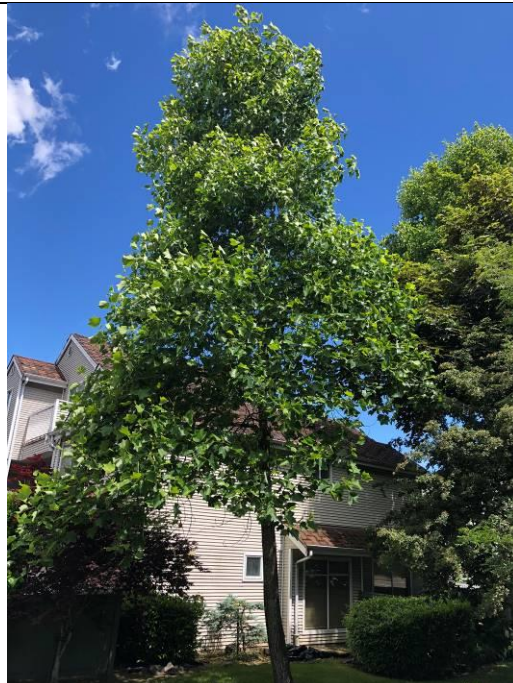
Photo 40: Tree #5127 (Remove), Tulip tree; self-corrected leaning west, trunk damage with CODT, young.

| Tree ID # | Botanical Name | Common Name | On Survey Y/N | Location: On, off, Shared, City | DBH (cm) | LCR (%) | Canopy (dia.) | Condition (Structure, Health, TRAQ rating) | Comments | Retention Suitability | Retain/ Remove | Tree Protection Zone (TPZ) |
|---|---|---|---|---|---|---|---|---|---|---|---|---|
| 5127 | <i>Liriodendron tulipifera</i> | Tulip tree | Y | On | 26 | 70 | 10m | Good condition; self-corrected leaning west; in compacted soil; damage on east side; CODT | Conflicts with development | p | Remove | |
