# Limited Visual Inspection Report

Property Address:  
4501 Arthur Drive, Delta

Client: Harjit Sandhu Landvision Group

January 14, 2023

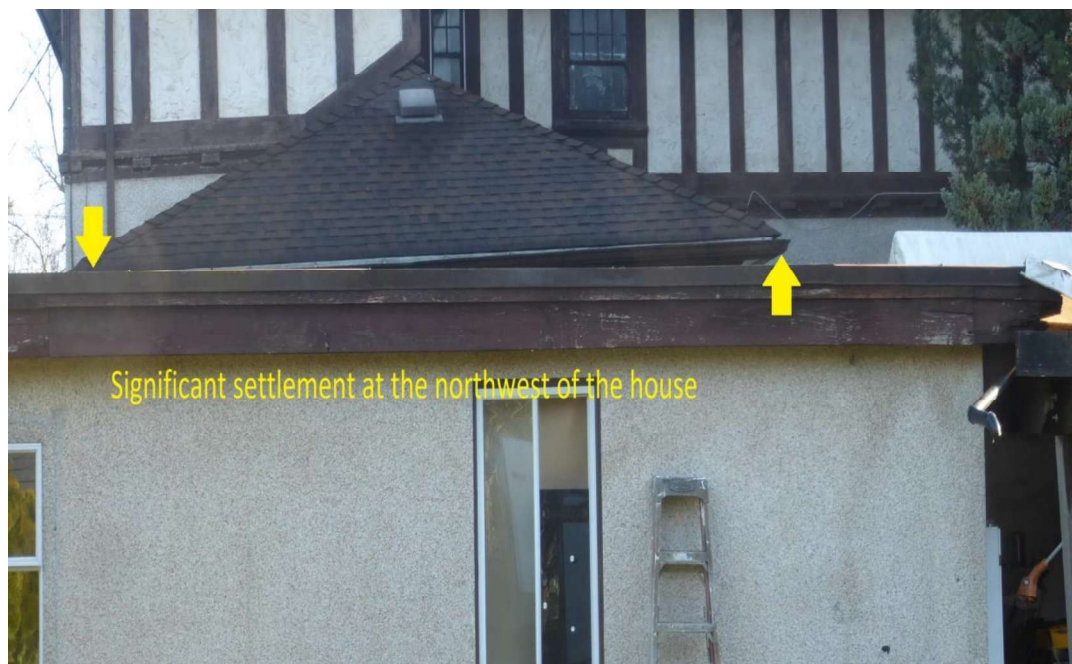
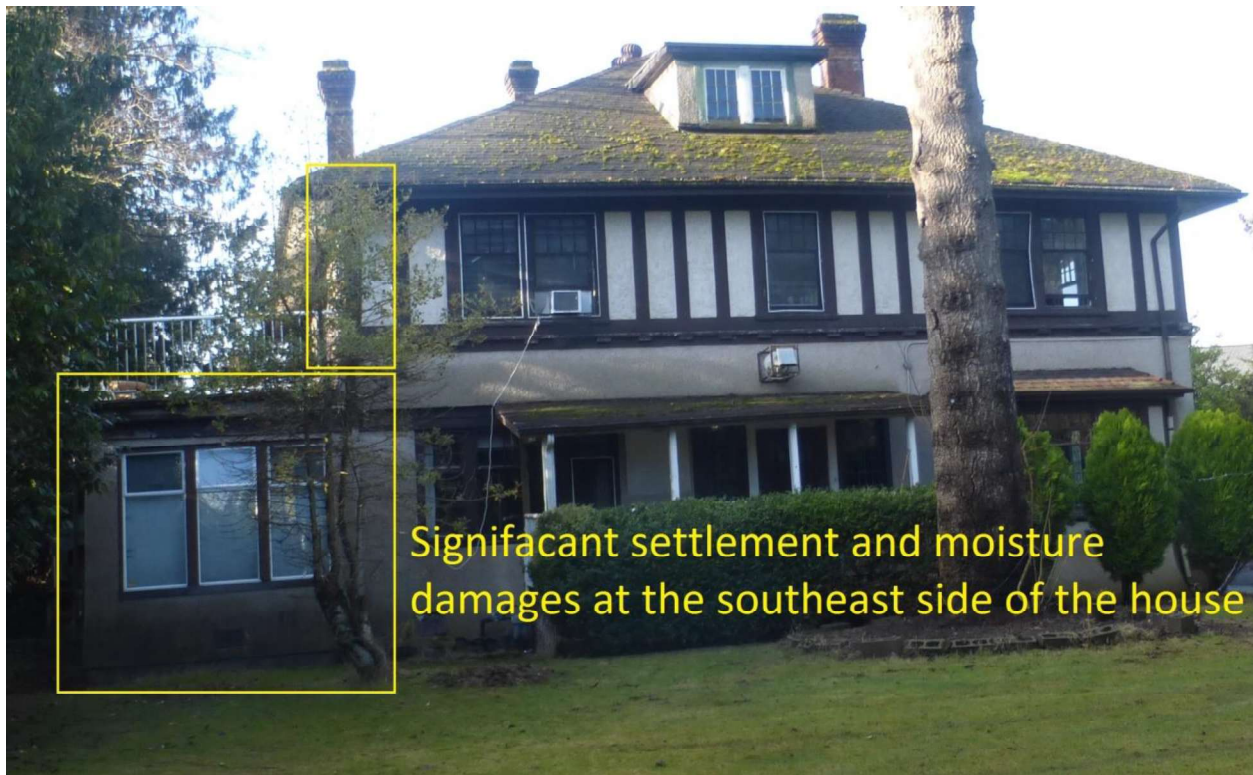
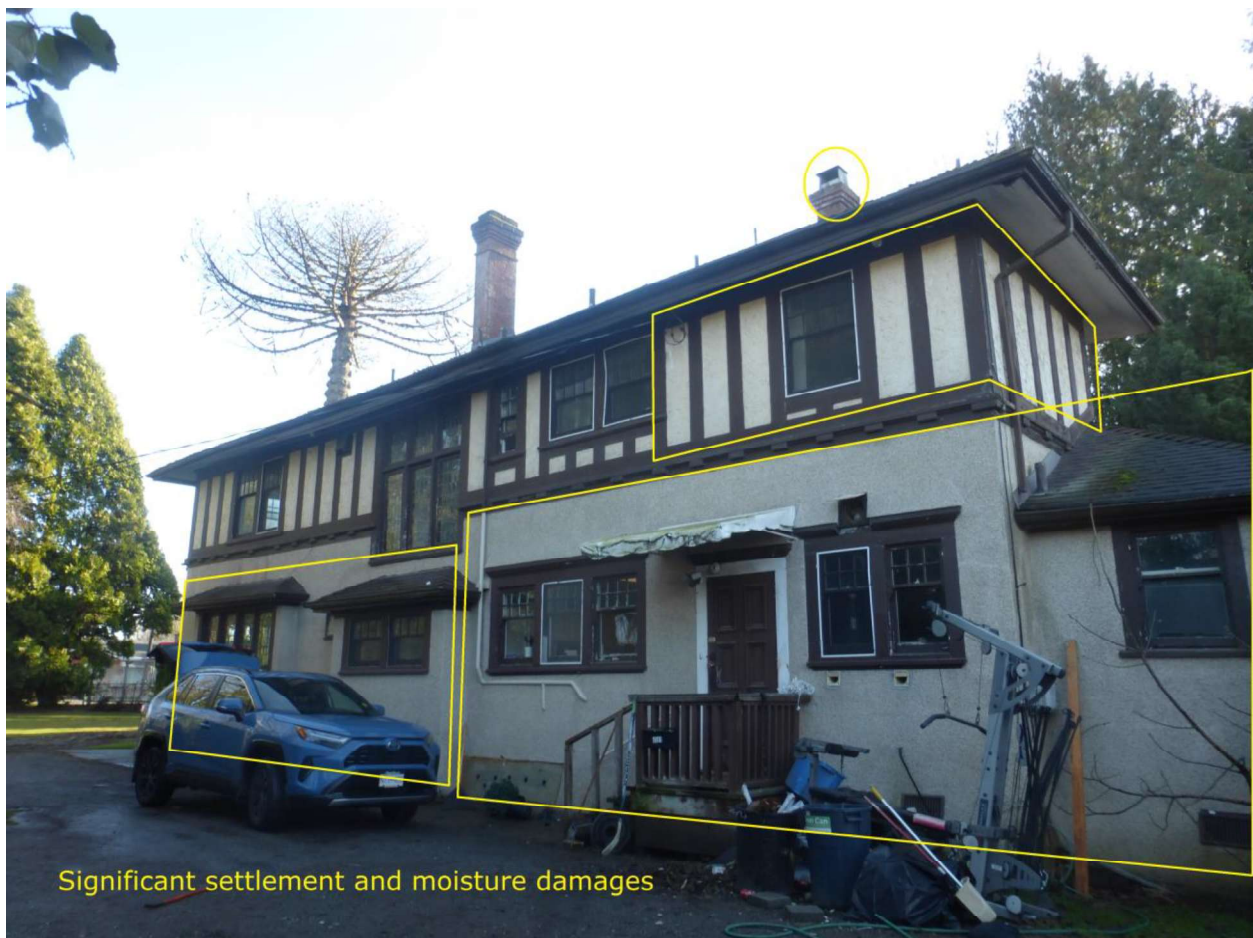
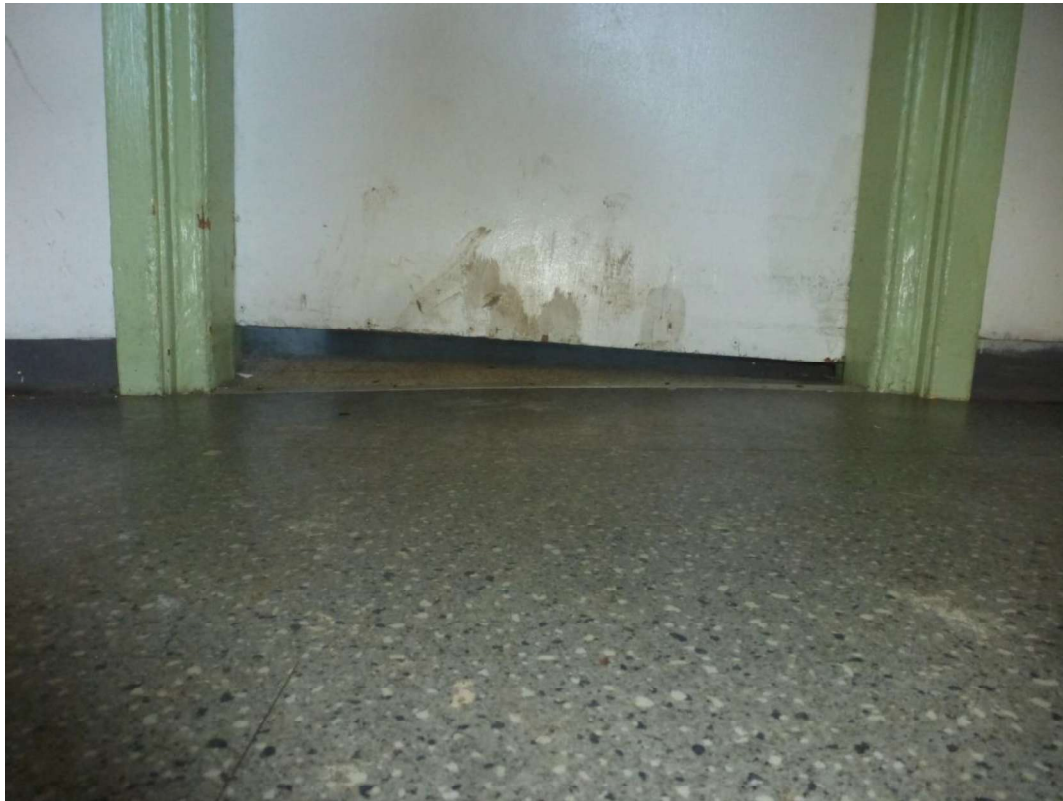
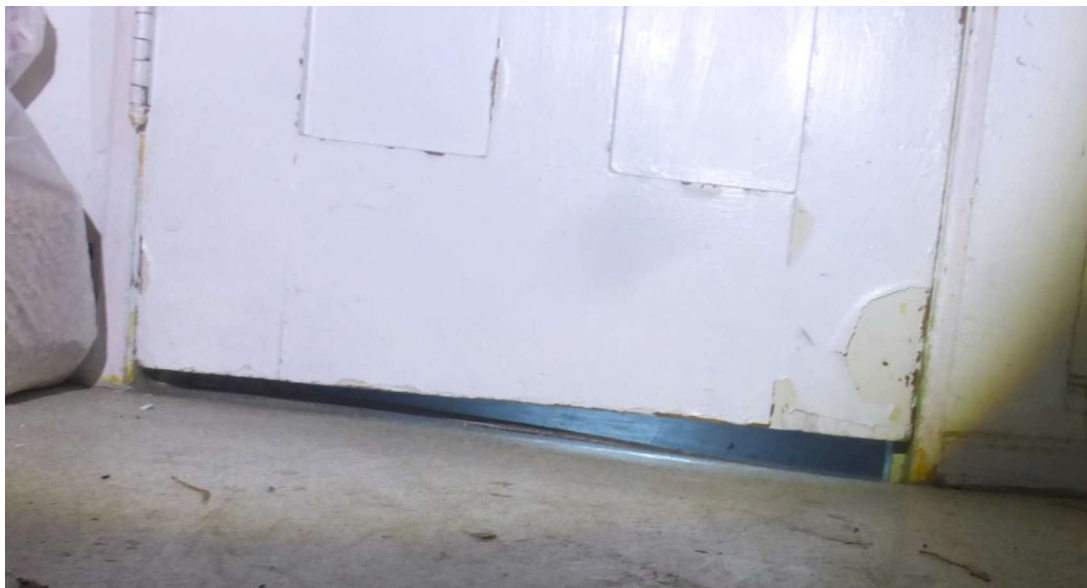
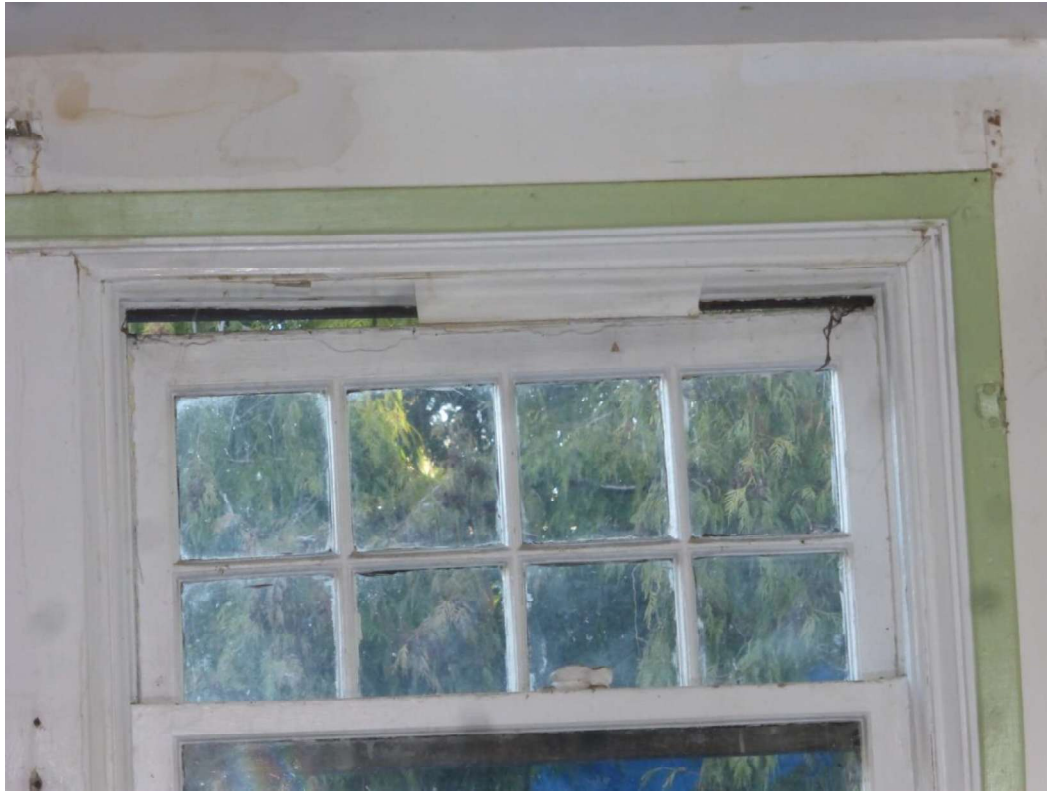
The house has visible signs of significant settlement due to the dysfunctional partly perimeter drains, negative ground slopes, water ponding, major foundation cracks and concealed water damage both above & below the foundation levels, roof and masonry chimney leakages. Visible structural damages at the southeast, northwest and center of the house are noticeable. Besides aging, the lack of maintenance for a quite long time has caused significant damages to the property.

Since the house heating system stopped working after the mechanical room flooded seven years ago, the exposure to the winter extreme weather conditions in the last 7 years may have caused serious concealed damages to plumbing, dampness, concealed mould growth in the wall assembly, flooring and other building components. Some visible damages are included with the report, but others were either not accessible or not visible. The current debilitating house condition is unsafe and unhealthy. House is uninhabitable at its present condition. Considering the apparent weakness of the structure debilitating condition of the both exterior and the interior relocating of the house is possible. Relocating is only possible when house structure is strong.

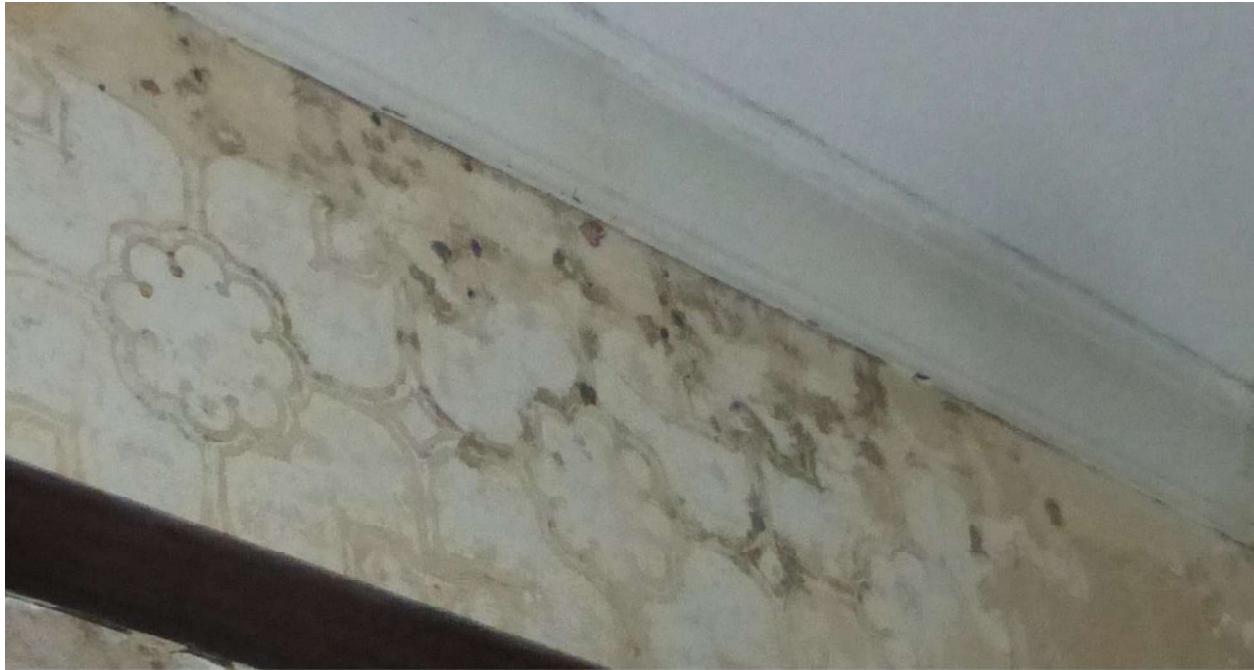
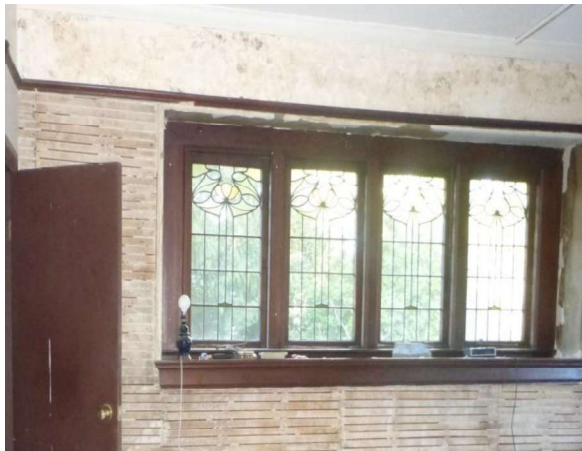
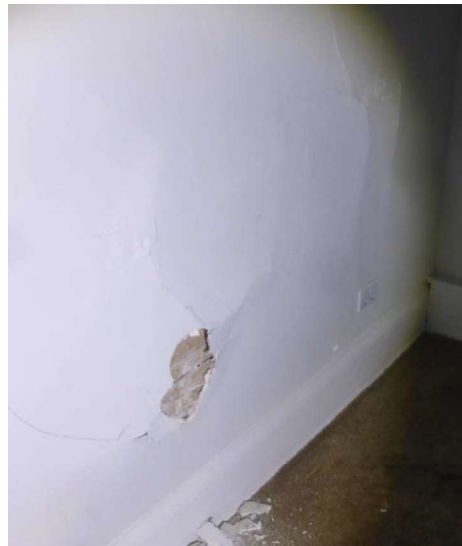
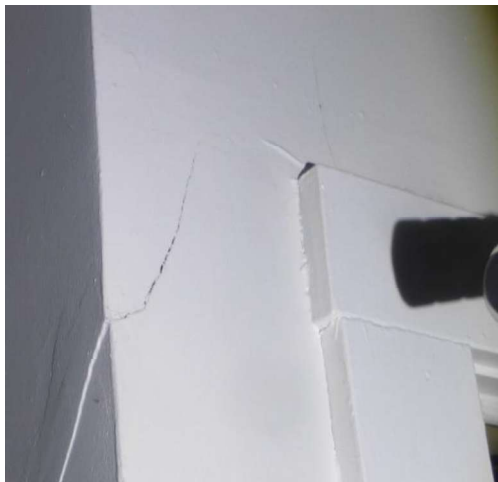
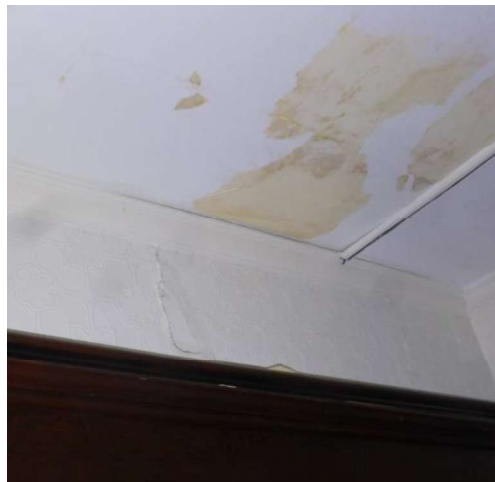
### **Presence of mould, damp air and poor ventilation**

The consequences of the unheated house are evident as copper pipes in the walls alongside the upper level northeast room froze. The expanding ice caused the copper pipe to rupture, and when it thawed, it leaked water, damaging drywall and floors. The pipes in the crawlspace also froze and that may have caused plumbing leakages.

After the plumbing leak, nearly 50 percent of upper level rooms and hallways flooded. The carpet flooring was not replaced after the flooding. The presence of mold is visible in the lower northeast room wall. Since, the scope of the work was limited to the visible, non-invasive investigation; concealed moisture damage is beyond the scope of the inspection. However, persistent musty and damp air with the presence of subtle odour is indicative of concealed moisture-related issues including the growth of organic matter.

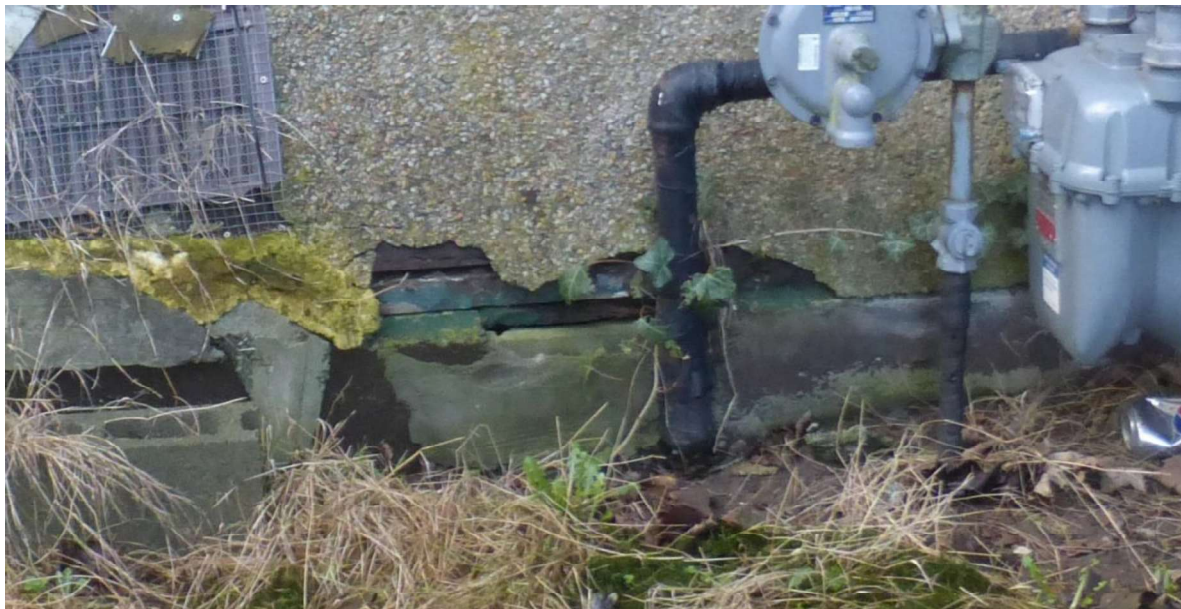
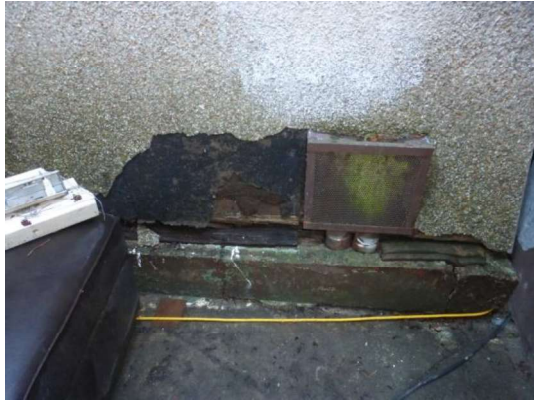
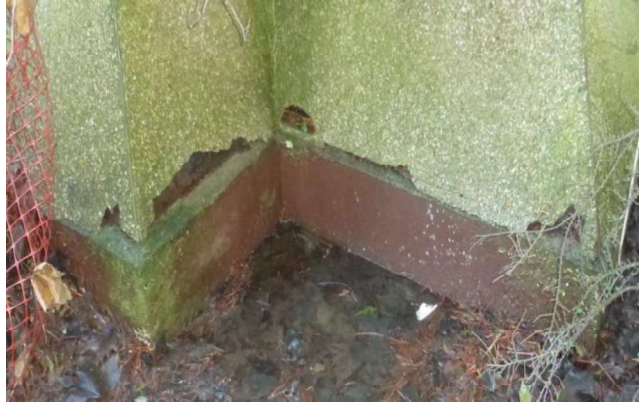
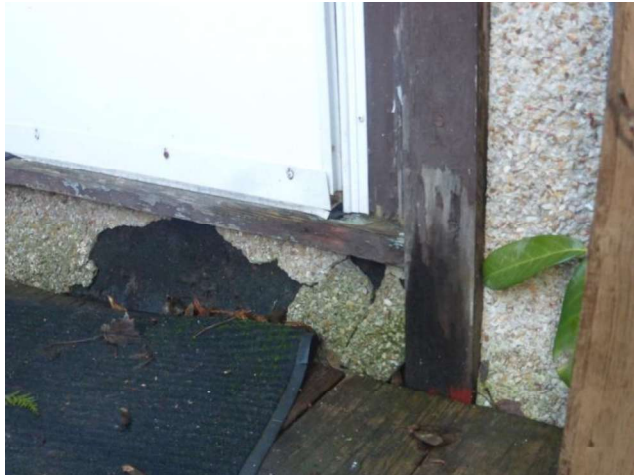
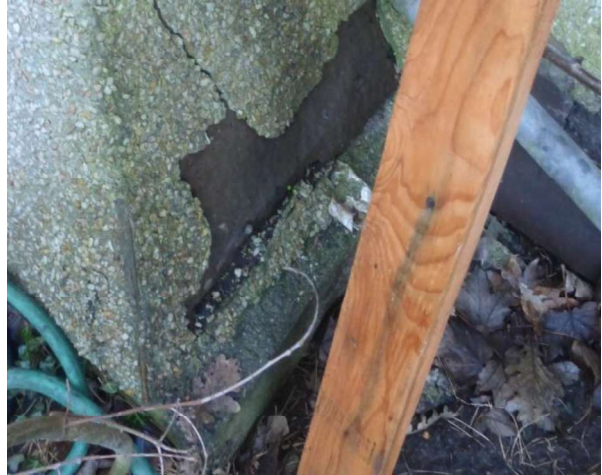
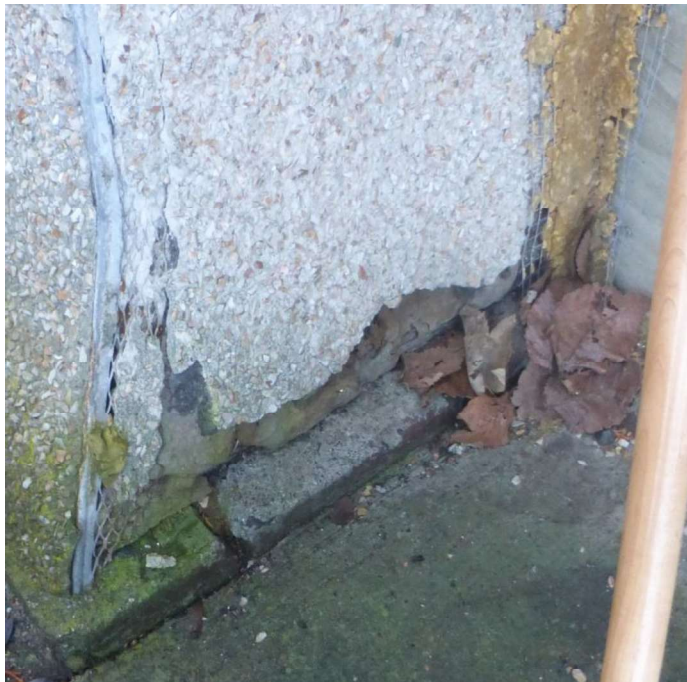
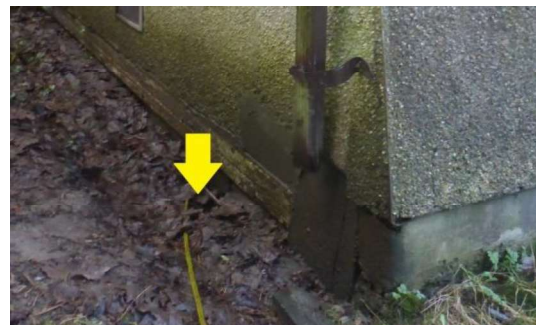
## Stucco siding damages

The bottom portion of the stucco siding above the foundation is damaged in several areas. The prolonged weather exposure due to the damaged siding and consistent moisture intrusion may have caused concealed moisture damages to the bottom plates (structural membranes) and adjacent bottom membranes of the wall structure. Stucco deterioration is the result of water infiltration into the building foundation due to excessive groundwater or moisture penetrating through, or splashing up from the foundation. Potential causes of deterioration include: ground settlement lintel and door frame settlement, inadequate or leaking gutters and downspouts; moisture migration within walls due to interior condensation and humidity, and rising damp resulting from excessive groundwater and poor drainage around the foundation. Water infiltration has caused wood lath to rot, and metal lath and nails to rust, which has caused stucco to lose its bond and pull away from its substrate.

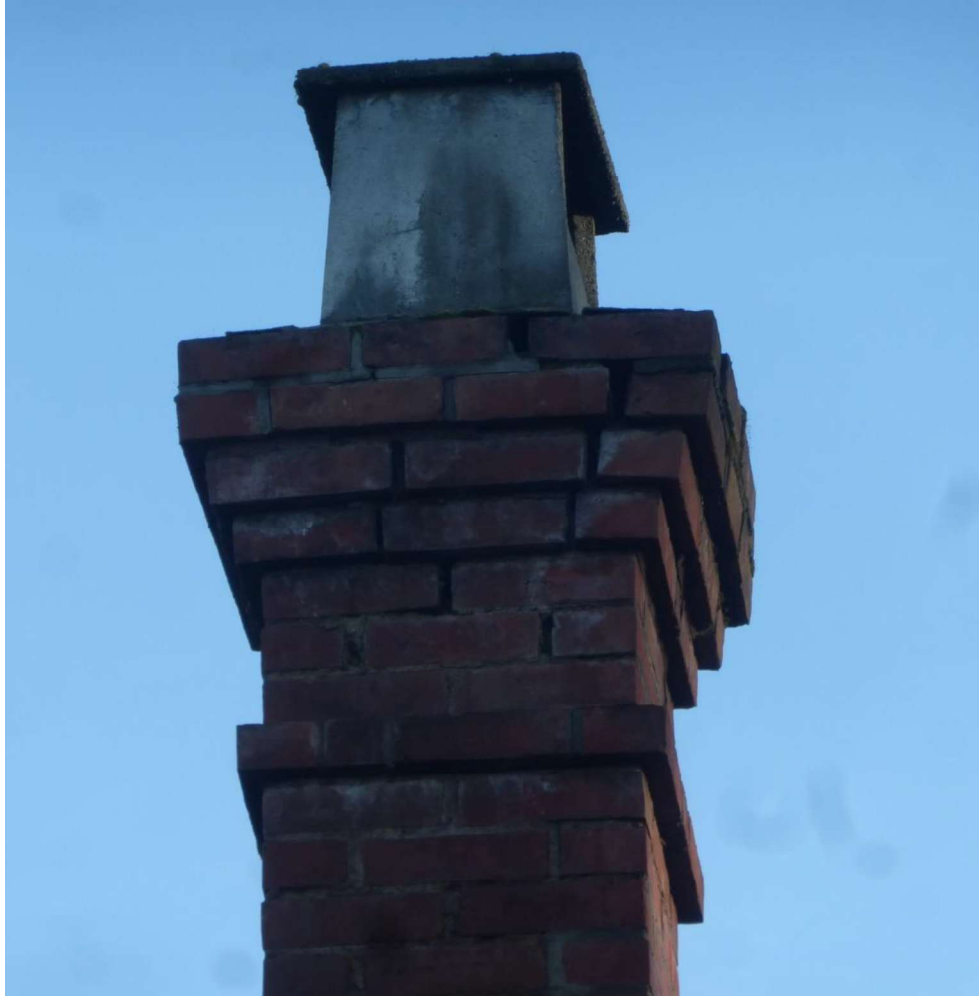
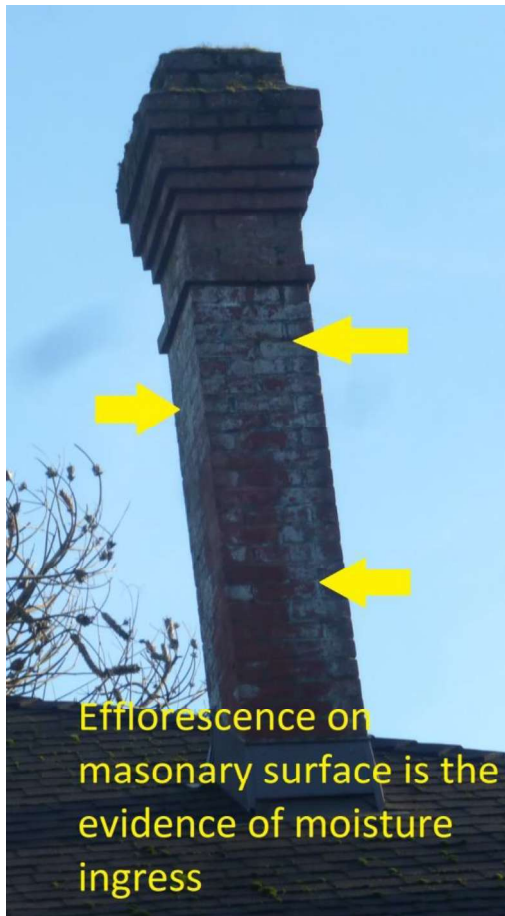
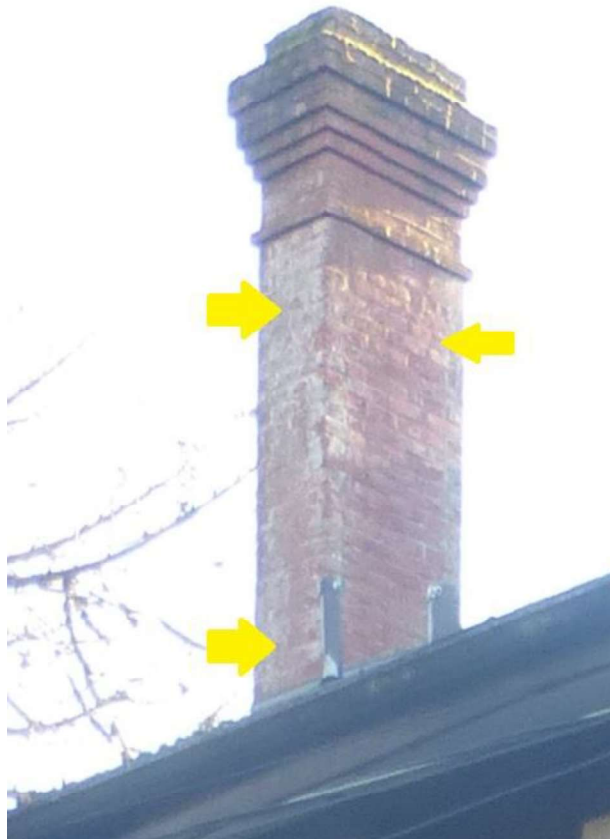
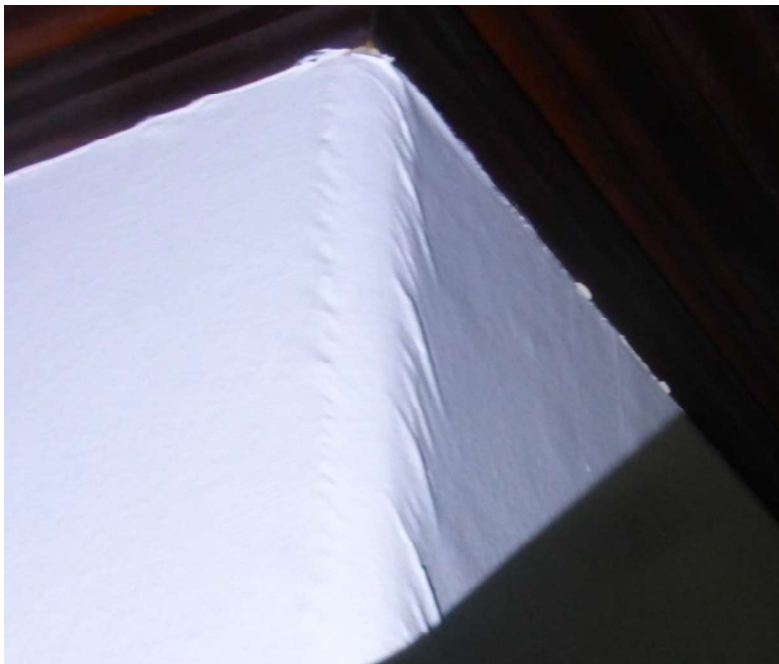
## **Masonry Chimneys**

The masonry chimney is failing and could damage the roof if it falls.

Efflorescence: The efflorescence on chimneys is the indication of water ingress. Moisture ingress can be traced to roof leaks and interior concealed water damages in the wall assembly indoors above the fireplace.

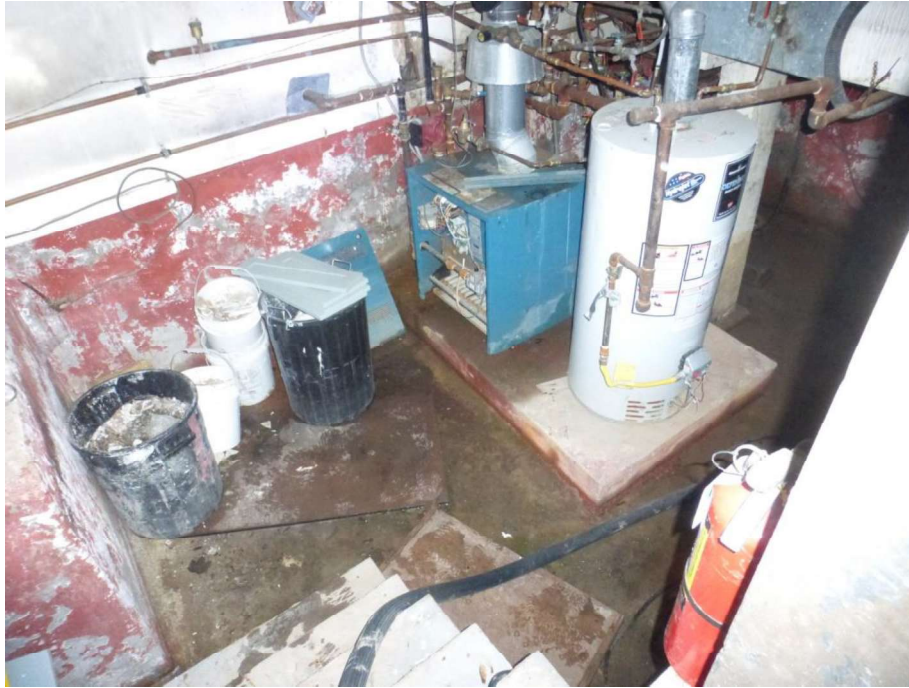
## Heating System

The failure of the sump pump caused flooding of the mechanical room in 2015, and the hydronic heating system stopped working. Since then the house is unheated.

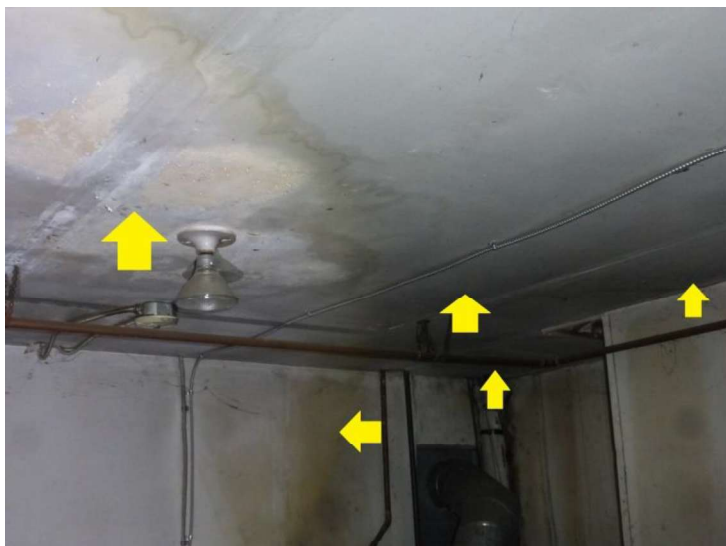
Damages in the mechanical room: Ceiling leaks in the mechanical room both due to the roof leak and condensation. visible condensation water on the domestic water line in the mechanical room.

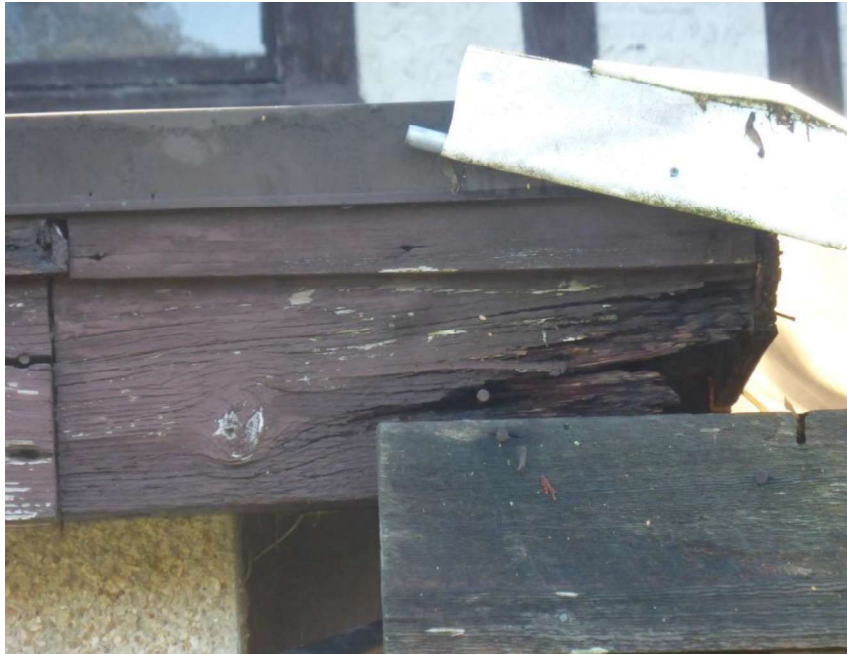
### **Built-in gutter damage**

Damage built-in gutter: The built-in gutter has visible damage at seam.

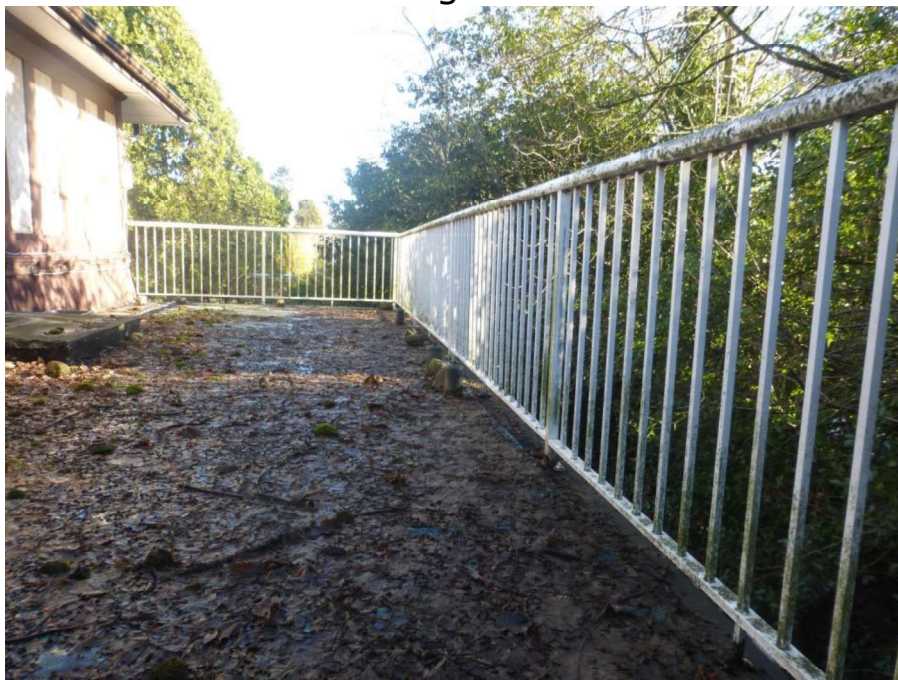
### **Southside deck**

The Southside deck floor has concealed water damage and leaks. Deck is unsafe to walk upon. The leak in the deck has caused moisture-related damages in the south room.

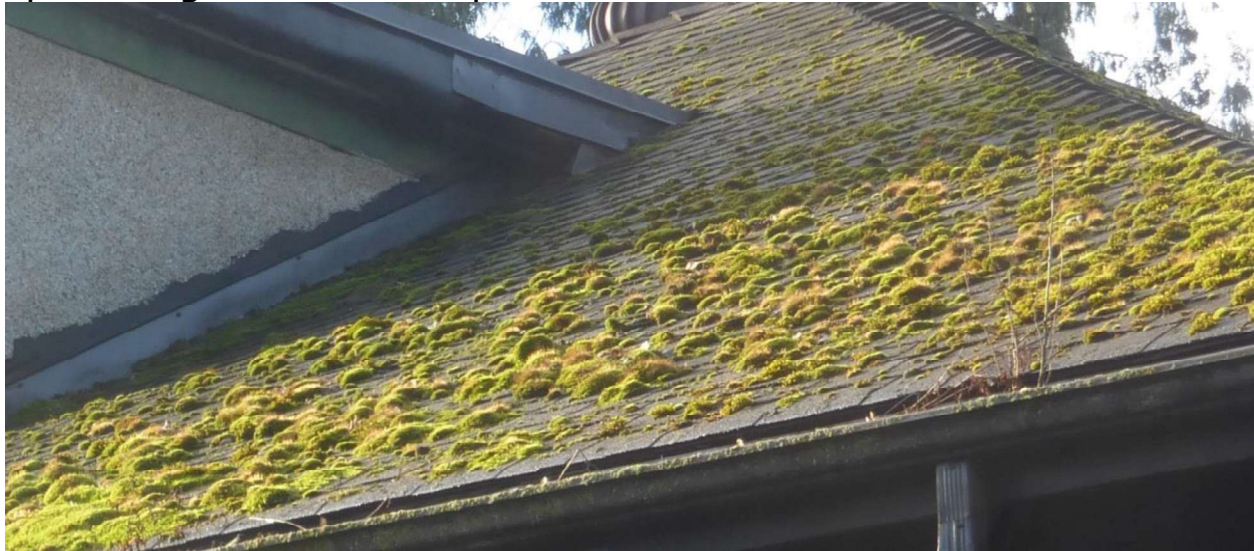
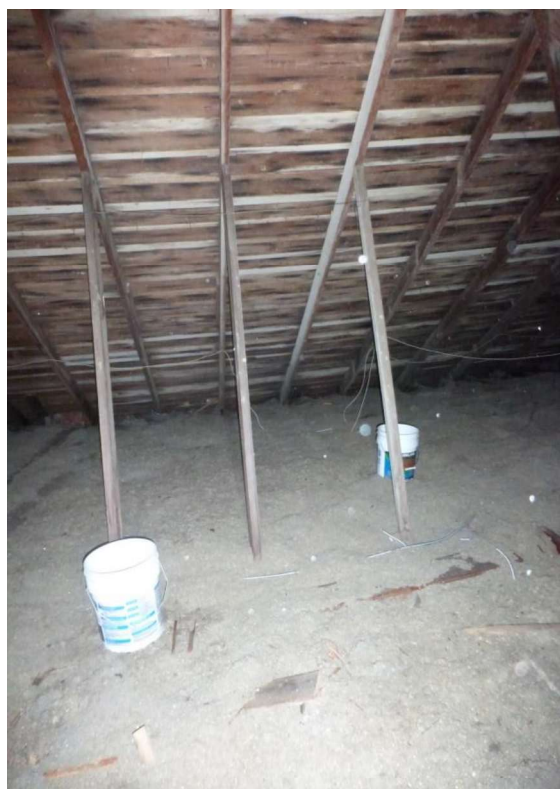
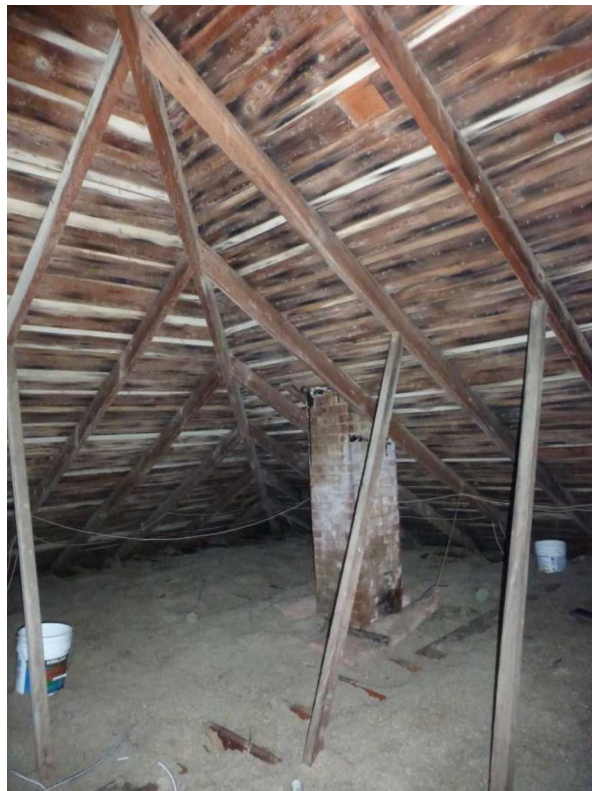
## Roof

The asphalt shingle sloped roof is not maintained for a while and the majority of the roof at the south, southeast and north sides are covered by moss. The roof leaks are occurring regularly and spot fixing has been the practice.

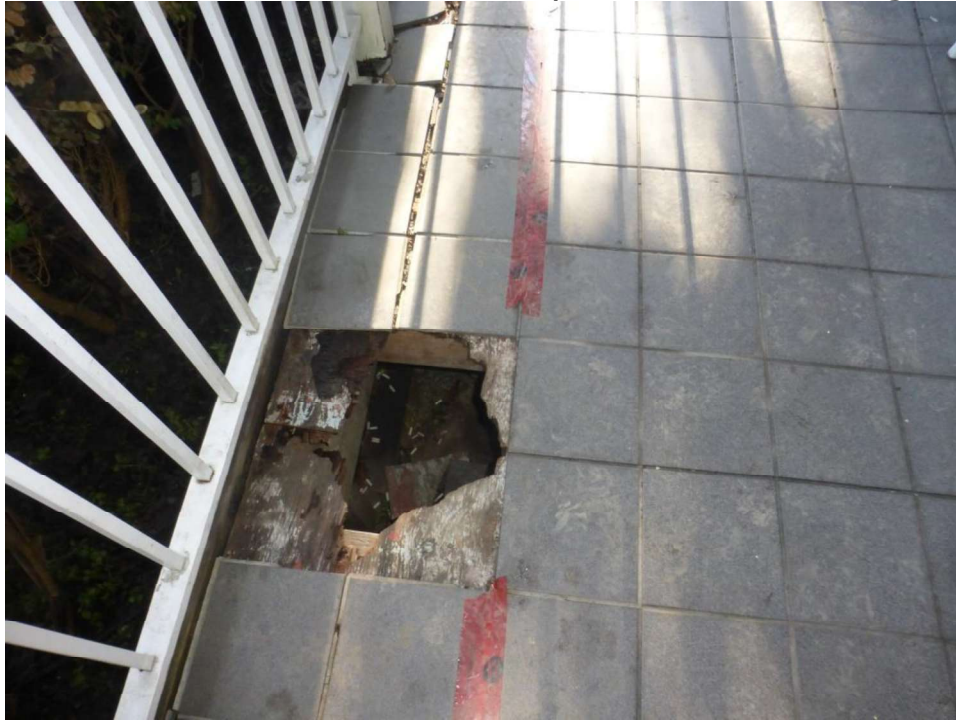
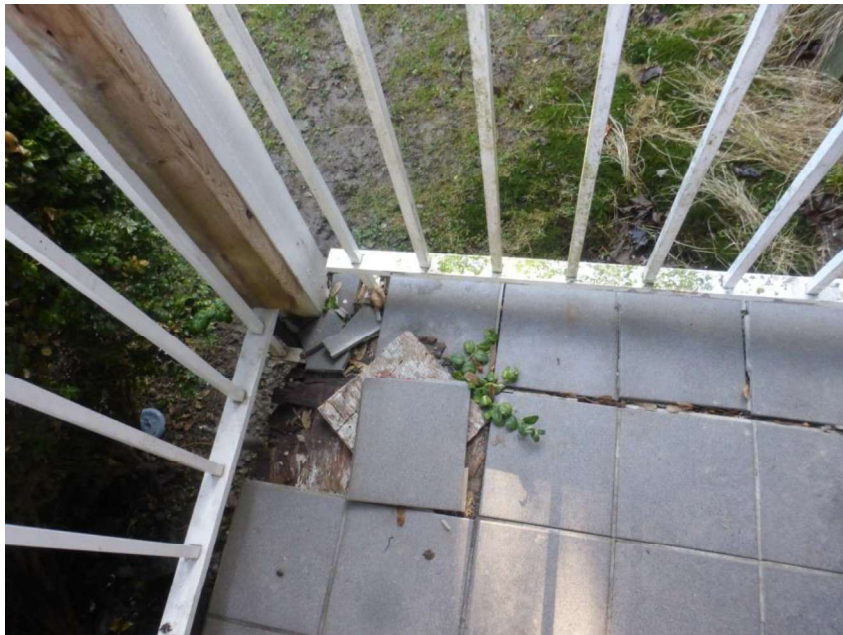
## Front Patio

Front Patio is uneven and sloped. Visible damage is observed.
