## Arborist Report

Inventory and Assessment of Trees Associated to Development at  
1170, 1156, 1146 53A Street and 5360 12 Avenue, Delta

Update April 21, 2025- Updated retention table

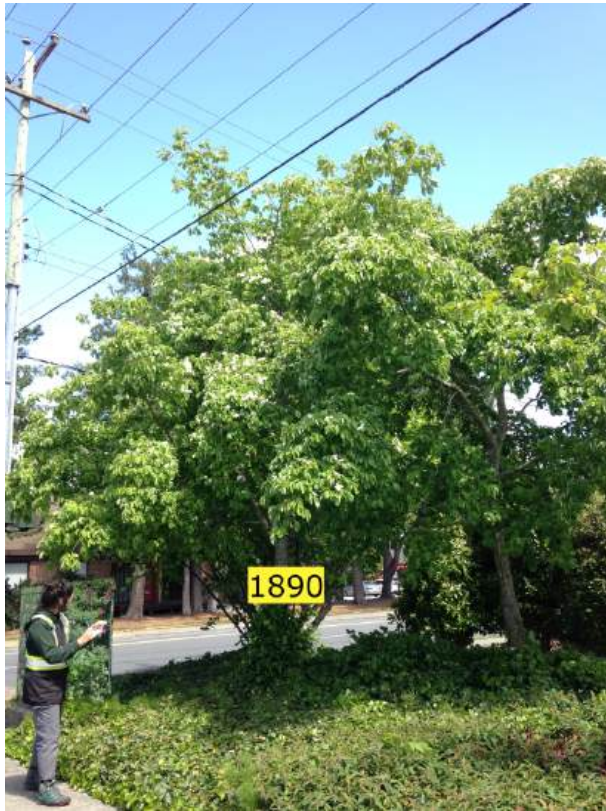
IMAGE 1- Tree 1890 - to be removed

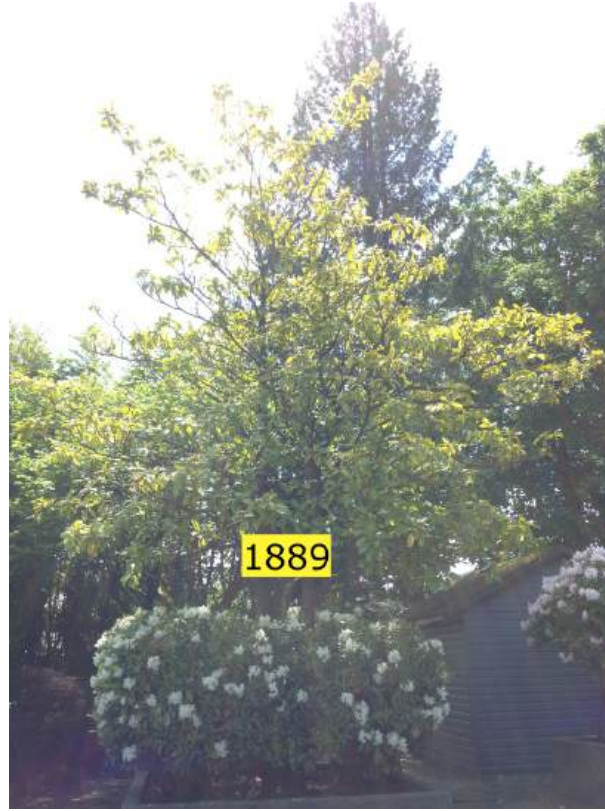
IMAGE 2- Tree #1889 - to be removed

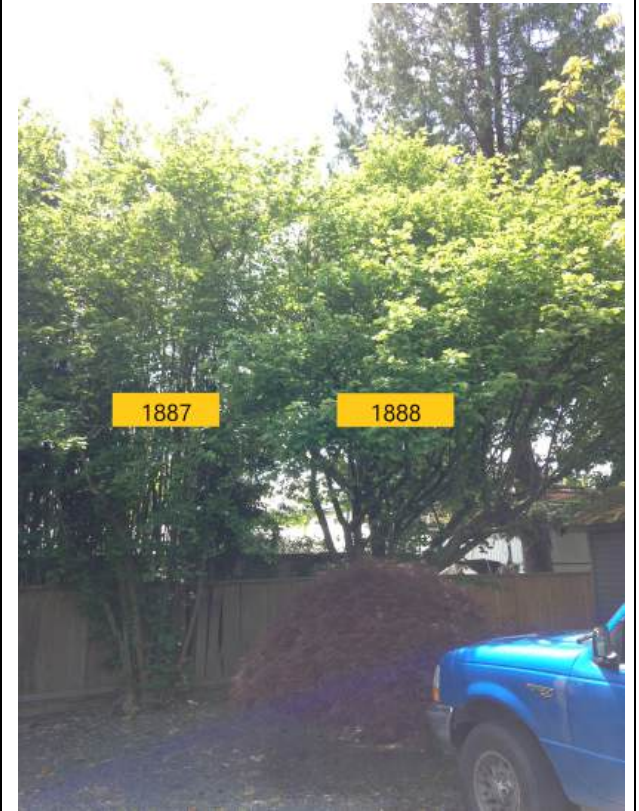
IMAGE 3- Trees #1888 - to be removed  
and #1887 - to be removed

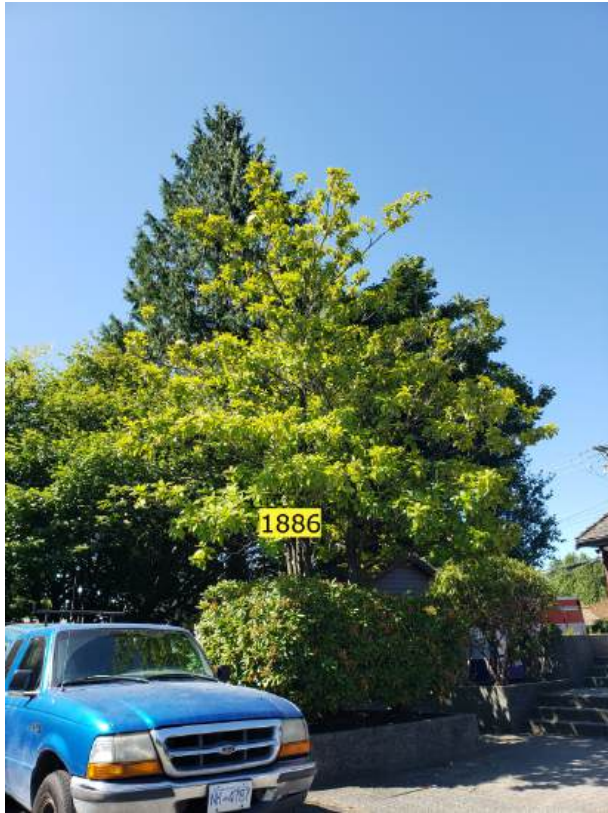
IMAGE 4- Tree #1886 - to be removed

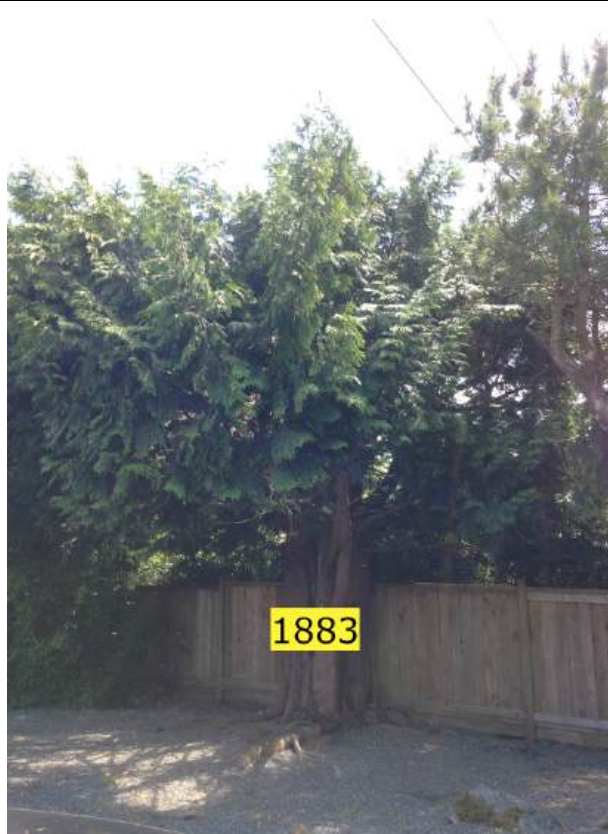
IMAGE 6- Tree #1883 - to be removed

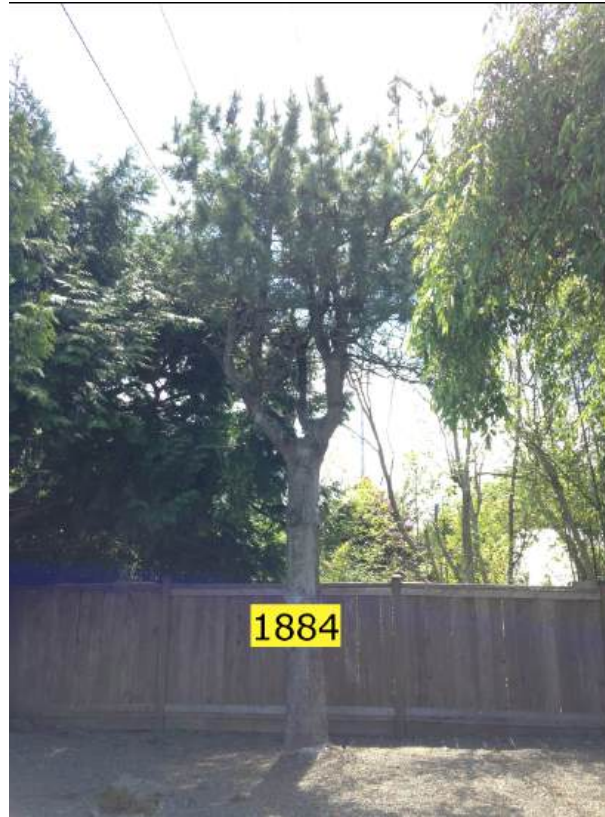
IMAGE 7- Tree #1884 - to be removed

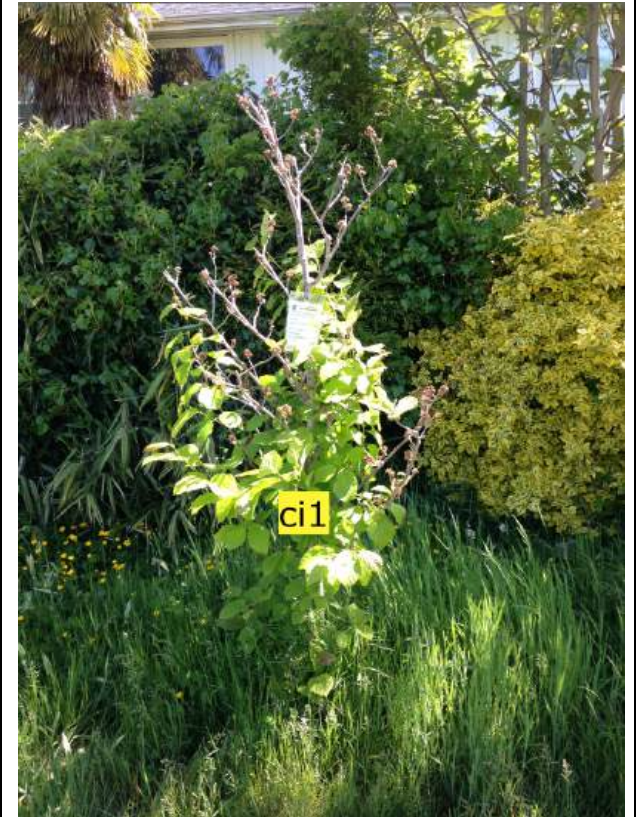
| ID# | S | L | Common Name | Botanical Name | DBH (cm) | LCR (%) | CR (m) | Condition & Comments | Health Rating | Action | TPZ (m) |
|---|---|---|---|---|---|---|---|---|---|---|---|
| ci1 | y | c | Witch Hazel | <i>Hamamelis virginiana</i> | 2 | 30 | 0.5 | Straight, single stem. Immature. Natural form. Dieback in upper crown.<br><br>Tree location conflicts with proposed sidewalk and road upgrades | Moderate | Remove | 1.20 |

IMAGE 8- Tree #ci1 - to be removed

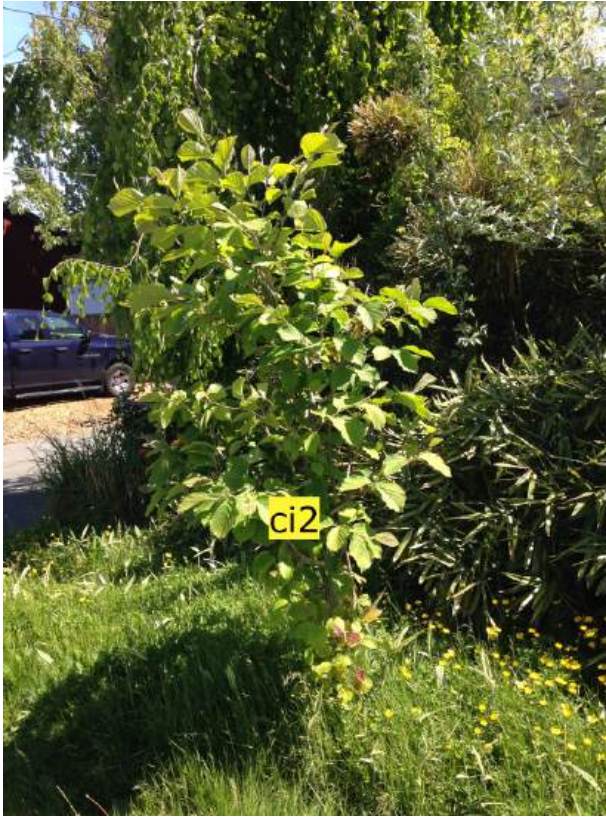
| ID# | S | L | Common Name | Botanical Name | DBH (cm) | LCR (%) | CR (m) | Condition & Comments | Health Rating | Action | TPZ (m) |
|---|---|---|---|---|---|---|---|---|---|---|---|
| ci2 | y | c | Witch Hazel | <i>Hamamelis virginiana</i> | 2 | 90 | 0.5 | Straight, single stem. Immature. Natural form.<br><br>Tree location conflicts with proposed sidewalk and road upgrades | Moderate | Remove | 1.20 |

IMAGE 9- Tree #ci2 - to be removed

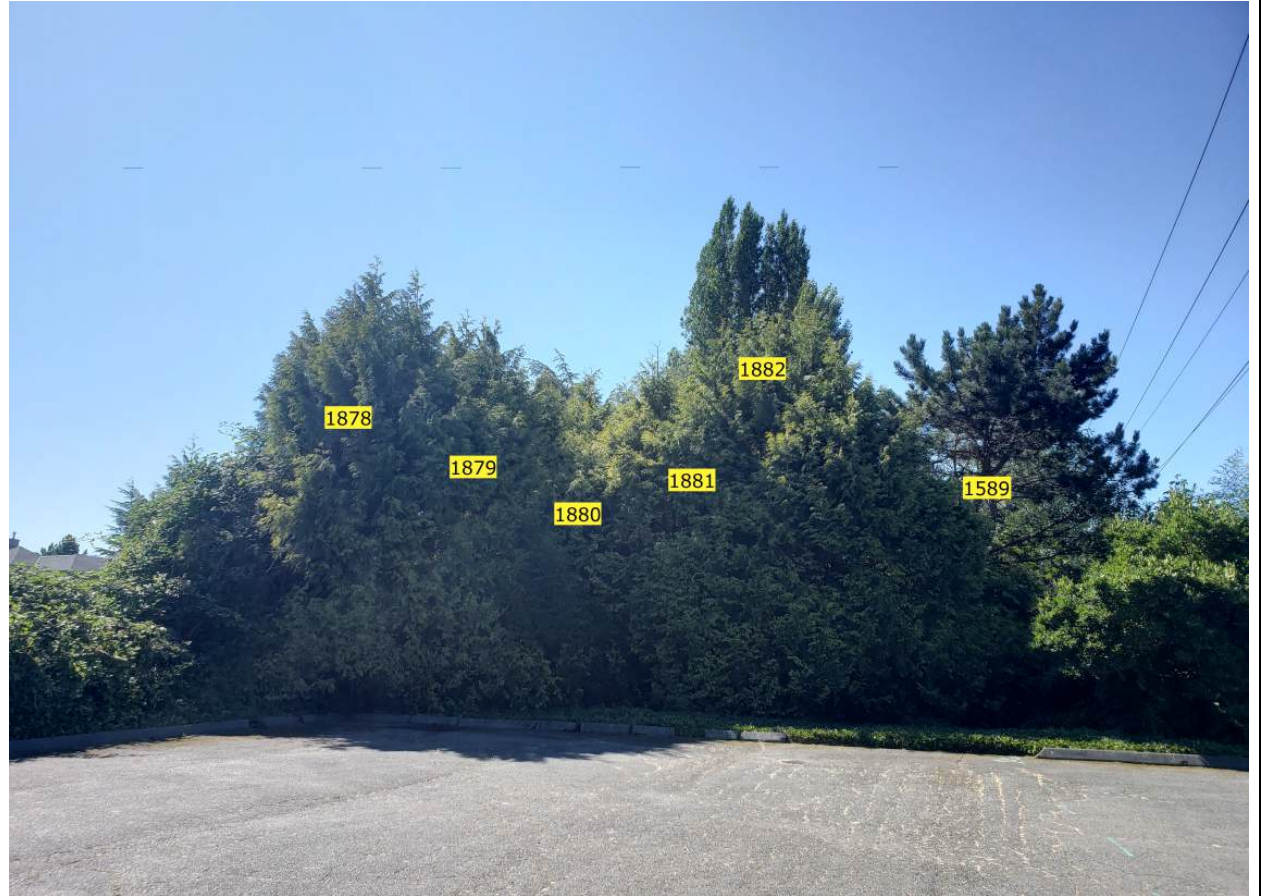
IMAGE 10-  
Tree #1878 - to be removed,  
Tree #1879 - to be removed,  
Tree #1880 - to be removed,  
Tree #1881 - to be removed,  
Tree# 1882 - to be removed,  
Tree #1589 (behind the row) - to be removed

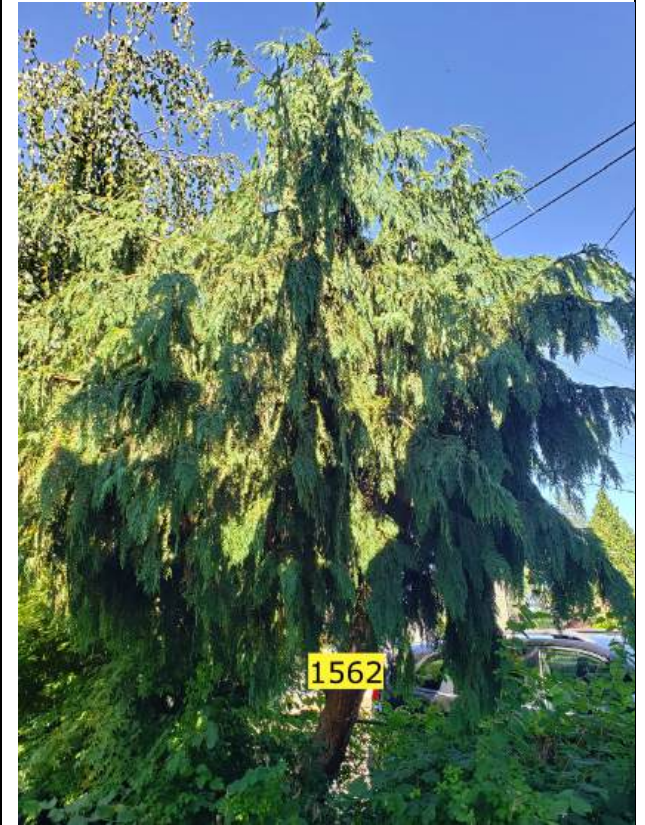
| ID# | S | L | Common Name | Botanical Name | DBH (cm) | LCR (%) | CR (m) | Condition & Comments | Health Rating | Action | TPZ (m) |
|---|---|---|---|---|---|---|---|---|---|---|---|
| 1562 | y | s | Lawson Cypress | <i>Chamaecyparis lawsoniana</i> | 28 | 70 | 1 | Weeping form. Leaning east. 2.9m from the house. 0.6m from the driveway.<br><br>Tree location conflicts with proposed building footprint | Moderate | Remove | 1.68 |

IMAGE 12- Tree #1562 - to be removed

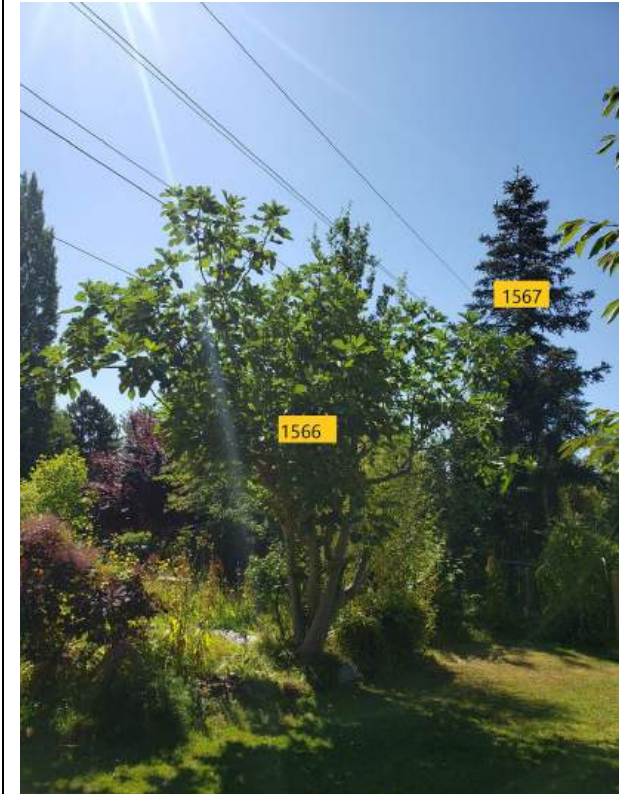
| ID# | S | L | Common Name | Botanical Name | DBH (cm) | LCR (%) | CR (m) | Condition & Comments | Health Rating | Action | TPZ (m) |
|---|---|---|---|---|---|---|---|---|---|---|---|
| 1566 | y | s | Fig | <i>Ficus carica</i> | 11+<br>10+<br>13=<br>34 | 30 | 1 | Multiple stems at base. Good fruit production. Many leaders have been topped and there is dieback throughout the crown.<br><br>Tree location conflicts with proposed pathway | Moderate | Remove | 2.04 |
| 1567 | y | s | Sitka Spruce | <i>Picea sitchensis</i> | 29 | 80 | 1.5 | Straight, single stem. Natural form. Leaning east. Adjacent to fence on the south side.<br>Tree location conflicts with proposed pathway and building footprint | Good | Remove | 1.74 |

IMAGE 15-  
Tree #1566 - to be removed  
Tree #1567 - to be removed

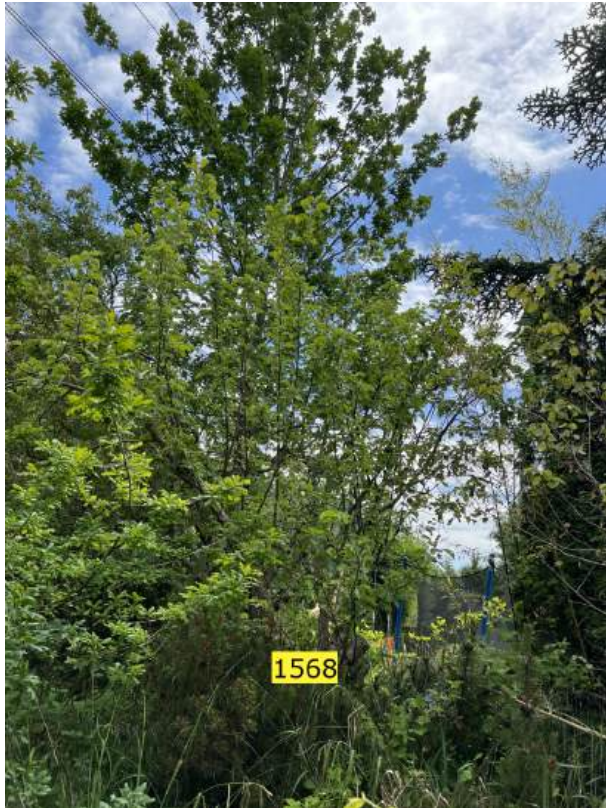
| ID# | S | L | Common Name | Botanical Name | DBH (cm) | LCR (%) | CR (m) | Condition & Comments | Health Rating | Action | TPZ (m) |
|---|---|---|---|---|---|---|---|---|---|---|---|
| 1568 | y | s | Apple | <i>Malus domestica</i> | 15+<br>13=<br>28 | 70 | 2.5 | Dual stem at base. Natural form. Topped with many regenerated leaders.<br><br>Conflicts with residential amenity area. | Moderate | Remove | 1.68 |

IMAGE 16- Tree #1568 - to be removed

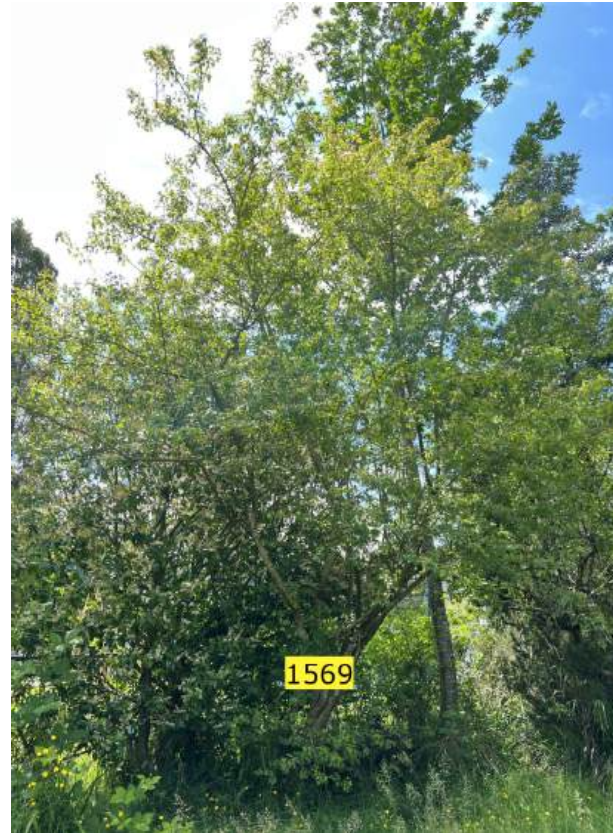
| ID# | S | L | Common Name | Botanical Name | DBH (cm) | LCR (%) | CR (m) | Condition & Comments | Health Rating | Action | TPZ (m) |
|---|---|---|---|---|---|---|---|---|---|---|---|
| 1569 | y | s | Hawthorn | <i>Crataegus laevigata</i> | 7+<br>7+<br>8=<br>22 | 70 | 1.5 | Multiple stems at base. Natural form. Adjacent to fence on the south side. Leaning south.<br>Conflicts with residential amenity area. | Moderate | Remove | 1.32 |

IMAGE 17- Tree #1569 - to be removed

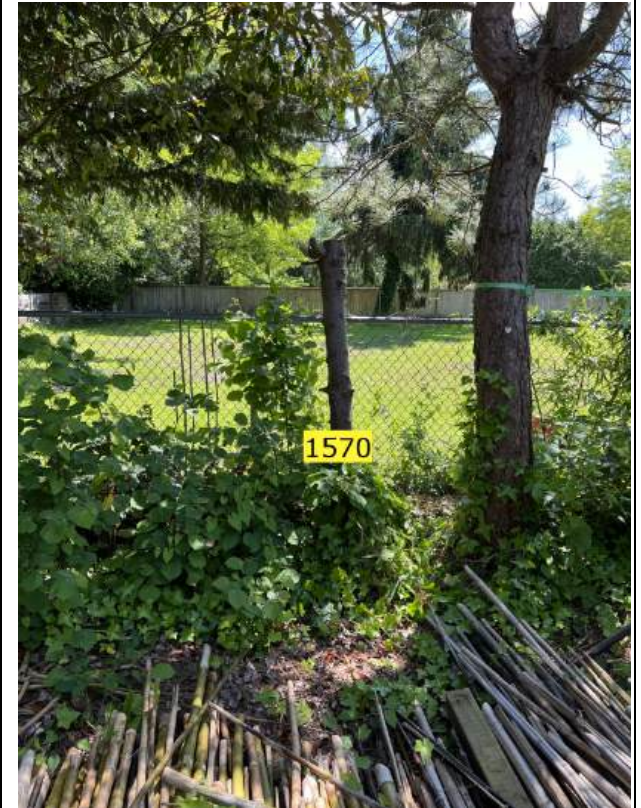
| ID# | S | L | Common Name | Botanical Name | DBH (cm) | LCR (%) | CR (m) | Condition & Comments | Health Rating | Action | TPZ (m) |
|---|---|---|---|---|---|---|---|---|---|---|---|
| 1570 | y | s | Hazelnut | <i>Corylus avellana</i> | 9+<br>9+<br>10=<br>28 | 0 | 1 | Dead tree and has been limbed. Adjacent to the fence on the south side.<br><br>Conflicts with residential amenity area. | Poor | Remove | 1.68 |

IMAGE 18- Tree #1570 - to be removed and has been limbed and is not alive.

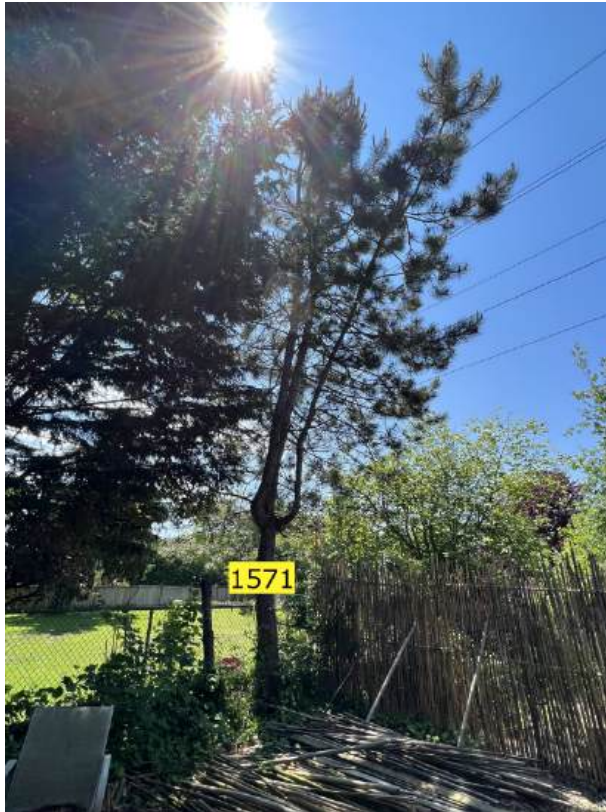
| ID# | S | L | Common Name | Botanical Name | DBH (cm) | LCR (%) | CR (m) | Condition & Comments | Health Rating | Action | TPZ (m) |
|---|---|---|---|---|---|---|---|---|---|---|---|
| 1571 | y | s | Scots Pine | <i>Pinus sylvestris</i> | 32 | 60 | 1.5 | Topped long ago at 2.5m with 3 dogleg regenerated leaders. Dieback on the east side.<br><br>Conflicts with residential amenity area. | Poor | Remove | 1.92 |

IMAGE 19- Tree #1571 - to be removed

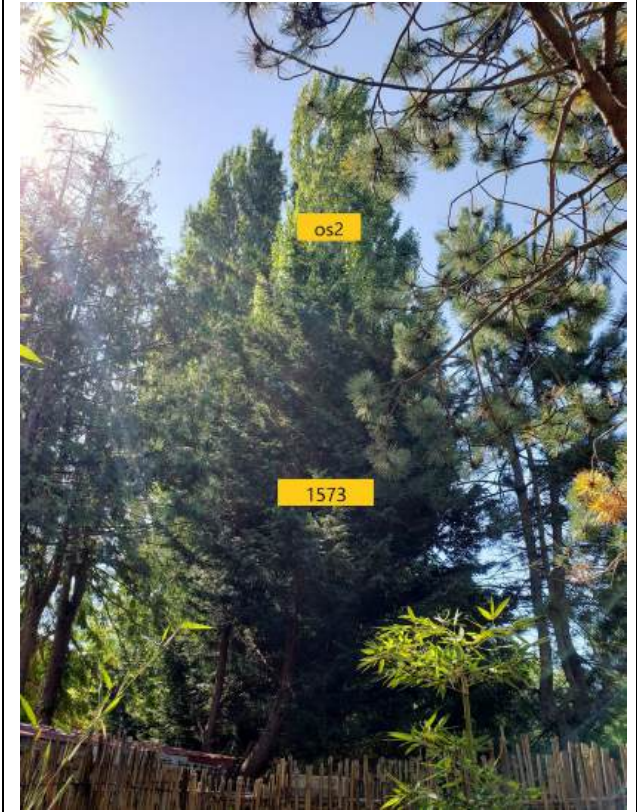
| ID# | S | L | Common Name | Botanical Name | DBH (cm) | LCR (%) | CR (m) | Condition & Comments | Health Rating | Action | TPZ (m) |
|---|---|---|---|---|---|---|---|---|---|---|---|
| 1573 | y | s | Yellow Cypress | <i>Cupressus nootkatensis</i> | 42 | 60 | 3 | Topped long ago at 2.5m with many regenerative leaders. Leaning west. Healthy foliage.<br><br>Conflicts with residential amenity area. | Moderate | Remove | 2.52 |

IMAGE 21- Tree #1573 - to be removed  
Tree #os2 - renumbered to 448- to be removed

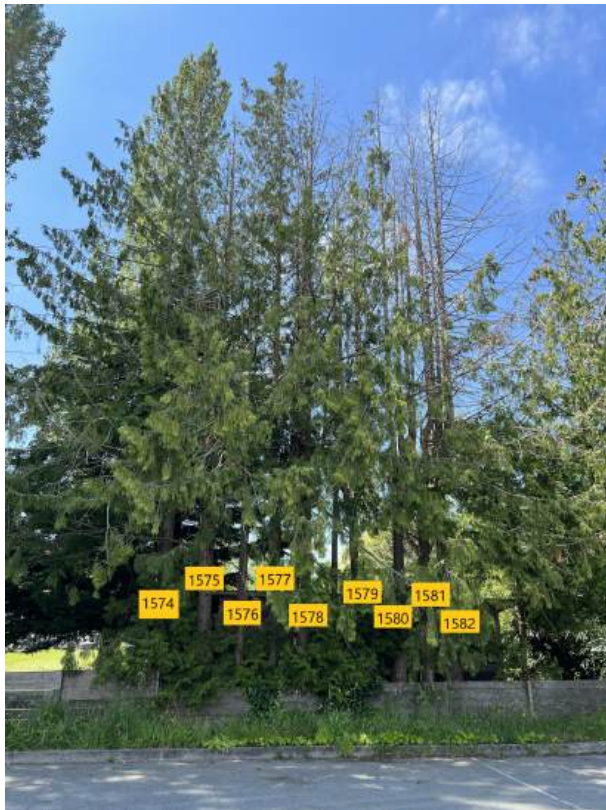
IMAGE 22-

Tree#1574 - to be removed  
Tree#1575 -- to be removed  
Tree#1576 - - to be removed  
Tree#1577 - to be removed  
Tree#1578 - to be removed  
Tree#1579 - to be removed  
Tree#1580 - to be removed  
Tree#1581 - to be removed  
Tree#1582 - to be removed

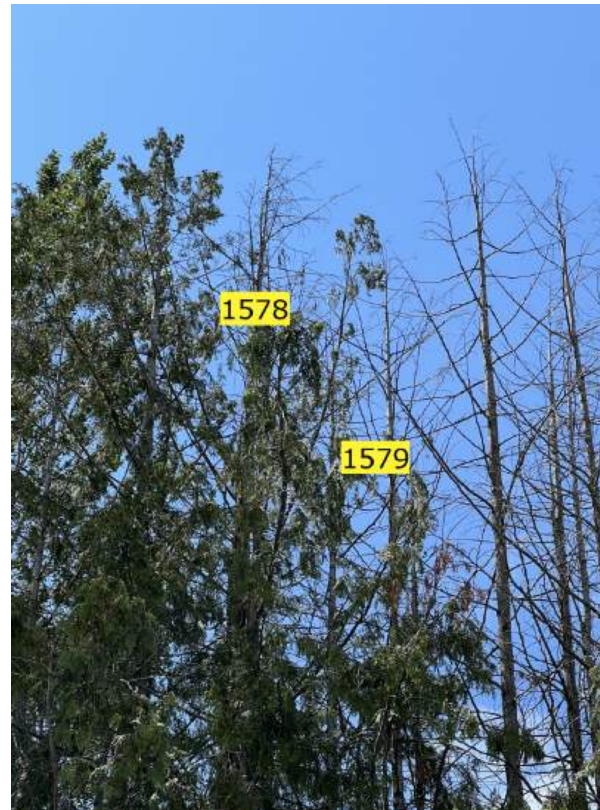
| ID# | S | L | Common Name | Botanical Name | DBH (cm) | LCR (%) | CR (m) | Condition & Comments | Health Rating | Action | TPZ (m) |
|---|---|---|---|---|---|---|---|---|---|---|---|
| 1578 | y | s | Western Red Cedar | <i>Thuja plicata</i> | 64 | 15 | 3 | Part of a hedge row. Dual stem at 2.0m. Topped at 3.0m with many regenerative leaders. Dieback throughout the crown and a very sparse upper crown(See Image 24).<br><br>Conflicts with residential amenity area. | Poor | Remove | 3.84 |
| 1579 | y | s | Western Red Cedar | <i>Thuja plicata</i> | 22 | 5 | 3 | Part of a hedge row. Topped at 3.0m with many regenerative leaders. Dieback throughout the crown and no foliage in the upper crown(See Image 24).<br><br>Conflicts with proposed outdoor commercial parking lot. | Poor | Remove | 1.32 |

IMAGE 23- Die back was found throughout the crown on tree#1578 and #1579- to be removed

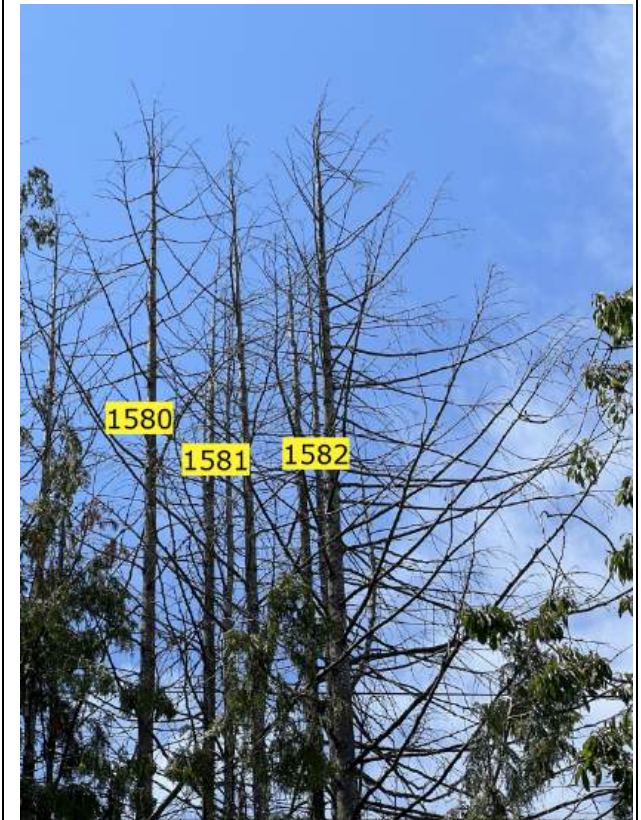
| ID# | S | L | Common Name | Botanical Name | DBH (cm) | LCR (%) | CR (m) | Condition & Comments | Health Rating | Action | TPZ (m) |
|---|---|---|---|---|---|---|---|---|---|---|---|
| 1580 | y | s | Western Red Cedar | <i>Thuja plicata</i> | 36 | 5 | 3 | Part of a hedge row. Topped at 3.0m with many regenerative leaders. Dieback throughout the crown and no foliage in the upper crown(See Image 25).<br><br>Conflicts with proposed outdoor parking area. | Poor | Remove | 2.16 |
| 1581 | y | s | Western Red Cedar | <i>Thuja plicata</i> | 30 | 5 | 3 | Part of a hedge row. Topped at 3.0m with many regenerative leaders. Dieback throughout the crown and no foliage in the upper crown(See Image 25).<br>Conflicts with proposed outdoor parking area. | Poor | Remove | 1.80 |

| ID# | S | L | Common Name | Botanical Name | DBH (cm) | LCR (%) | CR (m) | Condition & Comments | Health Rating | Action | TPZ (m) |
|---|---|---|---|---|---|---|---|---|---|---|---|
| 1582 | y | s | Western Red Cedar | <i>Thuja plicata</i> | 40 | 5 | 3 | Part of a hedge row. Topped at 3.0m with many regenerative leaders. Dieback throughout the crown and no foliage in the upper crown.<br><br>Conflicts with proposed outdoor parking area. | Poor | Remove | 2.40 |

IMAGE 24- Die back was found throughout the crown on tree#1580, #1581 and #1582- to be removed

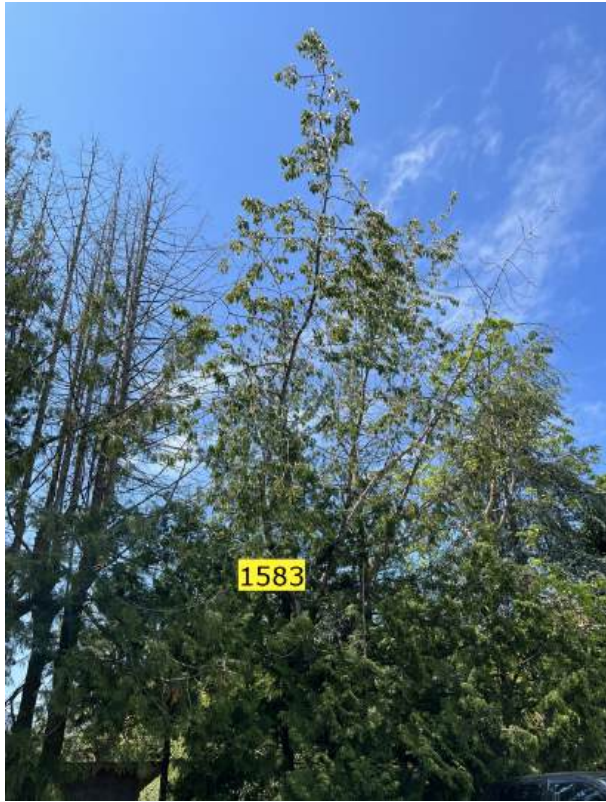
| ID# | S | L | Common Name | Botanical Name | DBH (cm) | LCR (%) | CR (m) | Condition & Comments | Health Rating | Action | TPZ (m) |
|---|---|---|---|---|---|---|---|---|---|---|---|
| 1583 | y | s | Western Red Cedar | <i>Thuja plicata</i> | 26 | 60 | 2 | Straight, single stem. Natural form. Slight dieback in inner crown. 2.0m crown radius<br><br>Conflicts with proposed outdoor parking area. | Good | Remove | 1.56 |

IMAGE 25 - Tree #1583 - to be removed

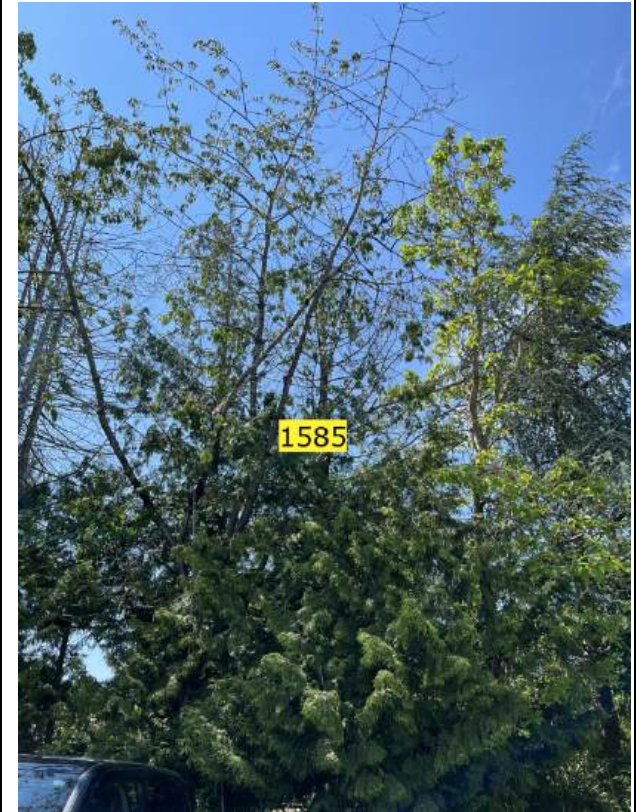
| ID# | S | L | Common Name | Botanical Name | DBH (cm) | LCR (%) | CR (m) | Condition & Comments | Health Rating | Action | TPZ (m) |
|---|---|---|---|---|---|---|---|---|---|---|---|
| 1585 | y | s | Western Red Cedar | <i>Thuja plicata</i> | 36 | 10 | 2 | Straight, single stem. Severe dieback throughout the crown with only tips of branches and epicormic shoots producing foliage.<br>Conflicts with proposed outdoor parking area. | Poor | Remove | 2.16 |

IMAGE 27 - Tree #1585 - to be removed

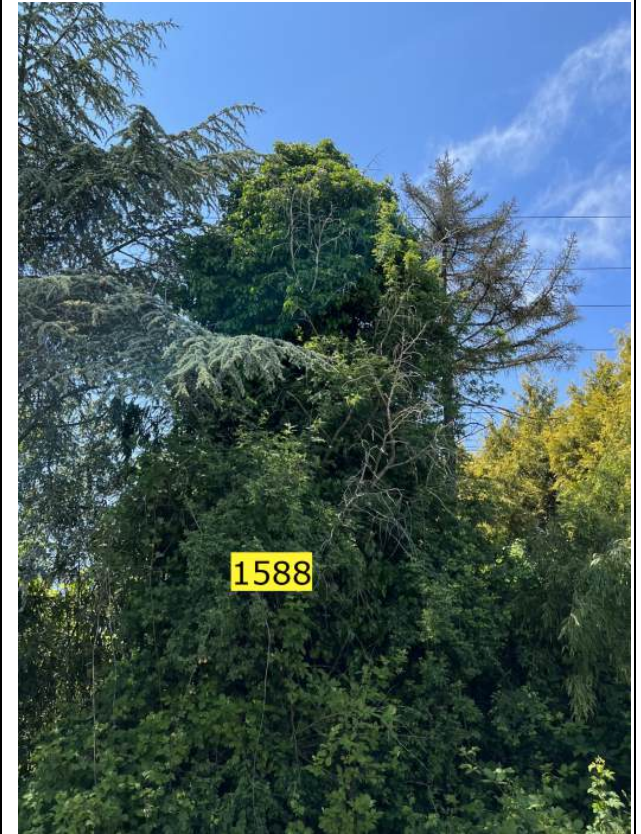
| ID# | S | L | Common Name | Botanical Name | DBH (cm) | LCR (%) | CR (m) | Condition & Comments | Health Rating | Action | TPZ (m) |
|---|---|---|---|---|---|---|---|---|---|---|---|
| 1588 | y | s | Western Red Cedar | <i>Thuja plicata</i> | 40 | 0 | 1 | Dead tree standing. Completely overwhelmed with ivy.<br><br>Conflicts with proposed outdoor parking area. | Poor | Remove<br><br>Dead tree | 2.40 |

IMAGE 30 - Tree #1588 - to be removed

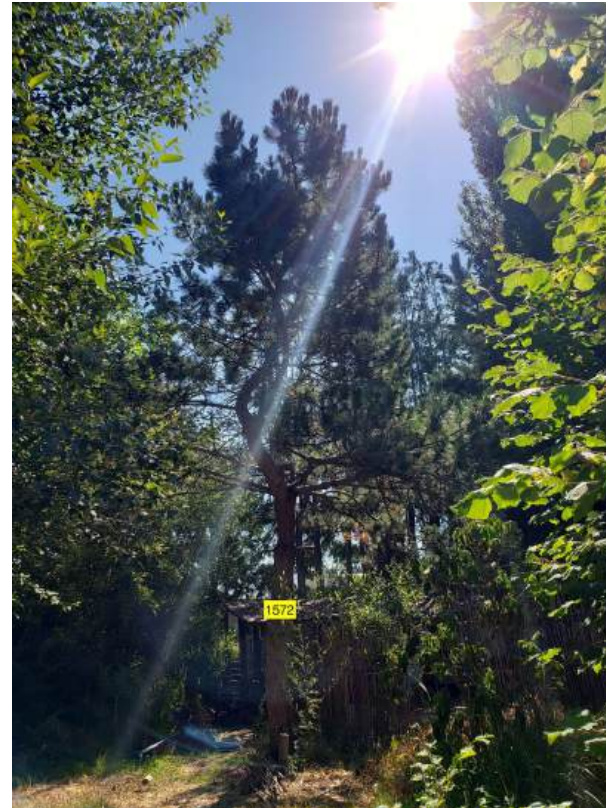
| ID# | S | L | Common Name | Botanical Name | DBH (cm) | LCR (%) | CR (m) | Condition & Comments | Health Rating | Action | TPZ (m) |
|---|---|---|---|---|---|---|---|---|---|---|---|
| 1572 | y | s | Scots Pine | <i>Pinus sylvestris</i> | 33 | 60 | 2 | Topped long ago at 2.5m with 2 regenerated leaders growing nearly horizontal<br><br>Conflicts with residential amenity area. | Moderate | Remove | 1.98 |

IMAGE 32- Tree 1572- to be removed

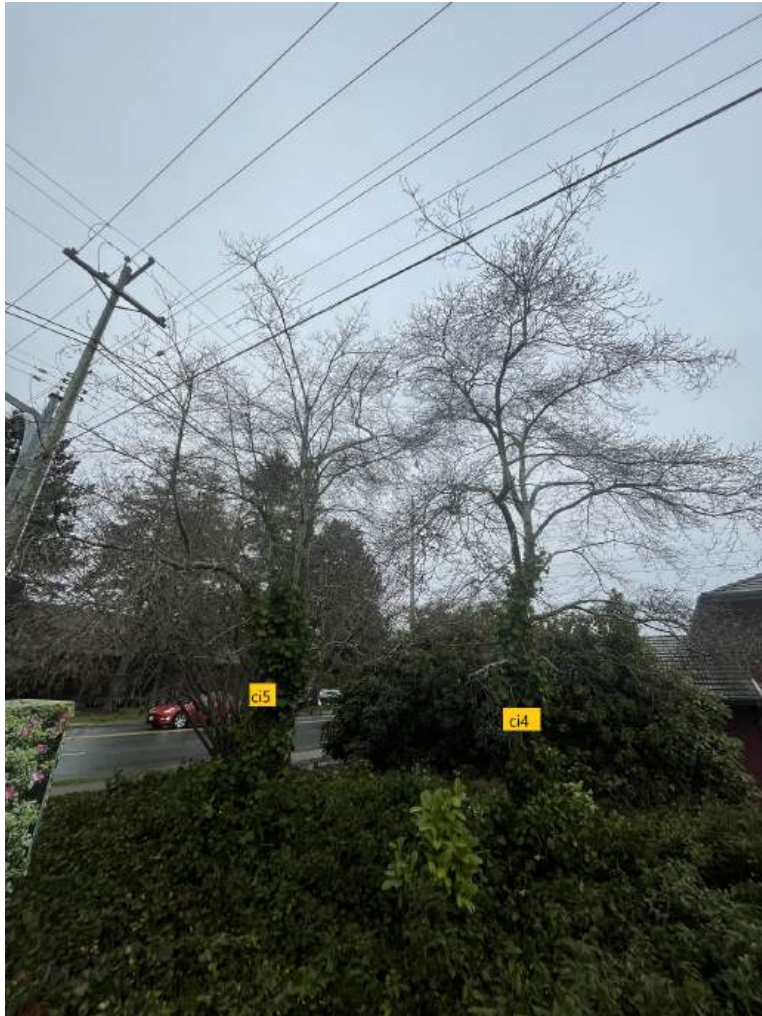
| ID# | S | L | Common Name | Botanical Name | DBH (cm) | LCR (%) | CR (m) | Condition & Comments | Health Rating | Action | TPZ (m) |
|---|---|---|---|---|---|---|---|---|---|---|---|
| ci4 | y | c | Pacific Dogwood | <i>Cornus nuttallii</i> | 18 | 55 | 3 | Single stem, completely taken over by ivy.<br><br>Tree location conflicts with proposed sidewalk and road upgrades | Moderate | Remove | 1.20 |
| ci5 | y | c | Pacific Dogwood | <i>Cornus nuttallii</i> | 25 | 55 | 5 | Single stem, completely taken over by ivy.<br><br>Tree location conflicts with proposed sidewalk and road upgrades | Moderate | Remove | 1.50 |

IMAGE 33- Tree ci4 & ci5- to be removed

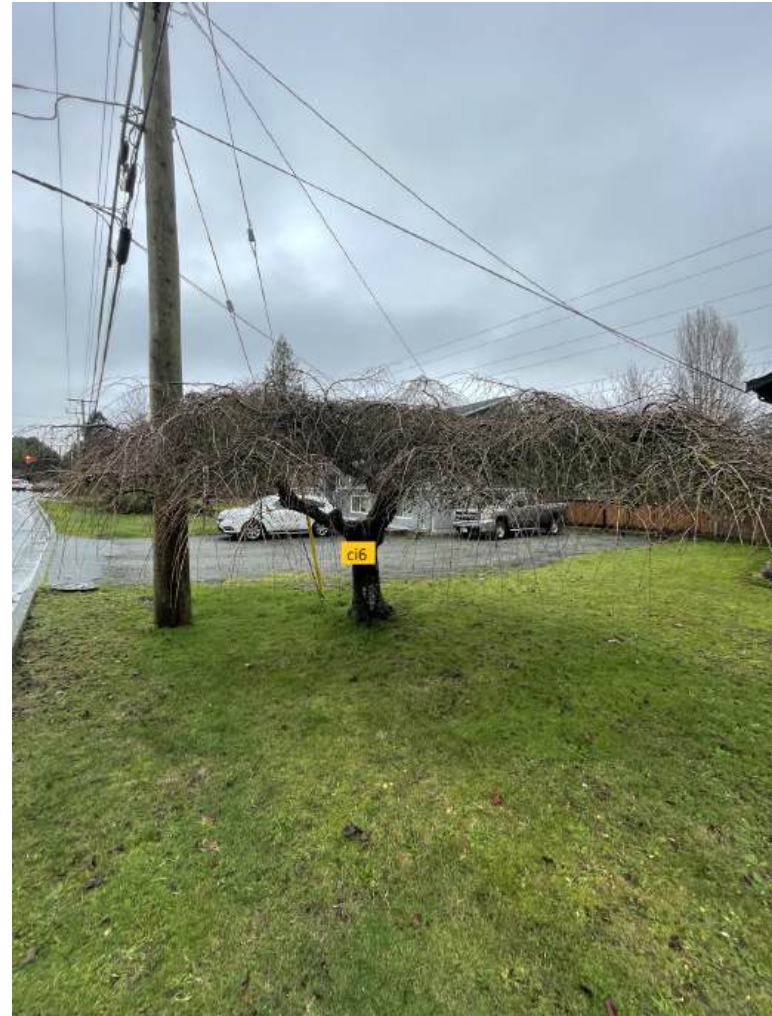
| ID# | S | L | Common Name | Botanical Name | DBH (cm) | LCR (%) | CR (m) | Condition & Comments | Health Rating | Action | TPZ (m) |
|---|---|---|---|---|---|---|---|---|---|---|---|
| ci6 | y | c | Weeping Cherry | <i>Prunus avium</i> | 54 | 50 | 4 | Growing beside hydro pole and guy wire. Improperly pruned<br><br>Tree location conflicts with proposed sidewalk and road upgrades | Moderate | Remove | 3.24 |

IMAGE 34- Tree ci6- to be removed

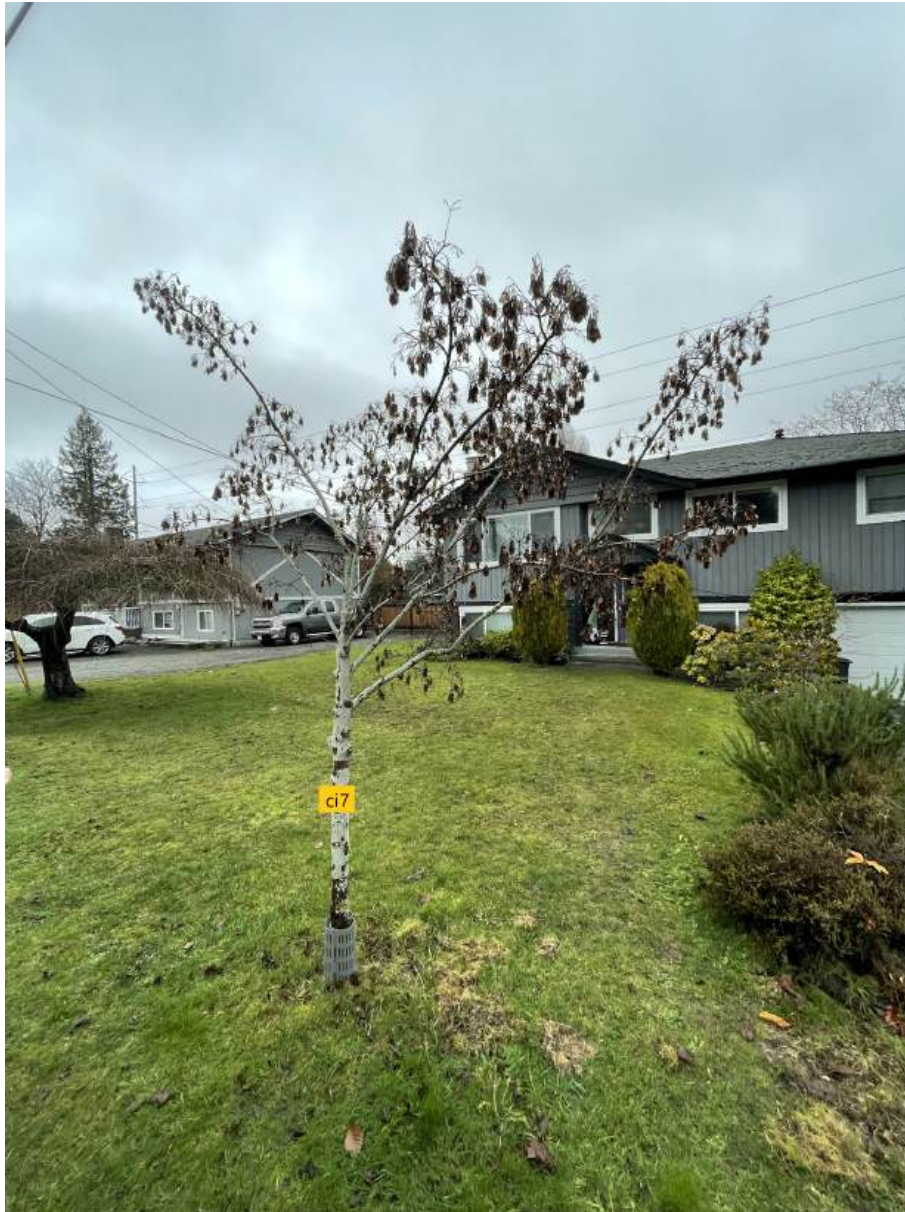
| ID# | S | L | Common Name | Botanical Name | DBH (cm) | LCR (%) | CR (m) | Condition & Comments | Health Rating | Action | TPZ (m) |
|---|---|---|---|---|---|---|---|---|---|---|---|
| ci7 | y | c | Amur Maple | <i>Acer ginnala</i> | 6 | 30 | 1 | Lower trunk has cambium damage, small dead buds are present and it is missing its central leader.<br>Tree location conflicts with proposed sidewalk and road upgrades | Poor | Remove | 1.20 |

IMAGE 35- Tree ci7- to be removed

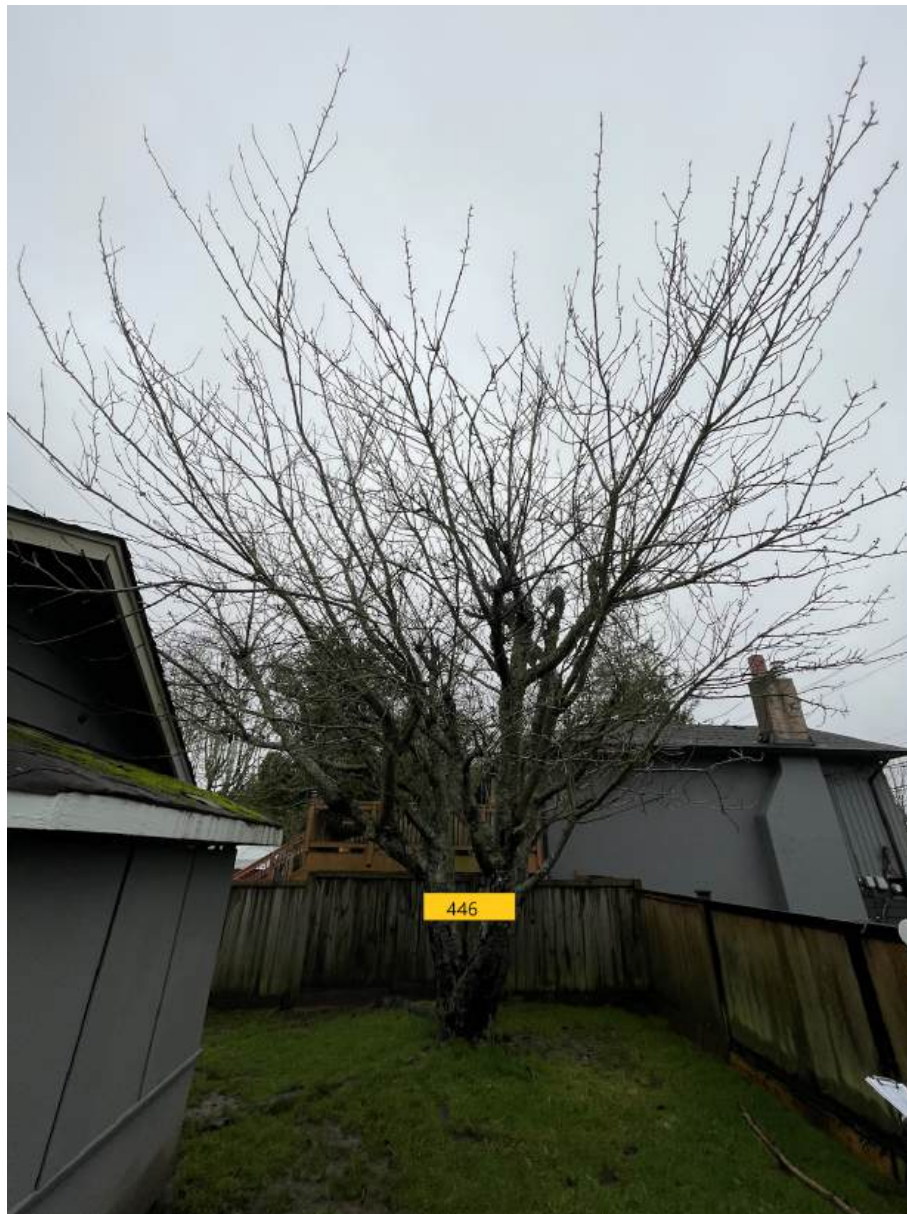
| ID# | S | L | Common Name | Botanical Name | DBH (cm) | LCR (%) | CR (m) | Condition & Comments | Health Rating | Action | TPZ (m) |
|---|---|---|---|---|---|---|---|---|---|---|---|
| 446 | y | s | Cherry | <i>Prunus</i> | 33+<br>37+<br>32=<br>102 | 70 | 8 | Historically topped, decay present in stems with old heading cuts. Surface roots present.<br><br>Conflicts with proposed building footprint. | Poor | Remove | 6.12 |

IMAGE 43-Tree 446- to be removed

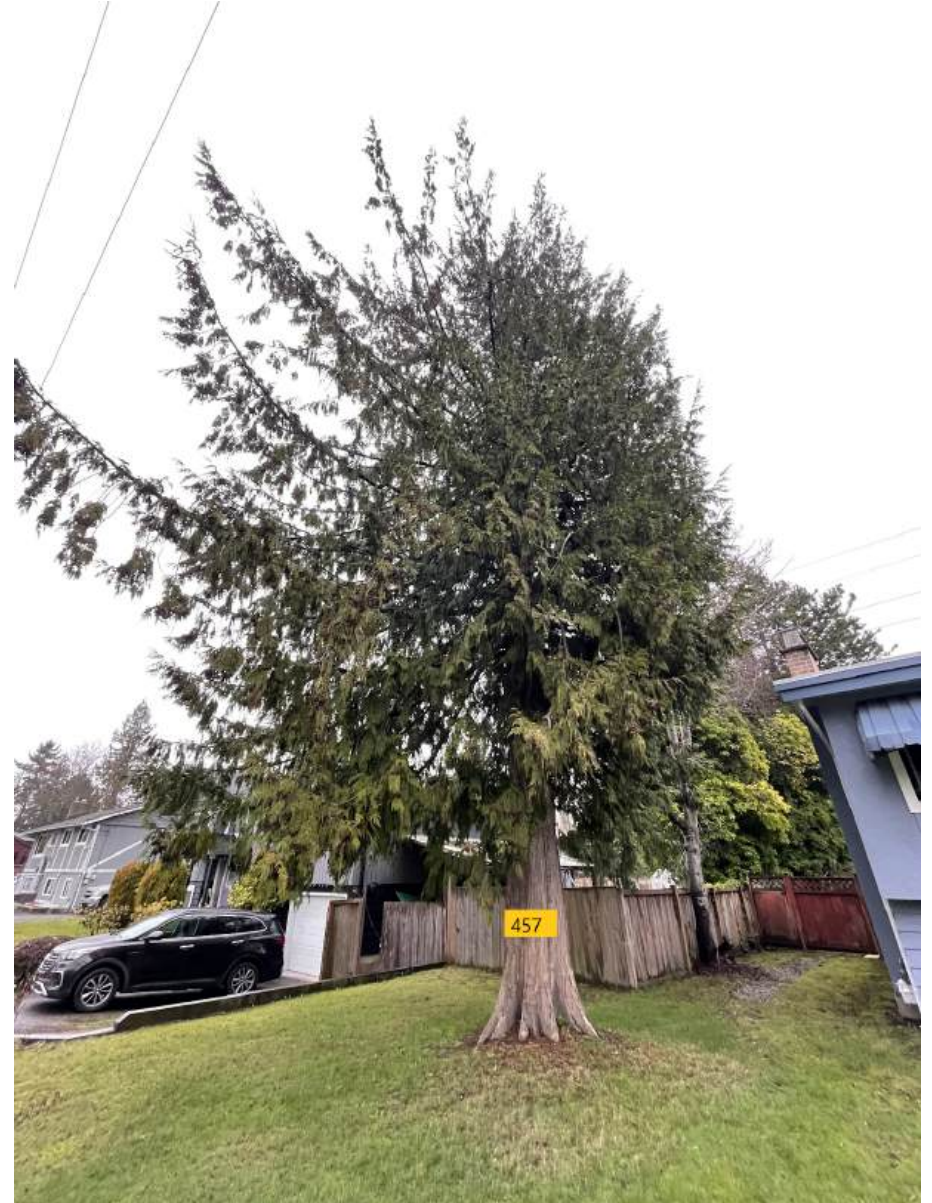
| ID# | S | L | Common Name | Botanical Name | DBH (cm) | LCR (%) | CR (m) | Condition & Comments | Health Rating | Action | TPZ (m) |
|---|---|---|---|---|---|---|---|---|---|---|---|
| 457 | y | s<br>h | Western Red Cedar | <i>Thuja plicata</i> | 74 | 85 | 8 | Top is sparse, thin foliage, insect galleries at base and root flare of the southern side. Decay is along the root flare.<br><br>The proposed installation of pathway and excavation for the parkade entrance is expected to significantly impact the tree to such an extent that removal is recommended. | Moderate | Remove | 4.44 |

IMAGE 52-Tree 457- to be removed

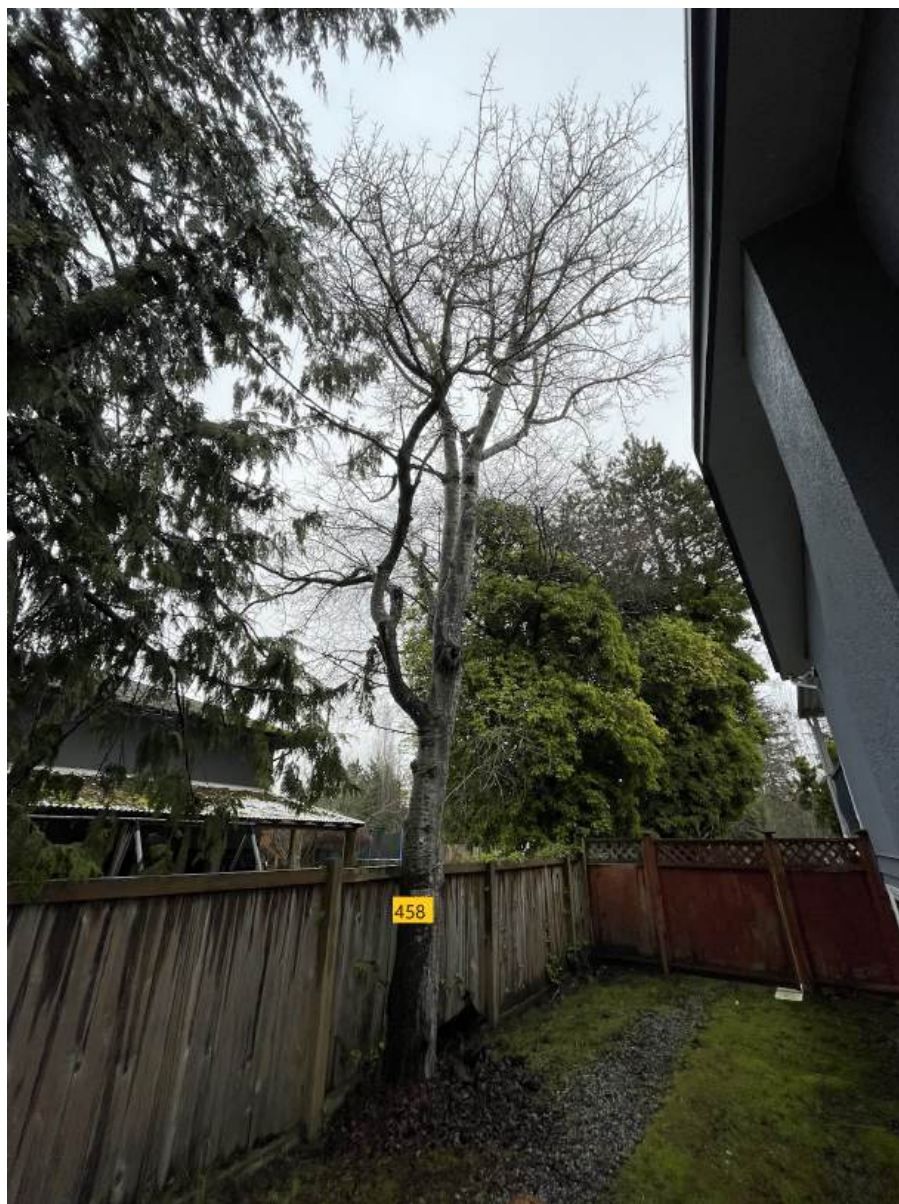
| ID# | S | L | Common Name | Botanical Name | DBH (cm) | LCR (%) | CR (m) | Condition & Comments | Health Rating | Action | TPZ (m) |
|---|---|---|---|---|---|---|---|---|---|---|---|
| 458 | y | s | Cherry | <i>Prunus spp.</i> | 32 | 85 | 4 | Clearance pruned from building, small cavity on the southern stem.<br><br>The proposed installation of pathway and excavation for the parkade entrance is expected to significantly impact the tree to such an extent that removal is recommended | Moderate | Remove | 1.92 |

IMAGE 53-Tree 458- to be removed

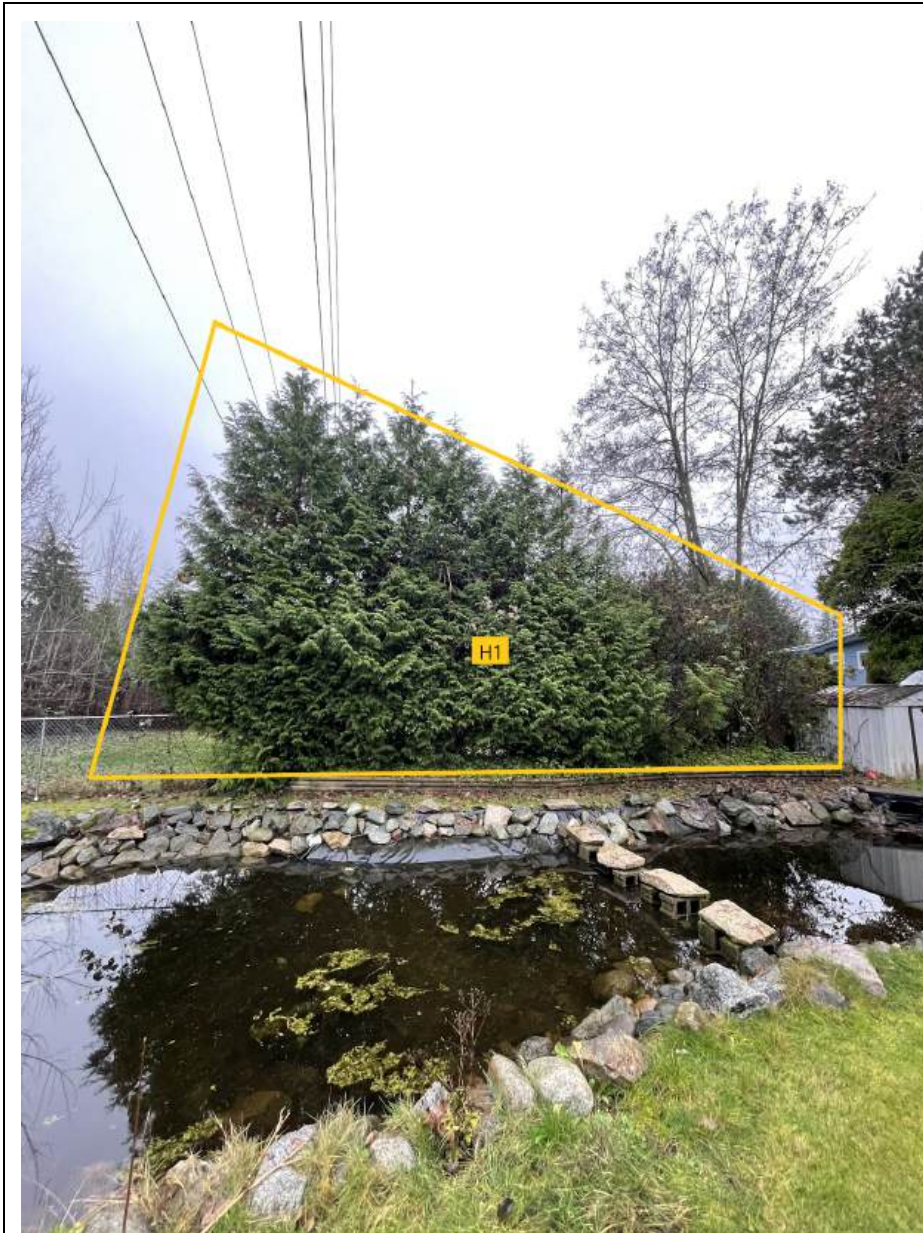
| ID# | S | L | Common Name | Botanical Name | DBH (cm) | LCR (%) | CR (m) | Condition & Comments | Health Rating | Action | TPZ (m) |
|---|---|---|---|---|---|---|---|---|---|---|---|
| H1 | y | s | Cedar hedge | <i>Thuja plicata</i> | n/a | 80 | 0.5 | Hedge is 12m long and there are 3 dead standing shrubs. Hedgerow is not bylaw applicable.<br><br>Removal within the TPZ of tree 461. Arborist to supervise removal | Poor | Remove<br><br>Arborist to supervise removal | n/a |

IMAGE 59-H1, Not bylaw applicable- to be removed
