## Arborist Report

Inventory and Assessment of Trees Associated to Development at  
1170, 1156, 1146 53A Street and 5360 12 Avenue, Delta

Update April 21, 2025- Updated retention table

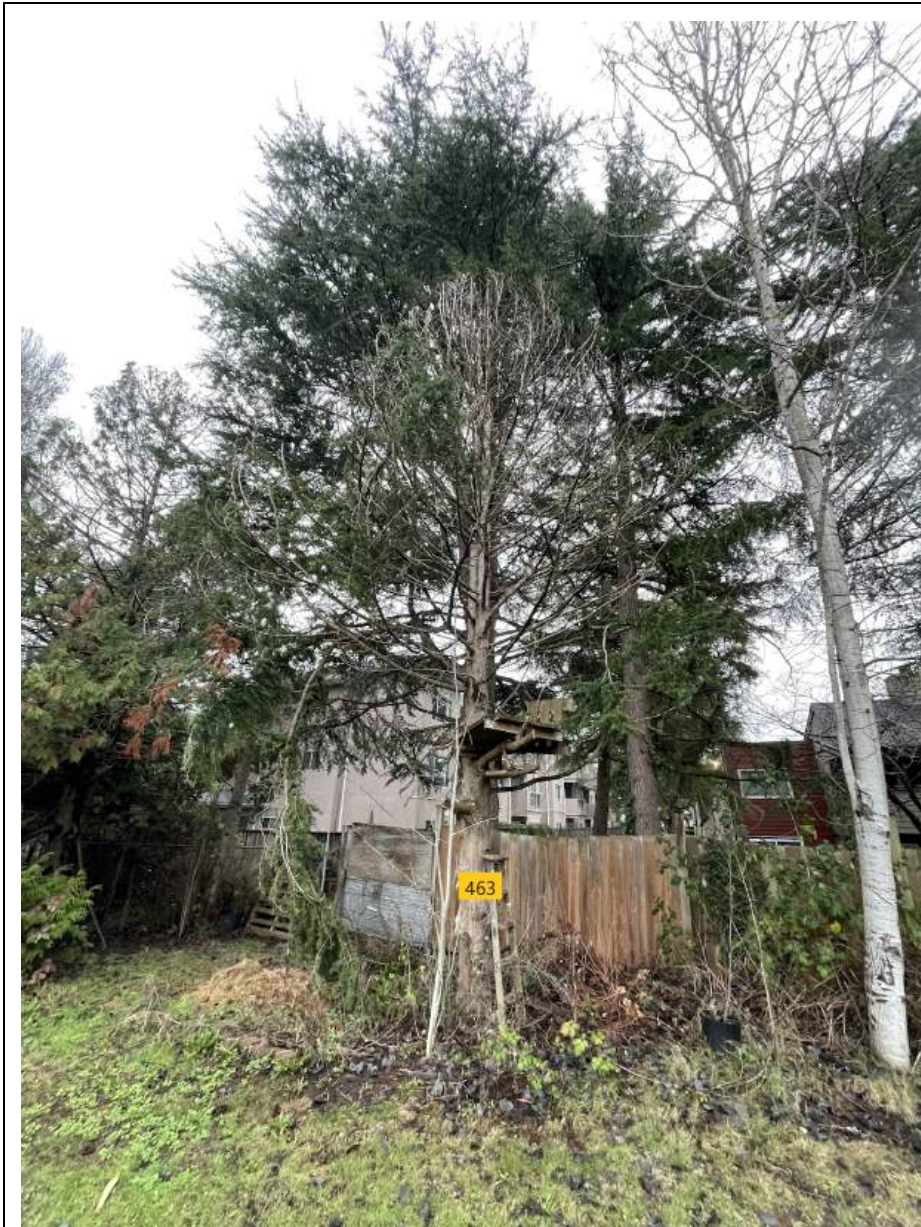
| ID# | S | L | Common Name | Botanical Name | DBH (cm) | LCR (%) | CR (m) | Condition & Comments | Health Rating | Action | TPZ (m) |
|---|---|---|---|---|---|---|---|---|---|---|---|
| 463 | y | s | Dead Cedar | <i>Thuja plicata</i> | 32 | 0 | 3 | Dead standing tree | Poor | Remove<br><br>Dead tree | 1.92 |

IMAGE 61-Tree 463, dead tree- to be removed

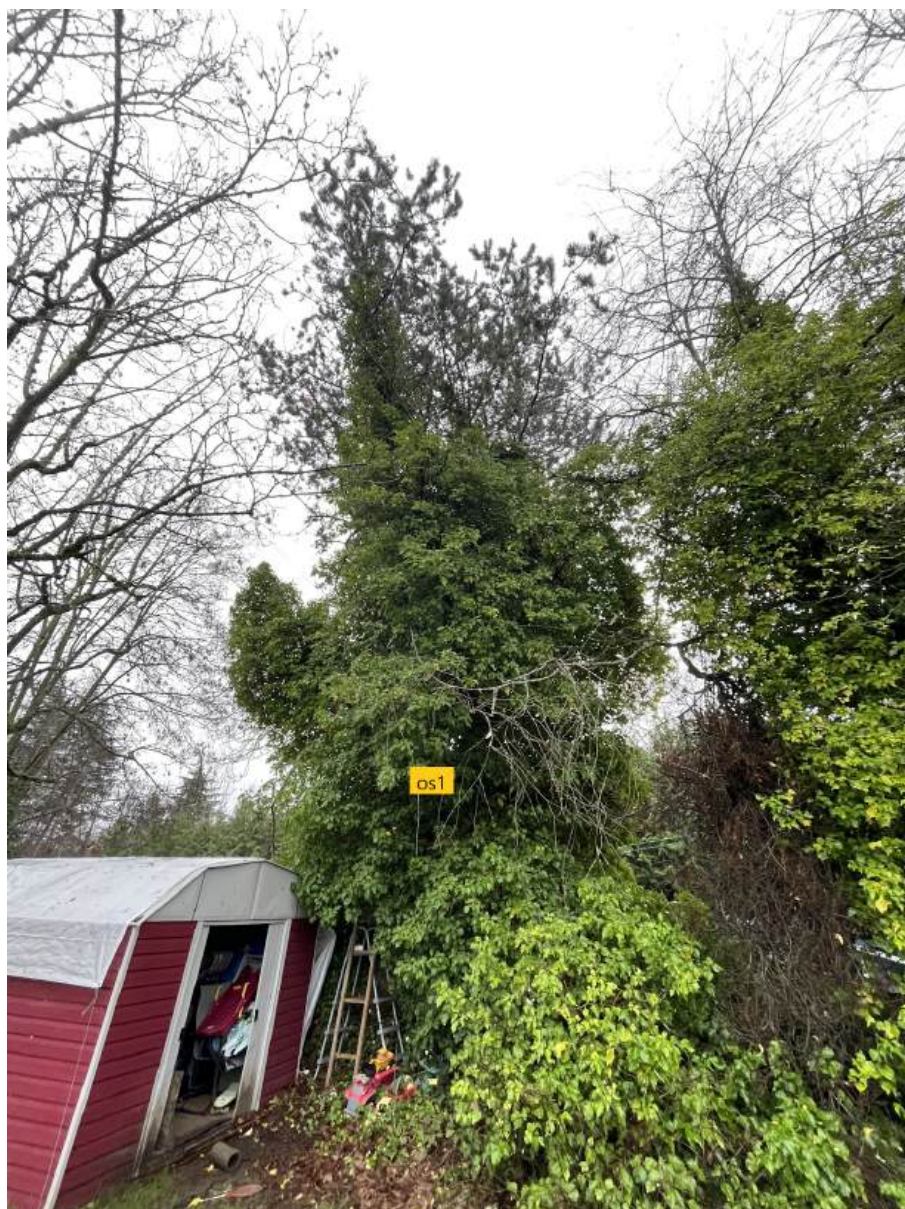
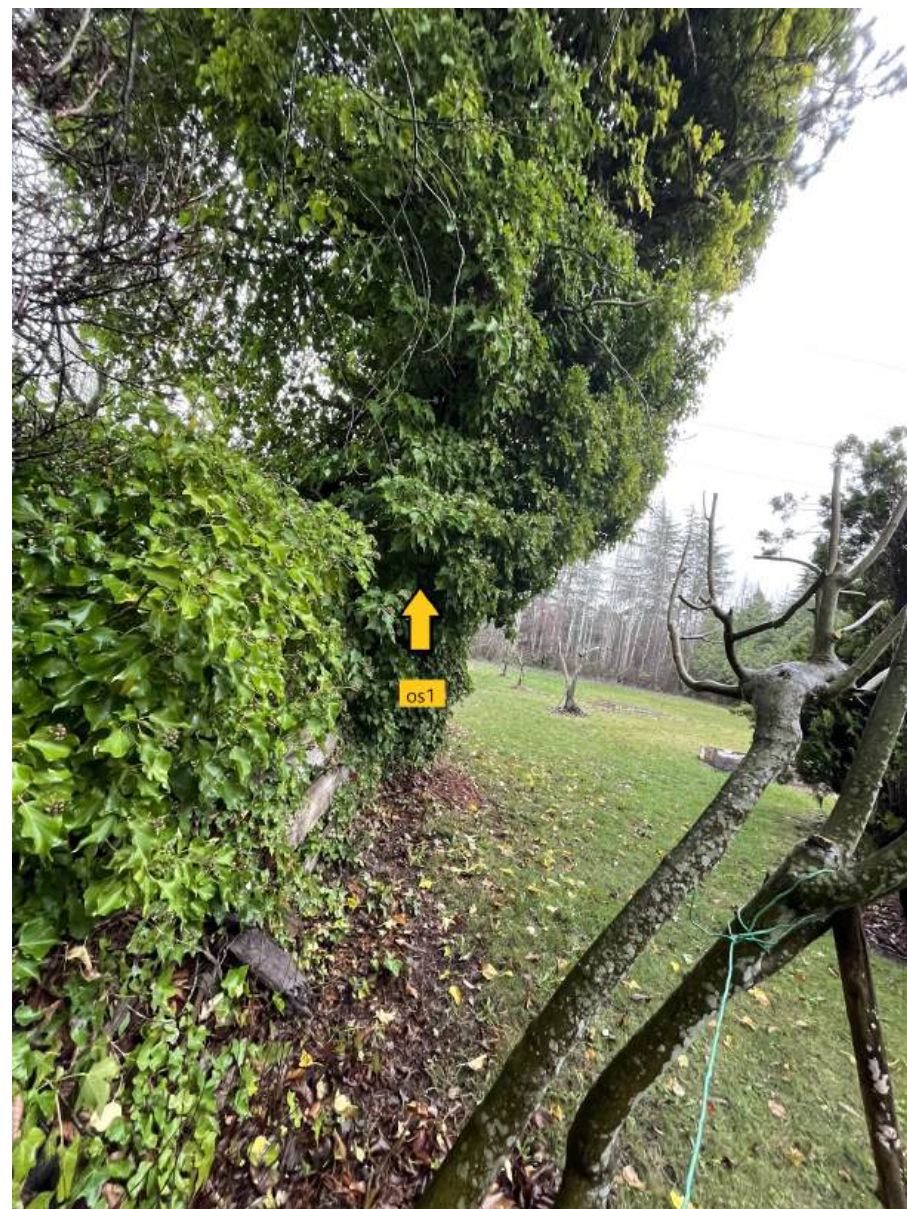
| ID# | S | L | Common Name | Botanical Name | DBH (cm) | LCR (%) | CR (m) | Condition & Comments | Health Rating | Action | TPZ (m) |
|---|---|---|---|---|---|---|---|---|---|---|---|
| OS1 | y | o | Shortleaf Pine | <i>Pinus enchinata</i> | 115 | 40 | 3 | Incorrectly surveyed showing the tree is on the north side of the fence and it is on the south.<br><br>The proposed installation of pathway and excavation for the parkade entrance is expected to significantly impact the tree to such an extent that removal is recommended. | Moderate | Remove | 6.90 |

IMAGE 65- Tree os1- to be removed

IMAGE 66-Tree base, tree os1- to be removed

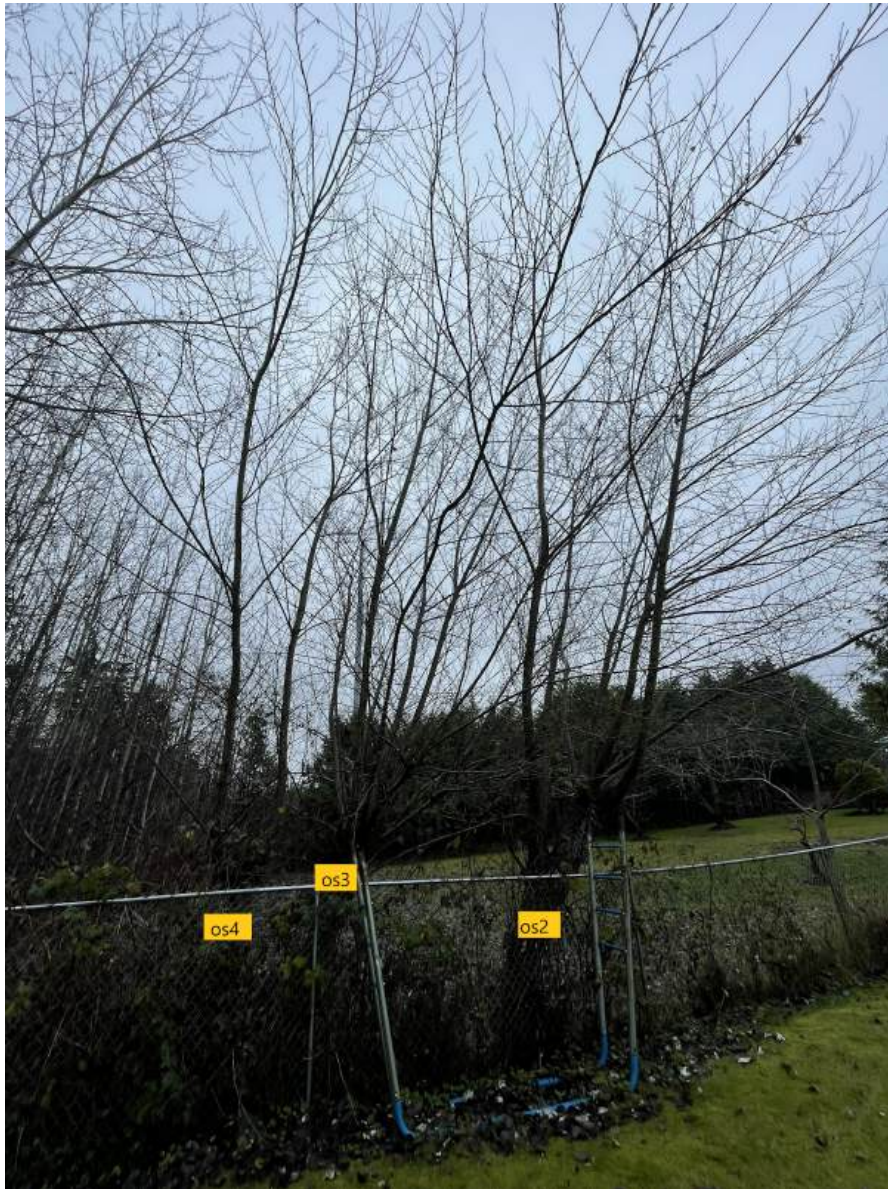
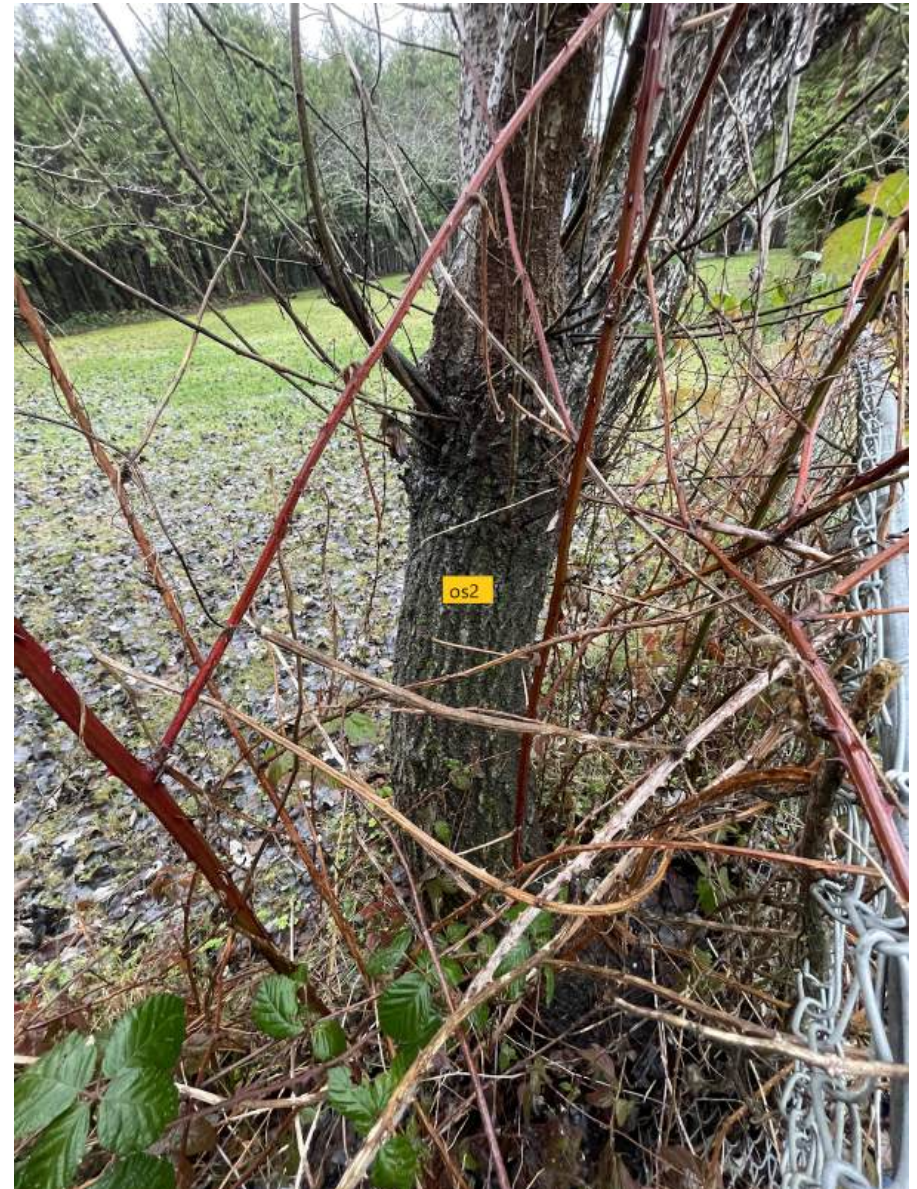
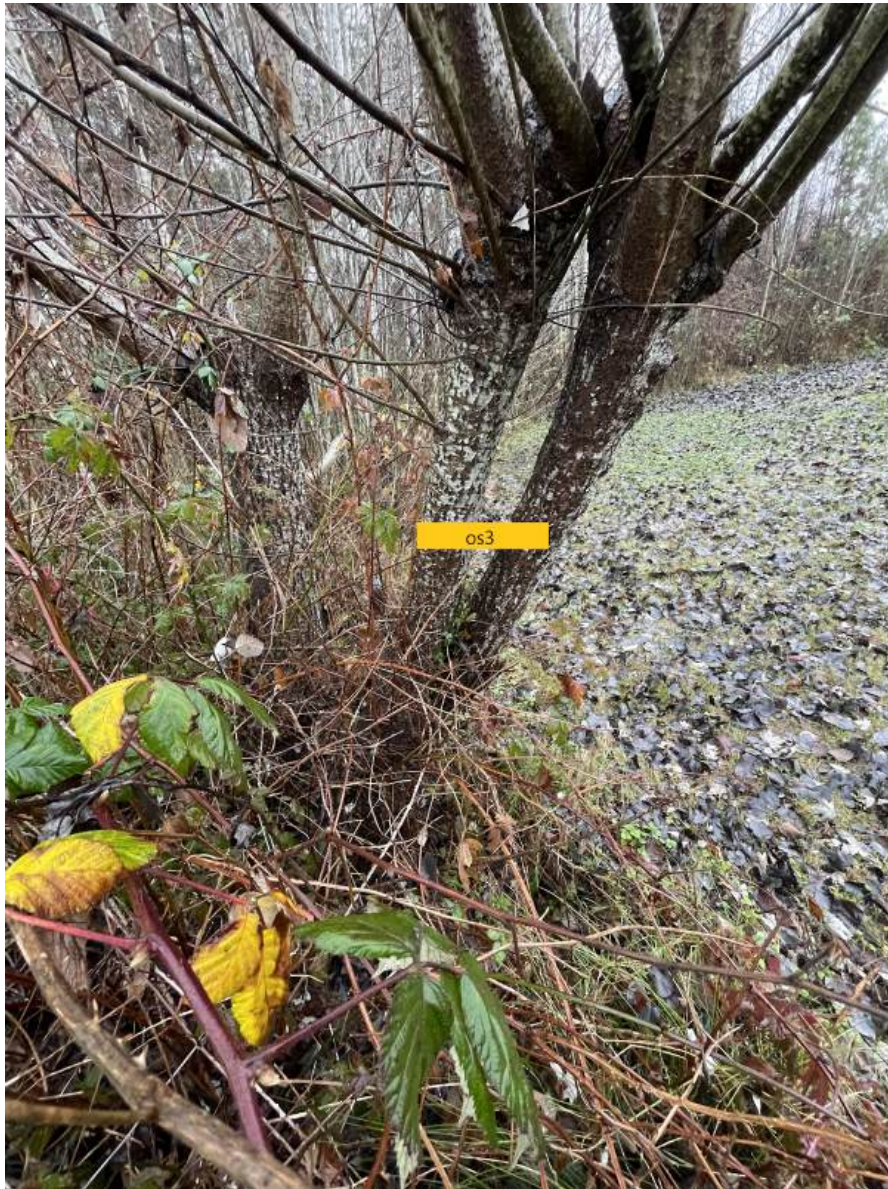
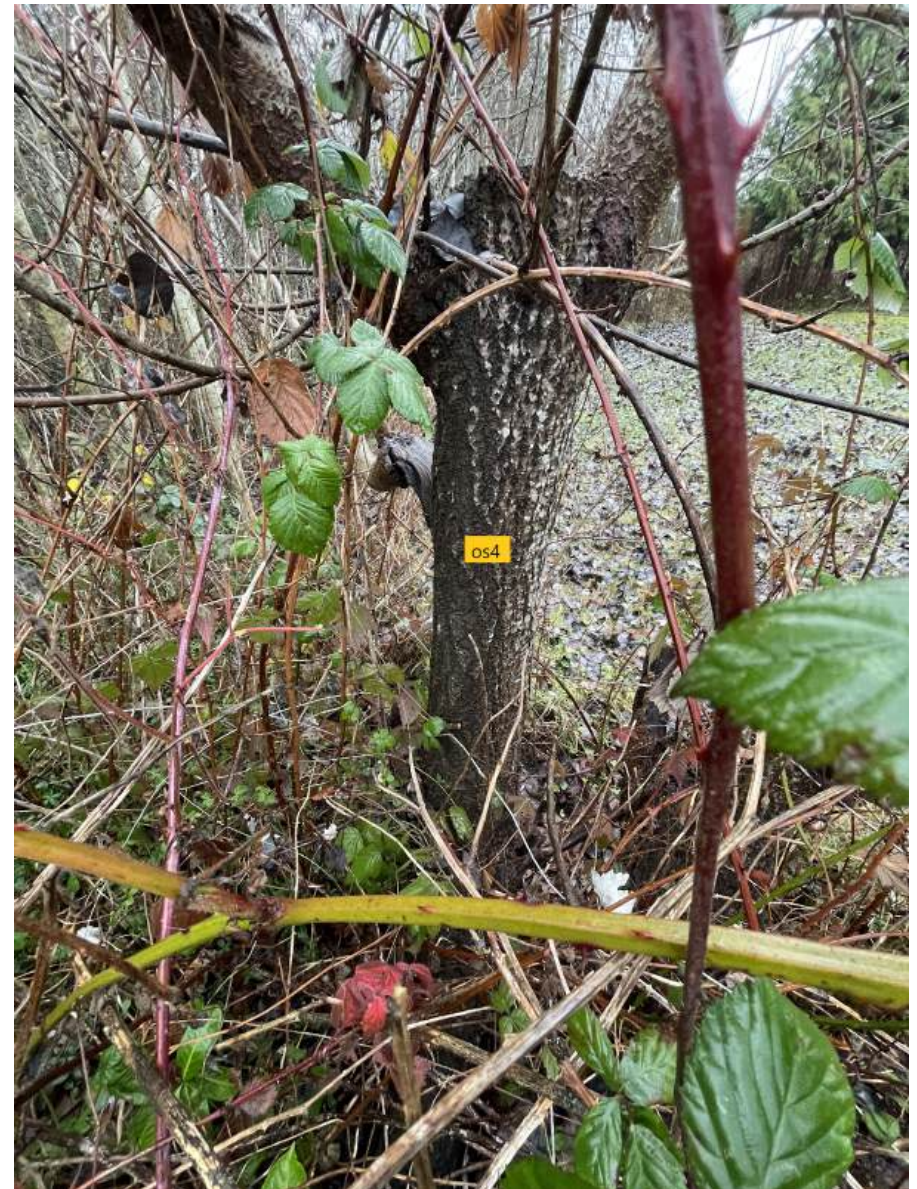
| ID# | S | L | Common Name | Botanical Name | DBH (cm) | LCR (%) | CR (m) | Condition & Comments | Health Rating | Action | TPZ (m) |
|---|---|---|---|---|---|---|---|---|---|---|---|
| OS2 | y | o | Maple | <i>Acer spp.</i> | 35 | 50 | 4-5 | Historically topped at 2m. Regenerated leaders have matured and are poorly attached.<br><br>Landscaping is within the TPZ. Arborist to supervise landscaping. Tree is not recommended for retention. | Poor | Retain<br><br>Arborist to supervise landscaping | 2.10 |
| OS3 | y | o | Maple | <i>Acer spp.</i> | 19+<br>18=<br>37 | 60 | 3-4 | Historically topped at 2m. Regenerated leaders have matured and are poorly attached.<br><br>Landscaping is within the TPZ. Arborist to supervise landscaping. Tree is not recommended for retention. | Poor | Retain<br><br>Arborist to supervise landscaping | 2.22 |
| OS4 | y | o | Maple | <i>Acer spp.</i> | 24 | 50 | 4-5 | Historically topped at 2m. Regenerated leaders have matured and are poorly attached.<br><br>Landscaping is within the TPZ. Arborist to supervise landscaping. Tree is not recommended for retention. | Poor | Retain<br><br>Arborist to supervise landscaping | 1.44 |

IMAGE 67- Tree os2, os3, & os4- to be retained

IMAGE 68- Tree base, tree os2- - to be retained

IMAGE 69-Tree base, tree os3- - to be retained

IMAGE 70-Tree base, tree os4- - to be retained

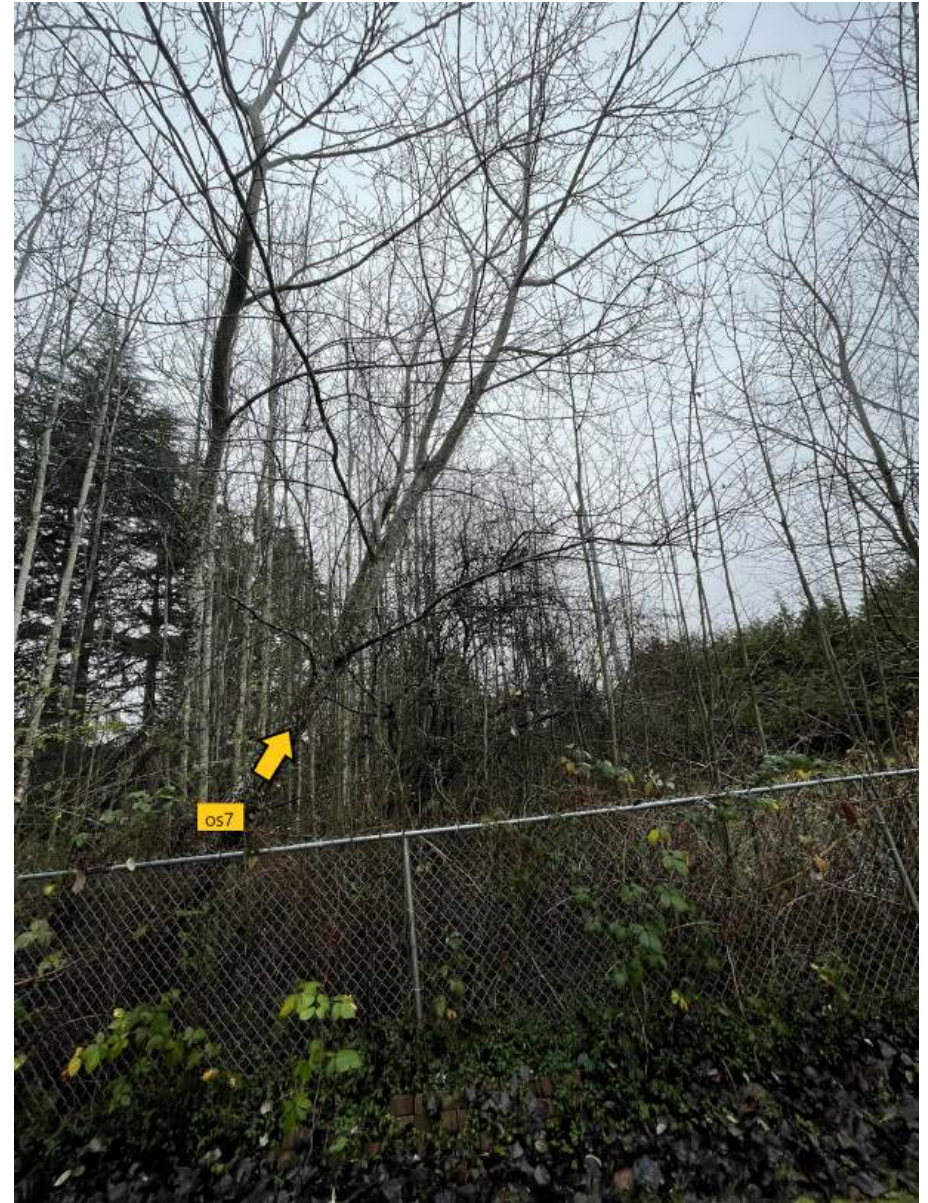
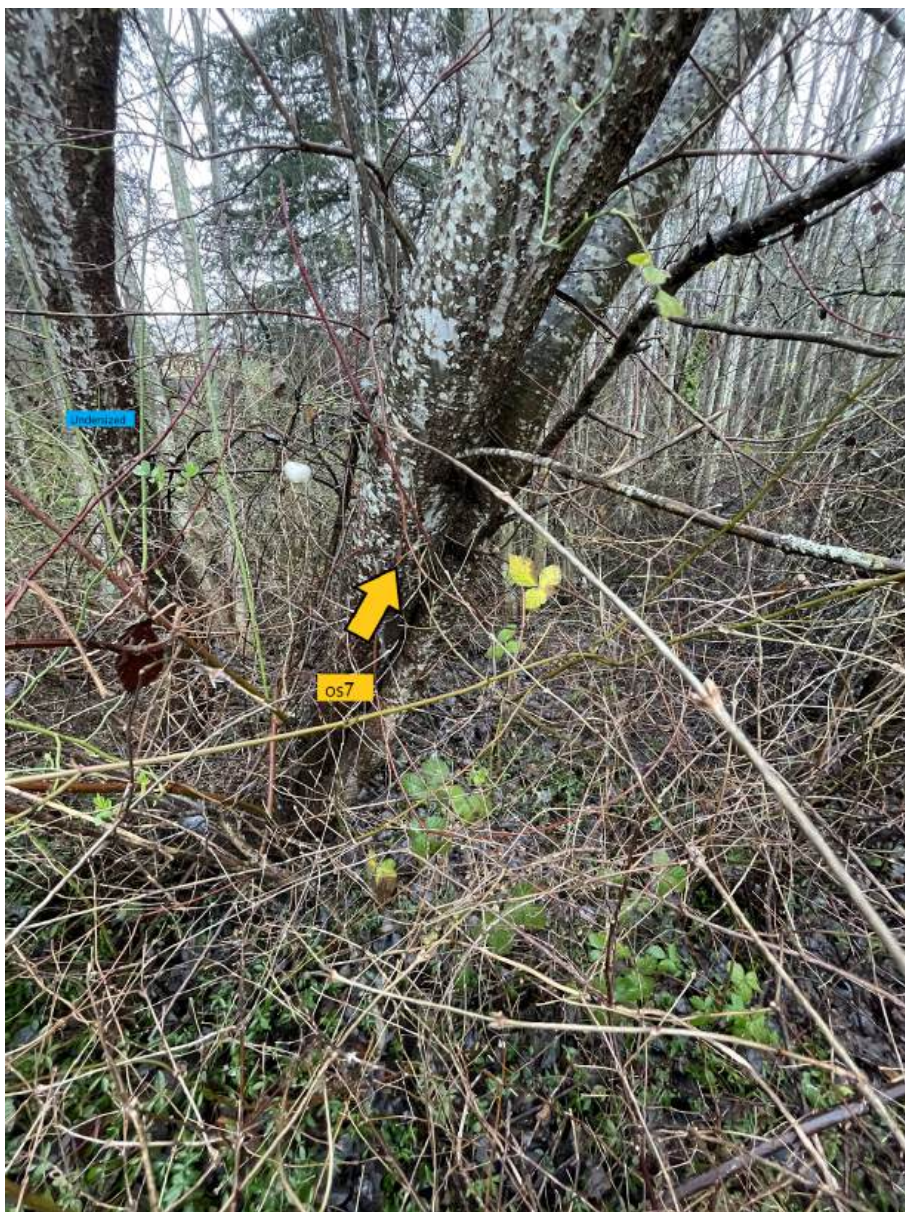
| ID# | S | L | Common Name | Botanical Name | DBH (cm) | LCR (%) | CR (m) | Condition & Comments | Health Rating | Action | TPZ (m) |
|---|---|---|---|---|---|---|---|---|---|---|---|
| OS7 | y | o | Maple | <i>Acer spp.</i> | 25+<br>12=<br>37 | 80 | 5-7 | Growing on a heavy lean to the west, trunk is covered in sap sucker damage.<br><br>Landscaping is within the TPZ. Arborist to supervise landscaping. Tree is not recommended for retention. | Poor | Retain<br><br>Arborist to supervise landscaping | 2.22 |

IMAGE 72- Tree os7-- to be retained

IMAGE 73-Tree base, tree os7- to be retained
