## Arborist Report

Inventory and Assessment of Trees Associated to Development at  
1170, 1156, 1146 53A Street and 5360 12 Avenue, Delta

Update April 21, 2025- Updated retention table

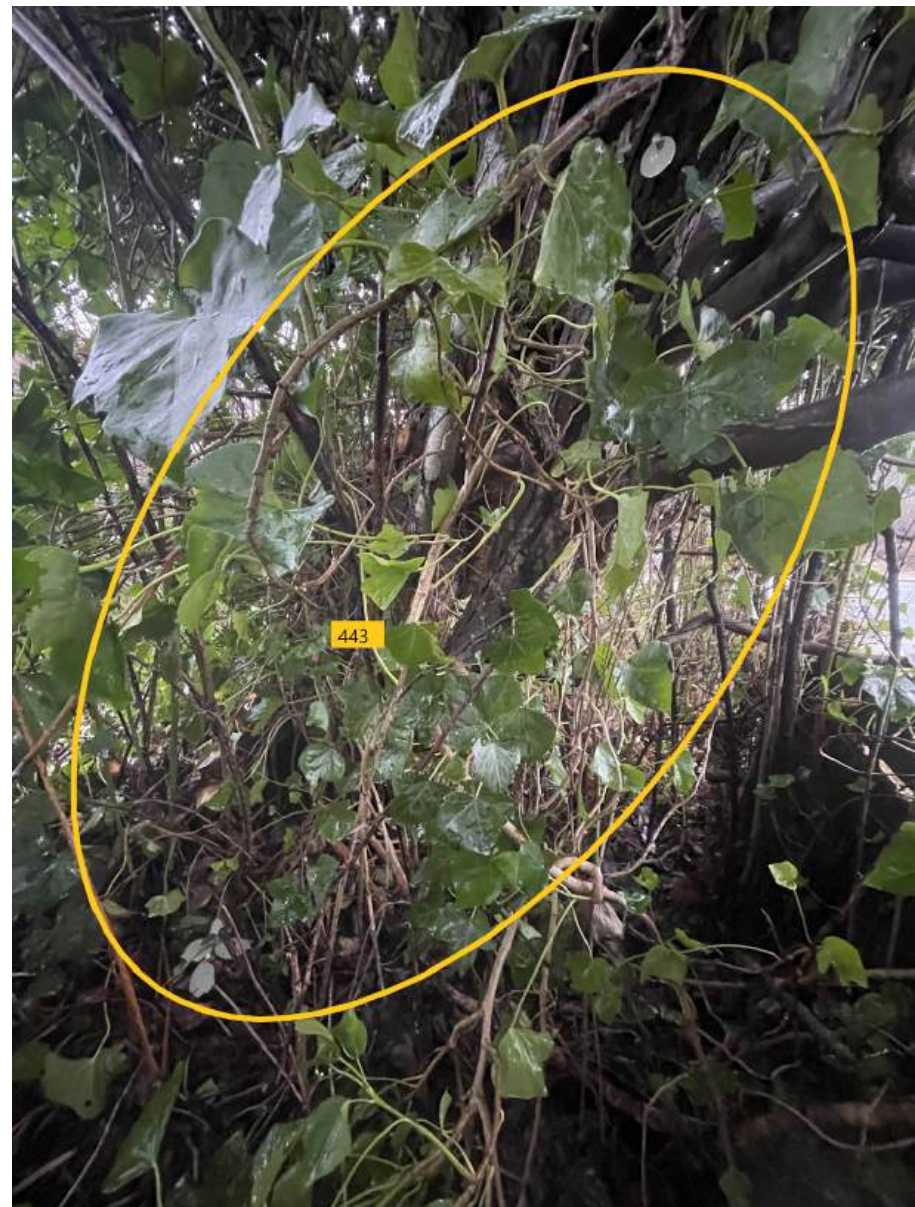
IMAGE 40-Tree base, tree 443- to be removed

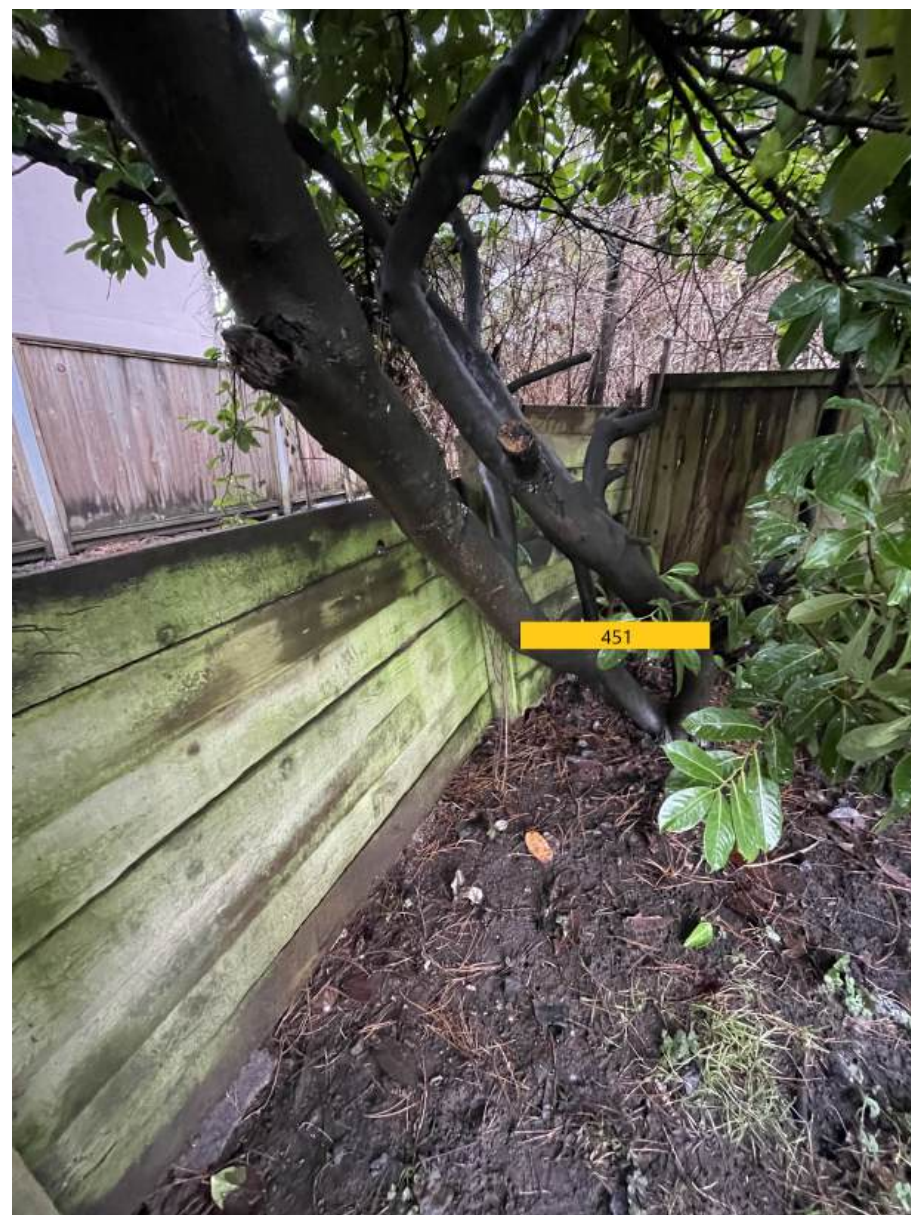
IMAGE 48-Tree base, tree 451- to be removed

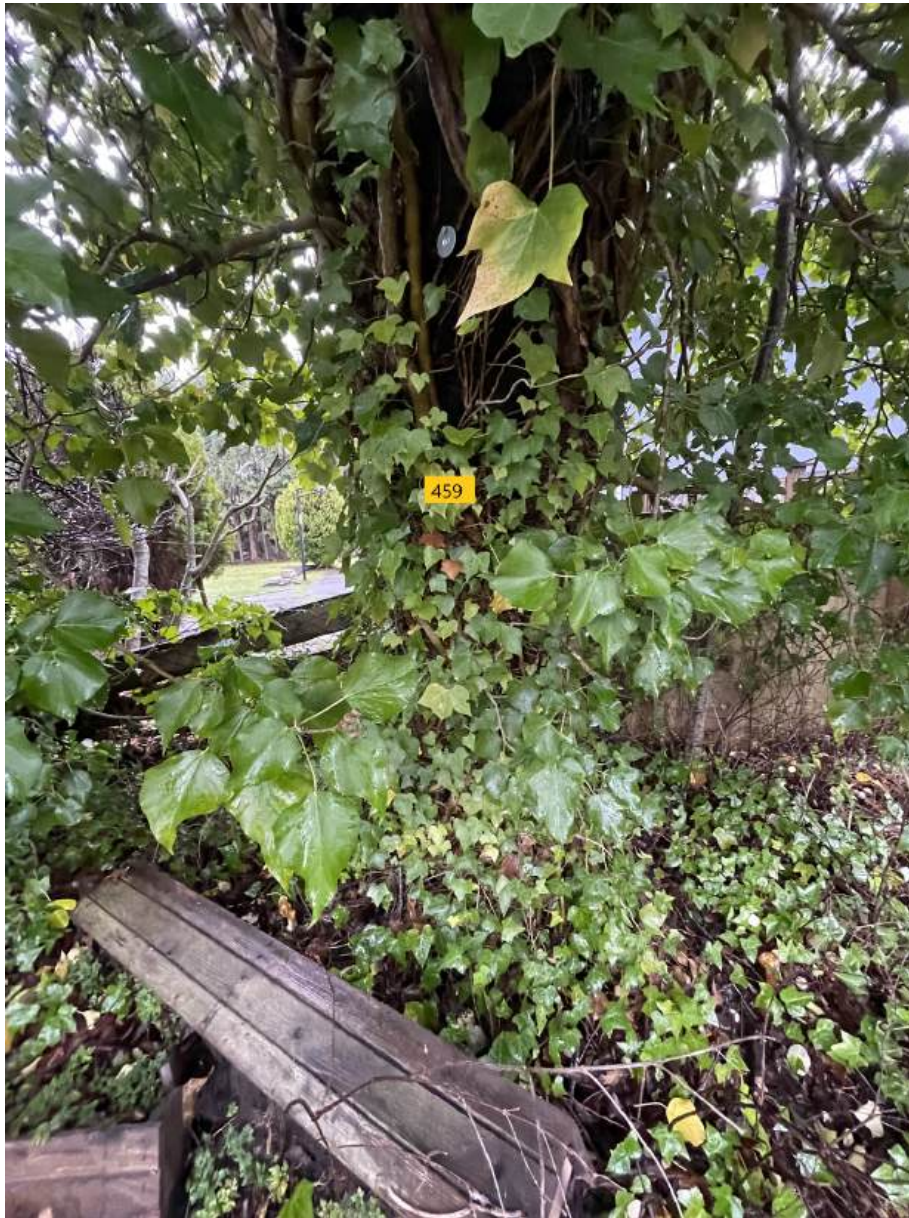
IMAGE 55-Tree base, tree 459- to be removed
