# Limited Visual Inspection Report

Property Address:  
4501 Arthur Drive, Delta

Client: Harjit Sandhu Landvision Group

January 14, 2023

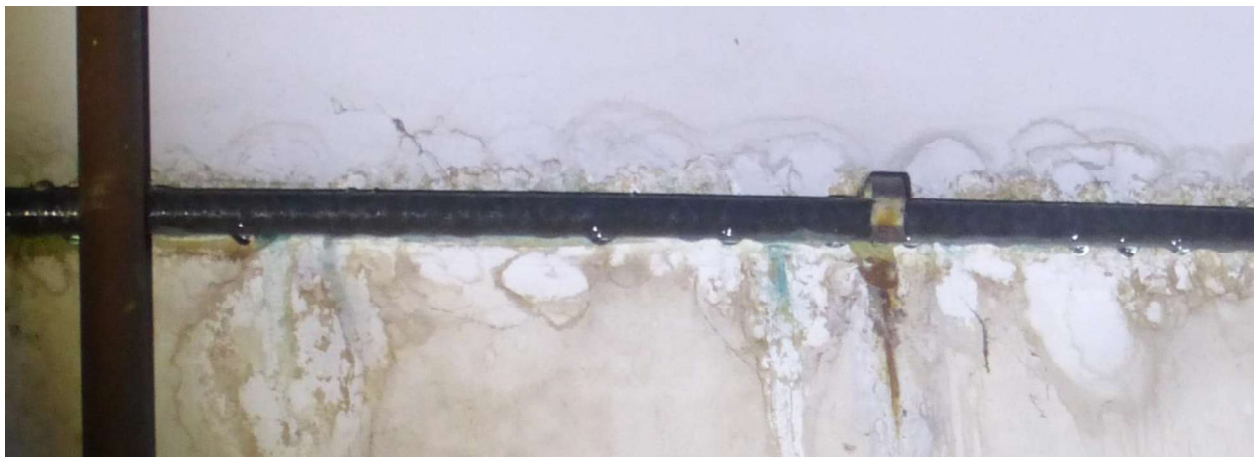
Damages in the mechanical room: Ceiling leaks in the mechanical room both due to the roof leak and condensation. visible condensation water on the domestic water line in the mechanical room.

Condensation of water line in the mechanical room
