## Arborist Report

Inventory and Assessment of Trees Associated to Development at  
1170, 1156, 1146 53A Street and 5360 12 Avenue, Delta

Update April 21, 2025- Updated retention table

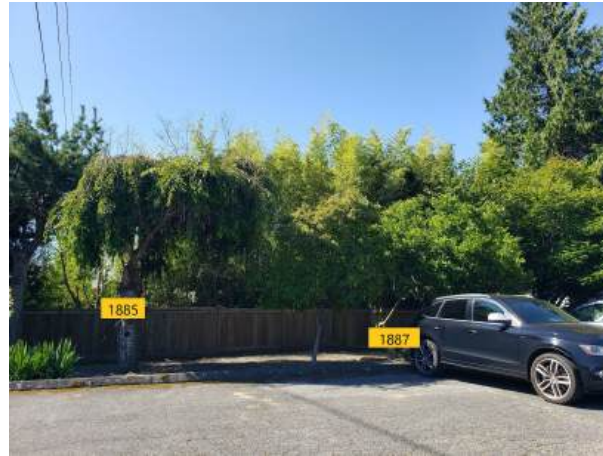
IMAGE 5- Tree #1885 - to be removed  
and tree #1887 - to be removed

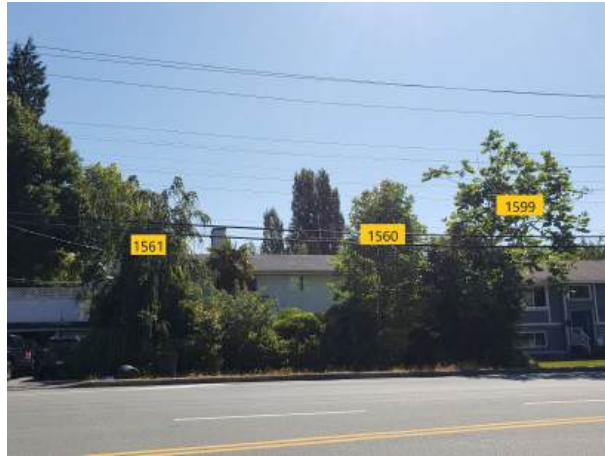
IMAGE 11-  
Tree #1560 - to be removed  
Tree #1561 - to be removed  
Tree #1599 - to be removed

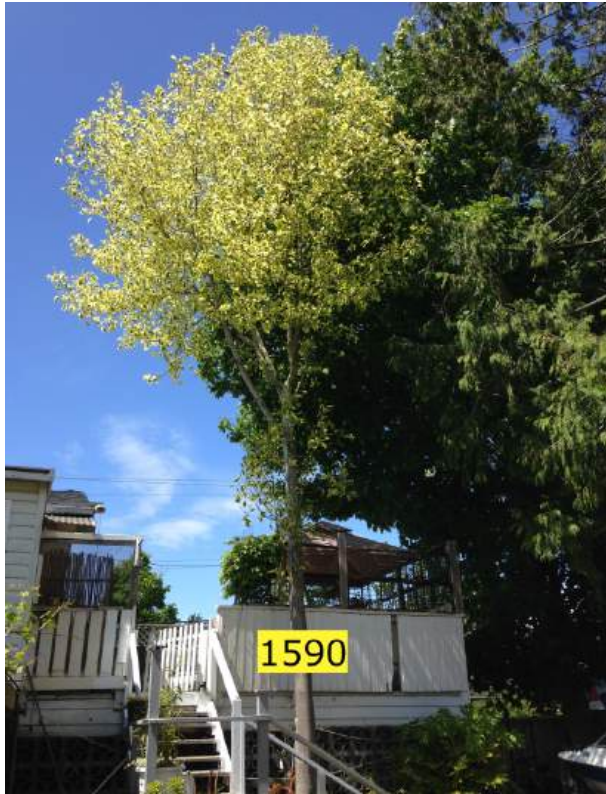
IMAGE 13- Tree #1590 - to be removed

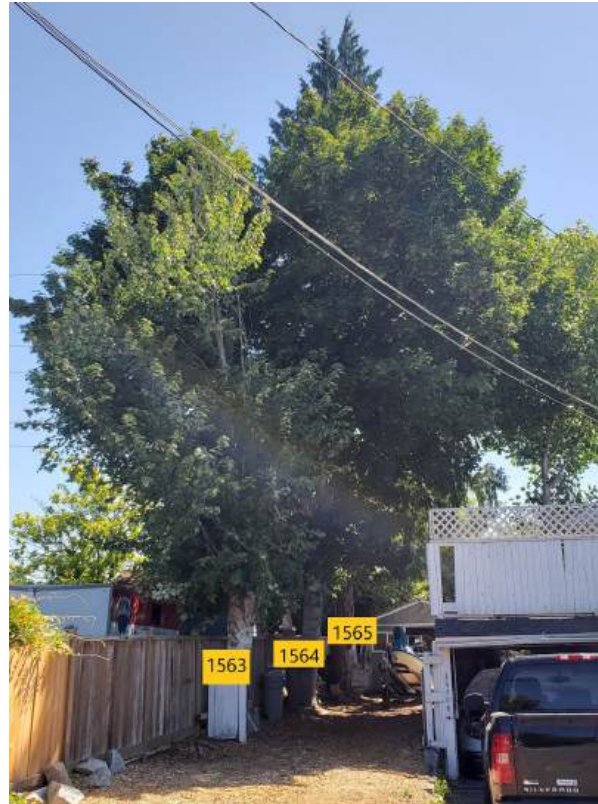
IMAGE 14 -  
Tree #1563 - to be removed  
Tree #1564 - to be removed  
Tree #1565 - to be removed

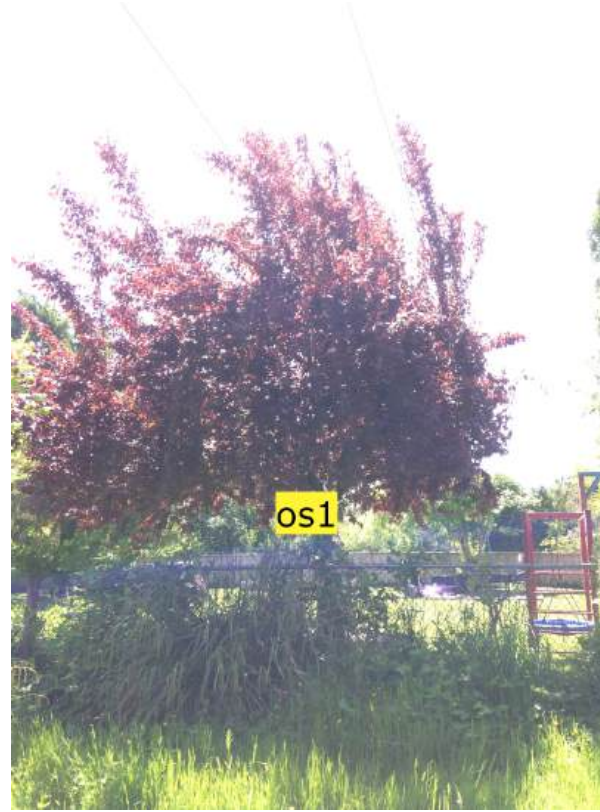
| ID# | S | L | Common Name | Botanical Name | DBH (cm) | LCR (%) | CR (m) | Condition & Comments | Health Rating | Action | TPZ (m) |
|---|---|---|---|---|---|---|---|---|---|---|---|
| OS1 | y | o | Shortleaf Pine | <i>Pinus enchinata</i> | 115 | 40 | 3 | Incorrectly surveyed showing the tree is on the north side of the fence and it is on the south.<br><br>The proposed installation of pathway and excavation for the parkade entrance is expected to significantly impact the tree to such an extent that removal is recommended. | Moderate | Remove | 6.90 |

IMAGE 20- Tree #os1, renumbered to 447- to be removed

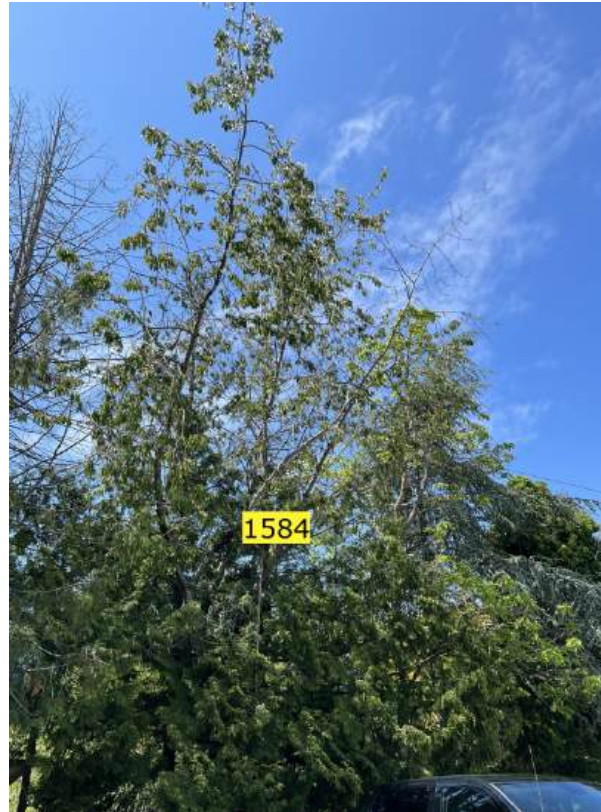
IMAGE 26 - #1584 - to be removed

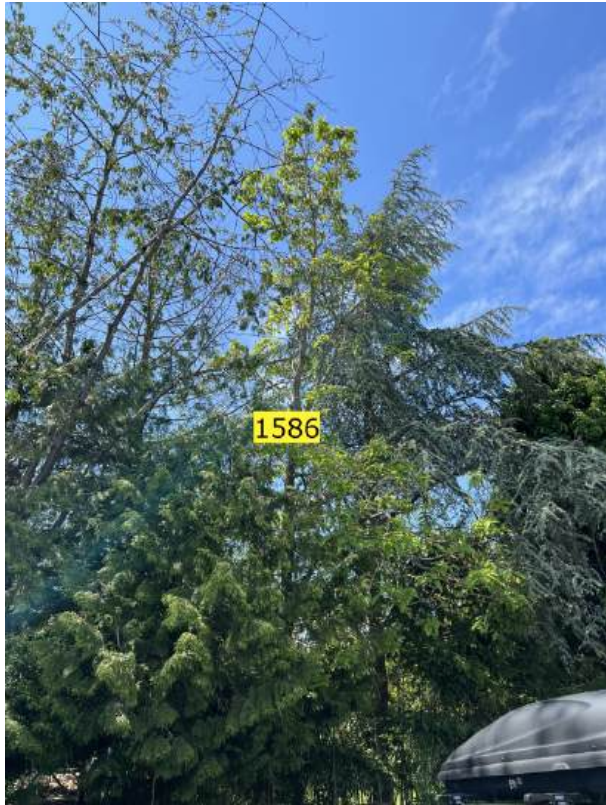
IMAGE 28 - Tree #1586 - to be removed,

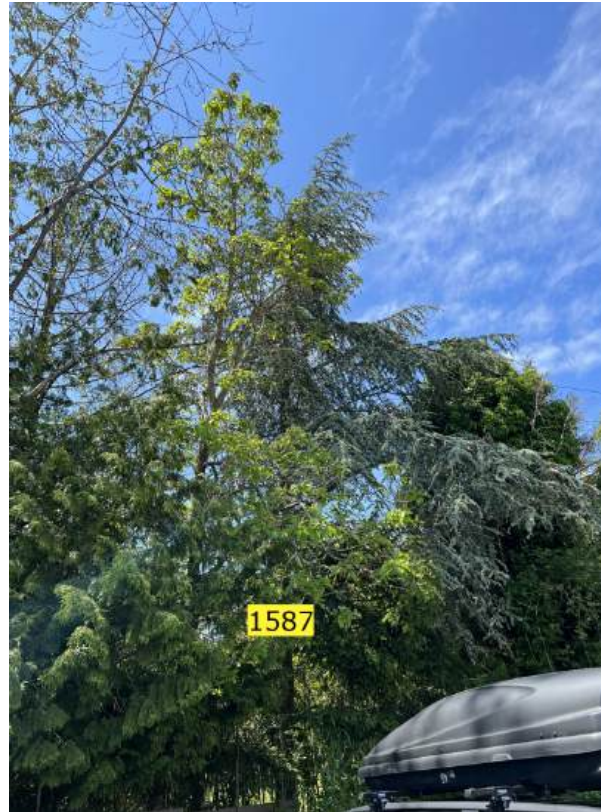
IMAGE 29 - Tree #1587 - to be removed

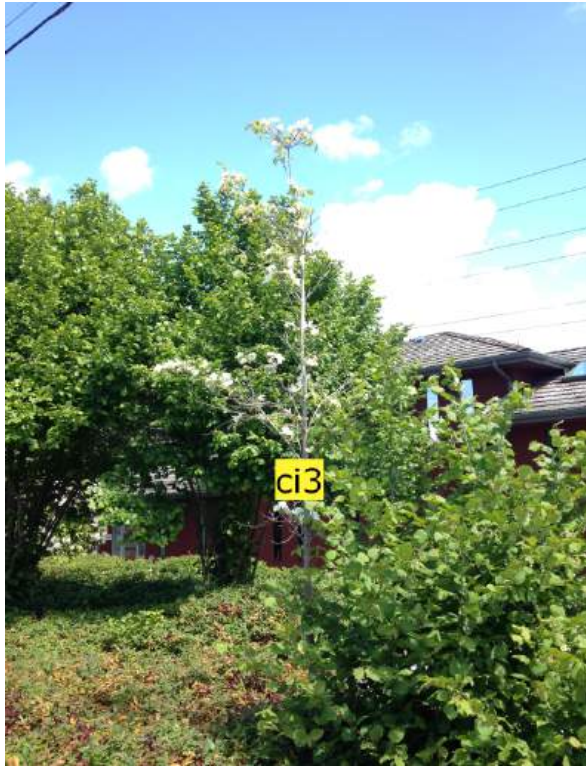
IMAGE 31- Tree #ci3 - to be removed

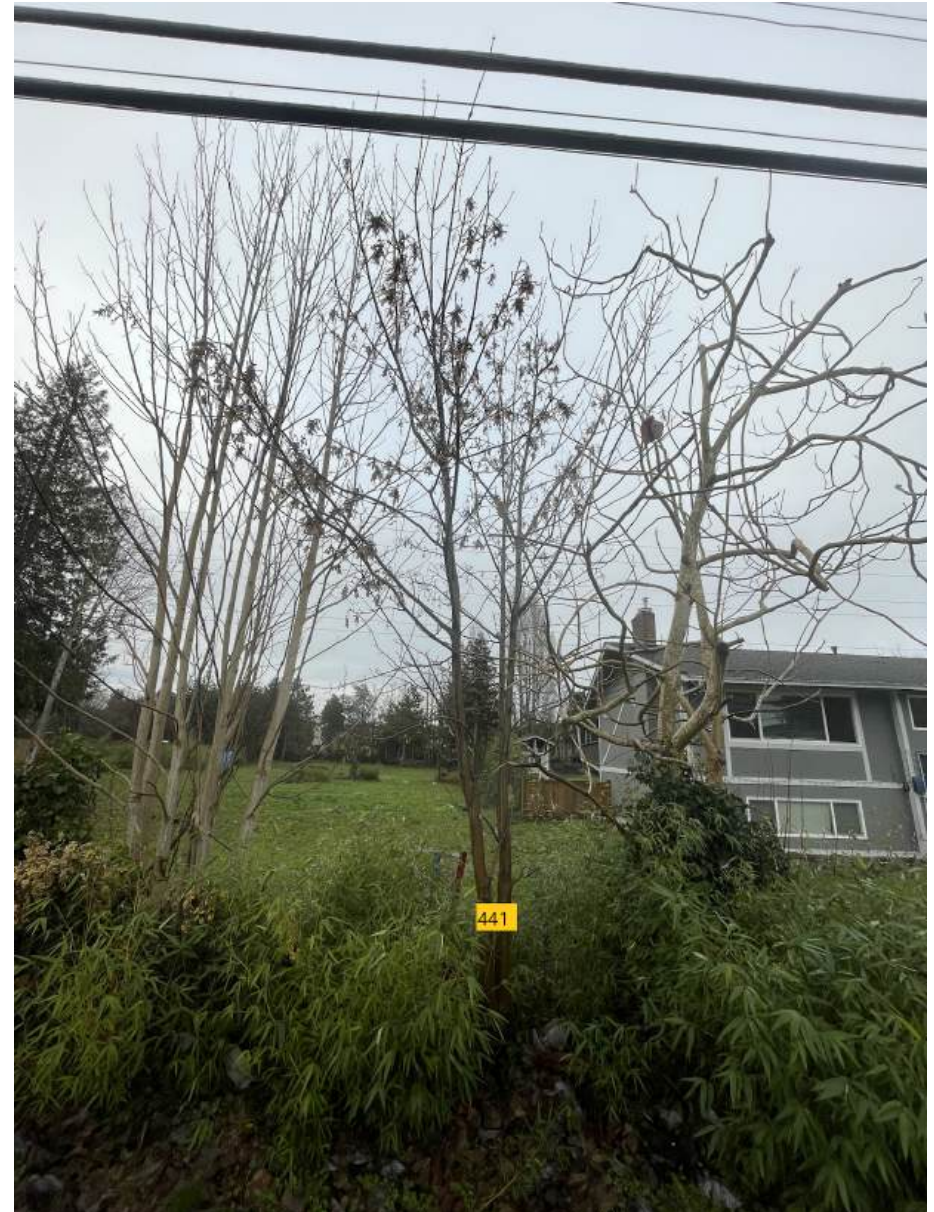
IMAGE 36- Tree 441- to be removed

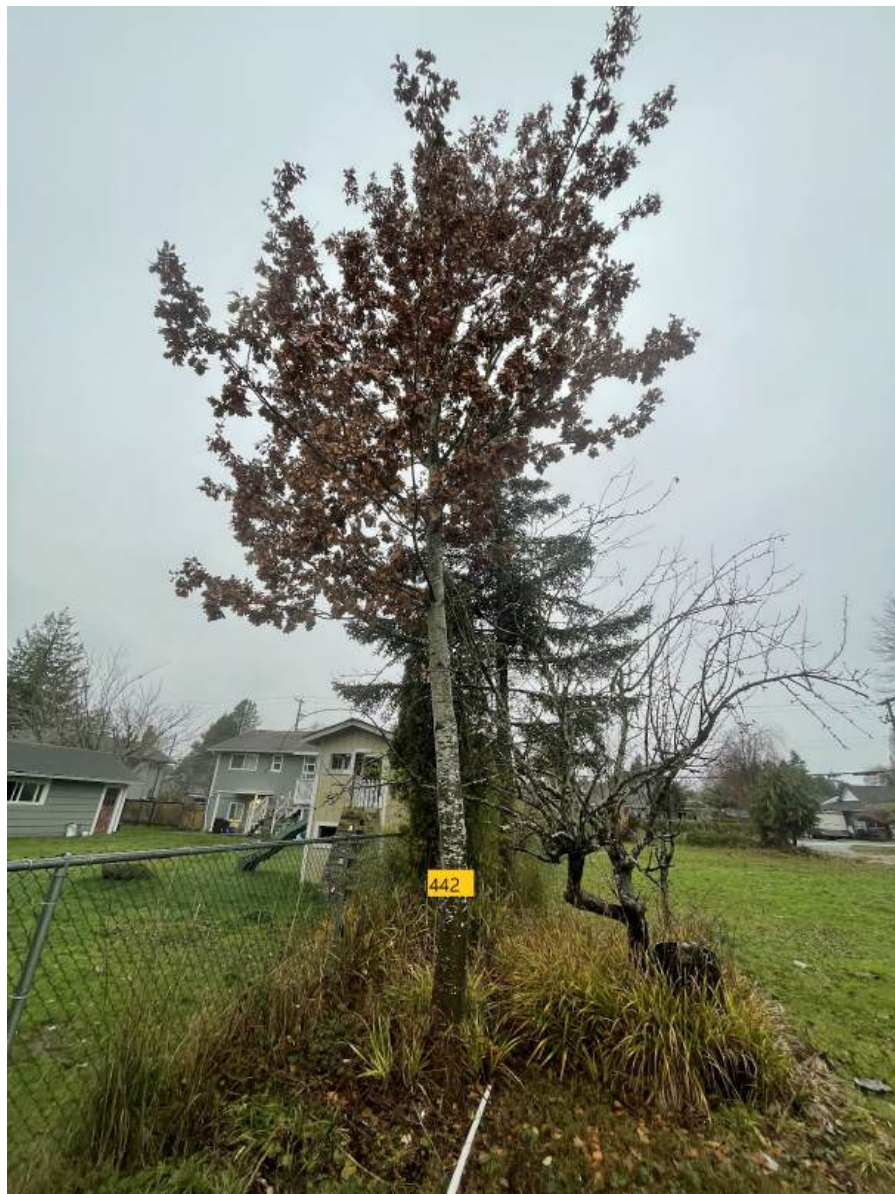
IMAGE 37-Tree 442- to be removed

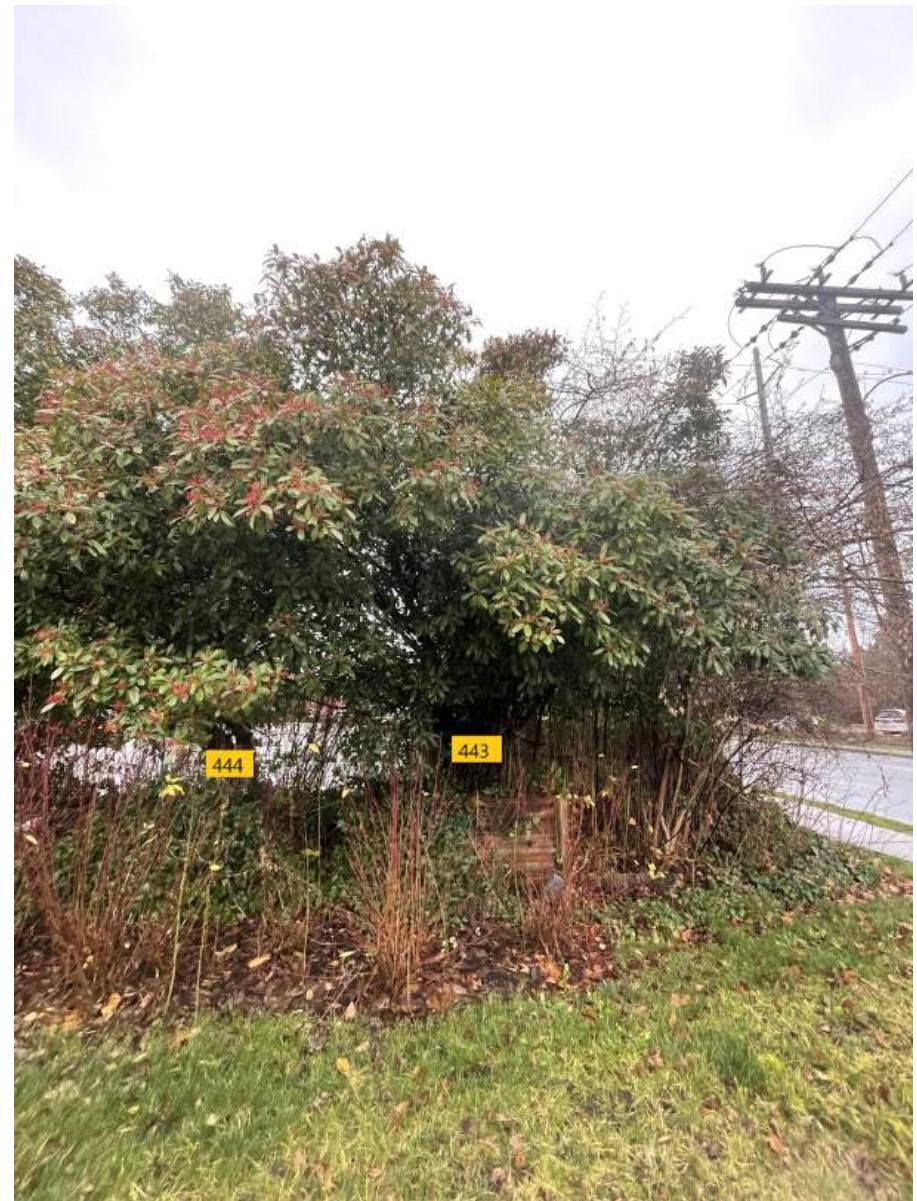
IMAGE 38-Tree 443 & 444- to be removed

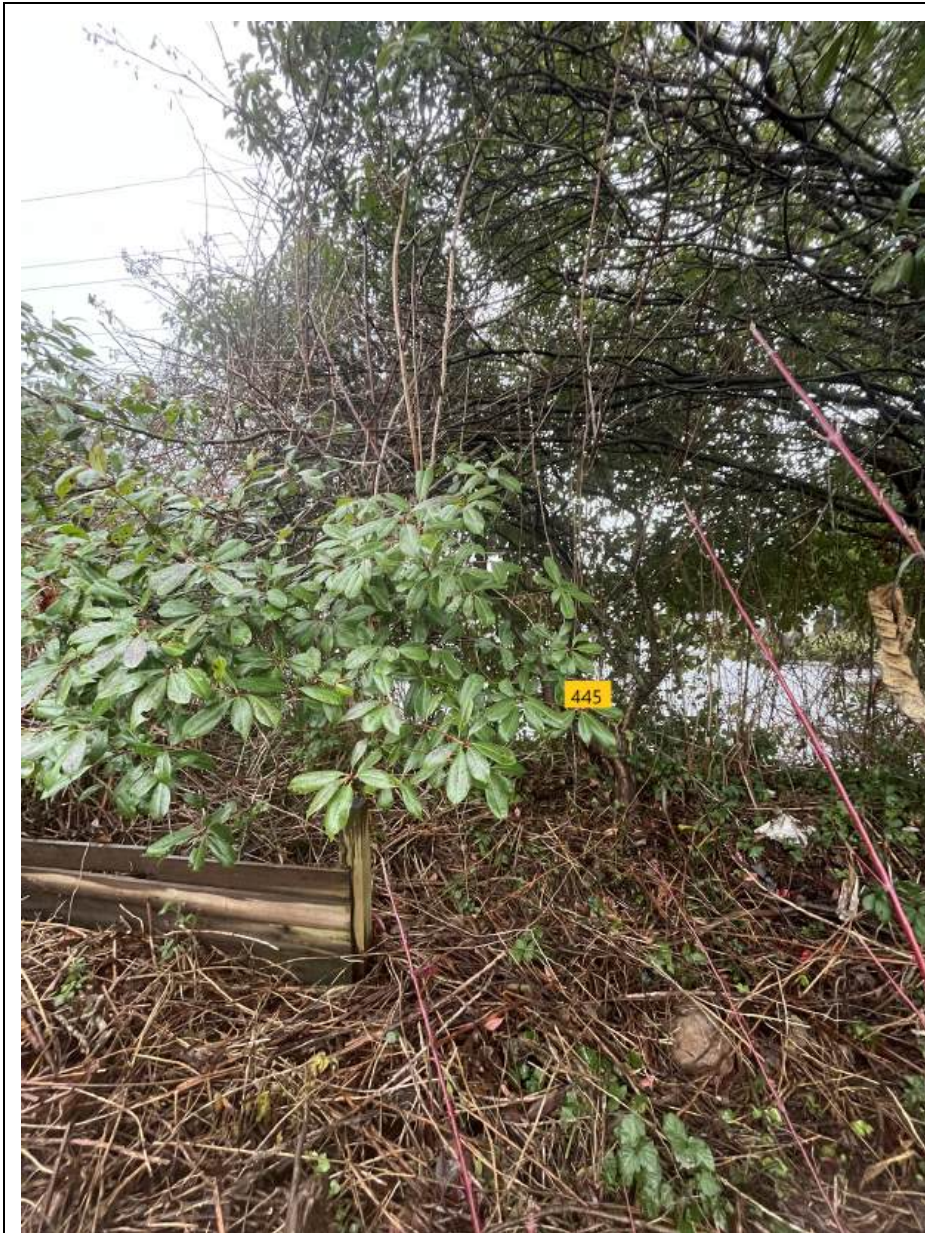
IMAGE 39-Tree 445- to be removed

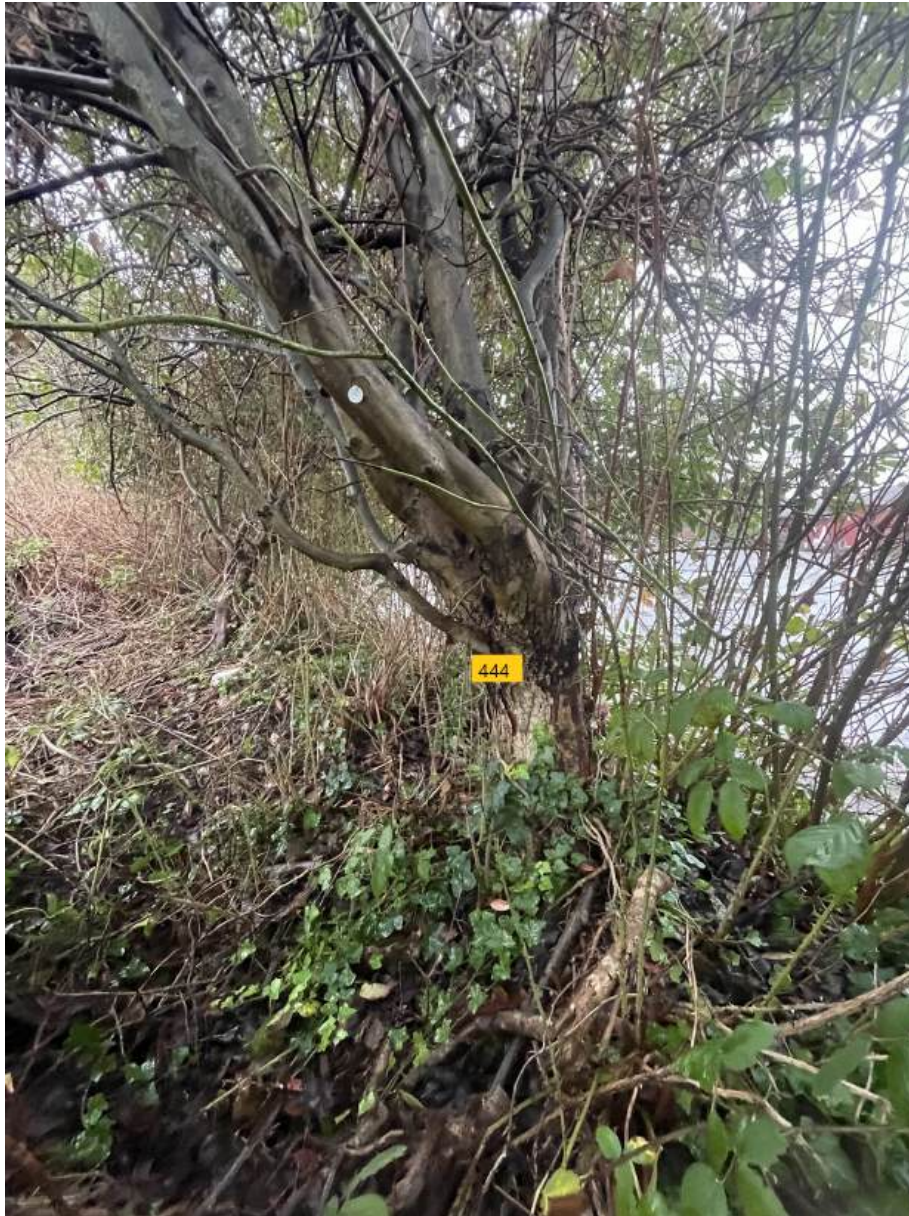
IMAGE 41-Tree base, tree 444- to be removed

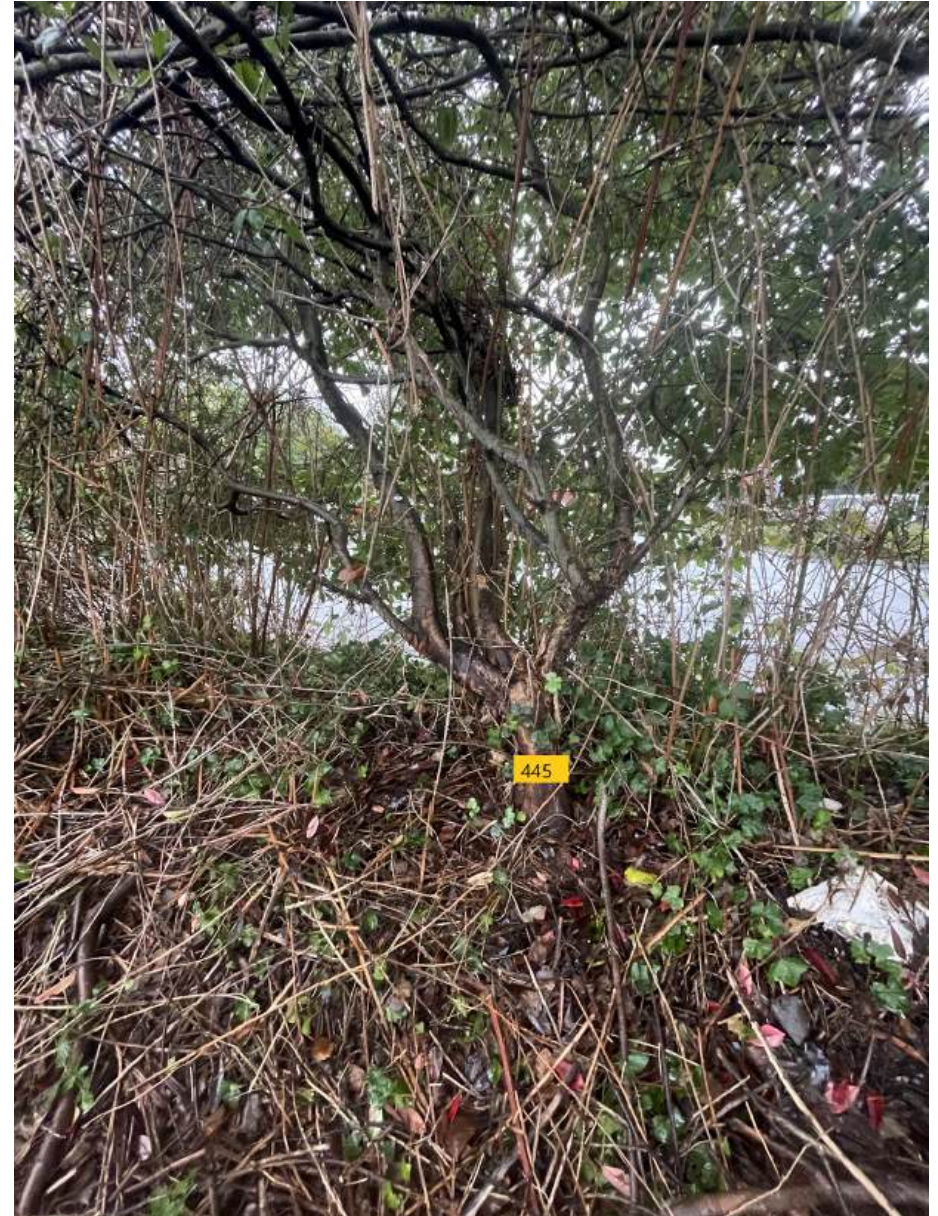
IMAGE 42-Tree base, tree 445- to be removed

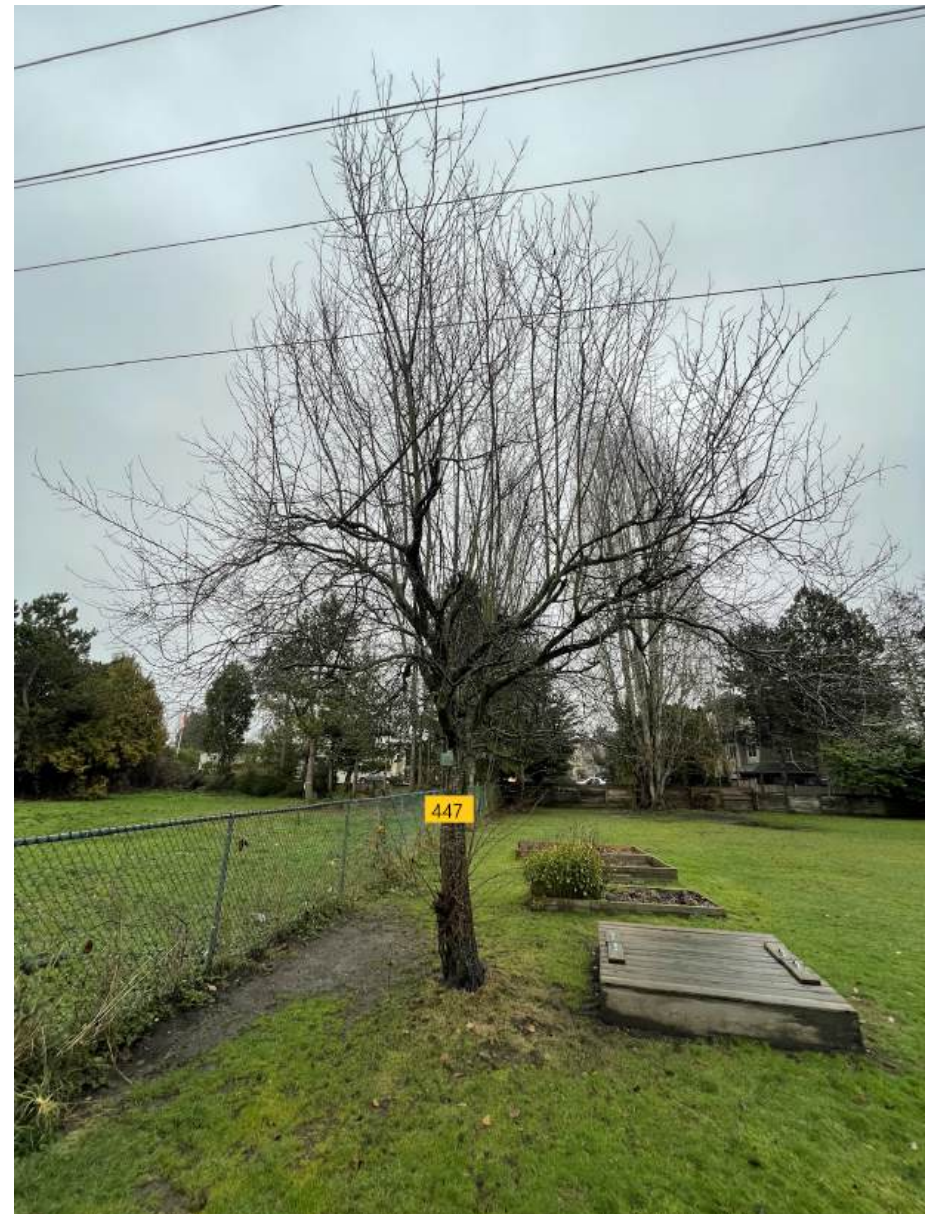
IMAGE 44-Tree 447- to be removed

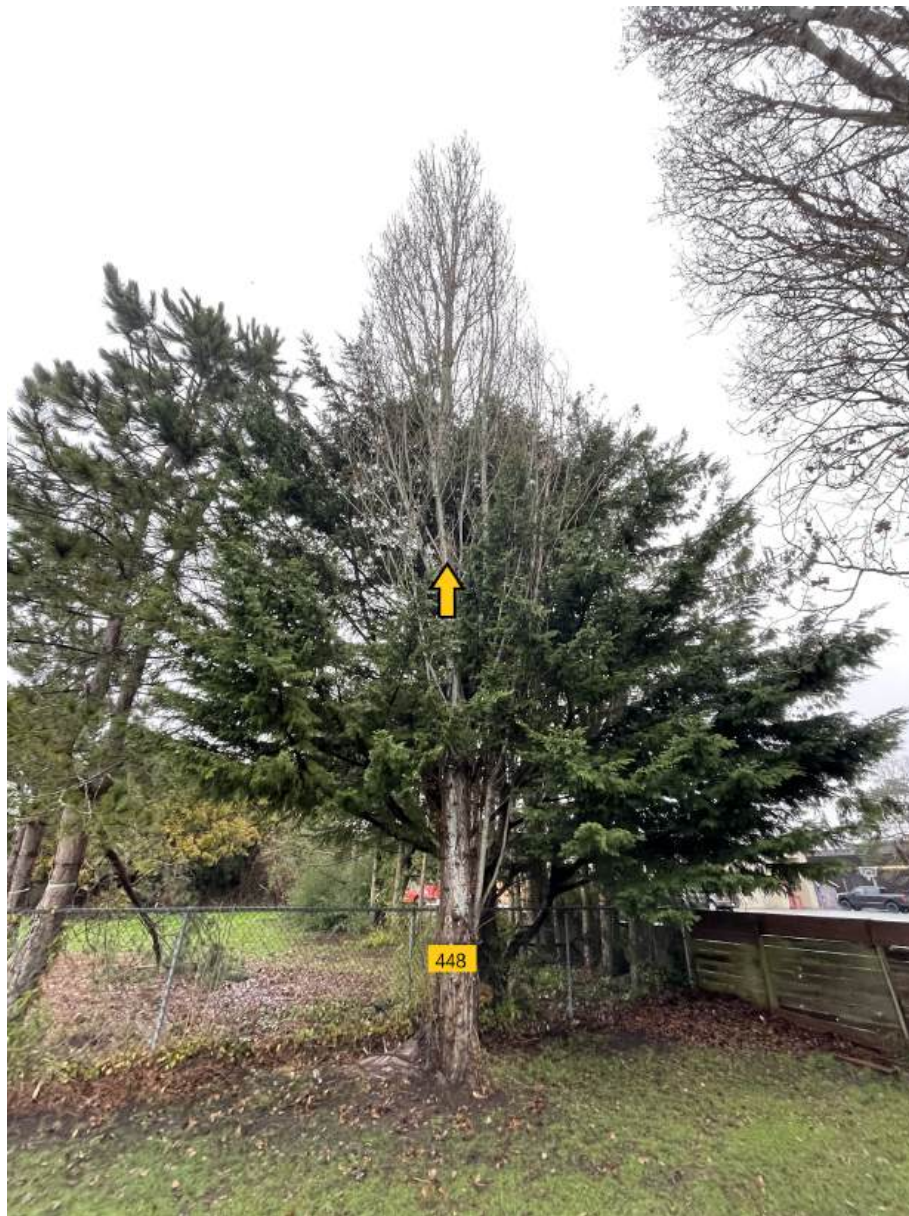
IMAGE 45-Tree 448- to be removed

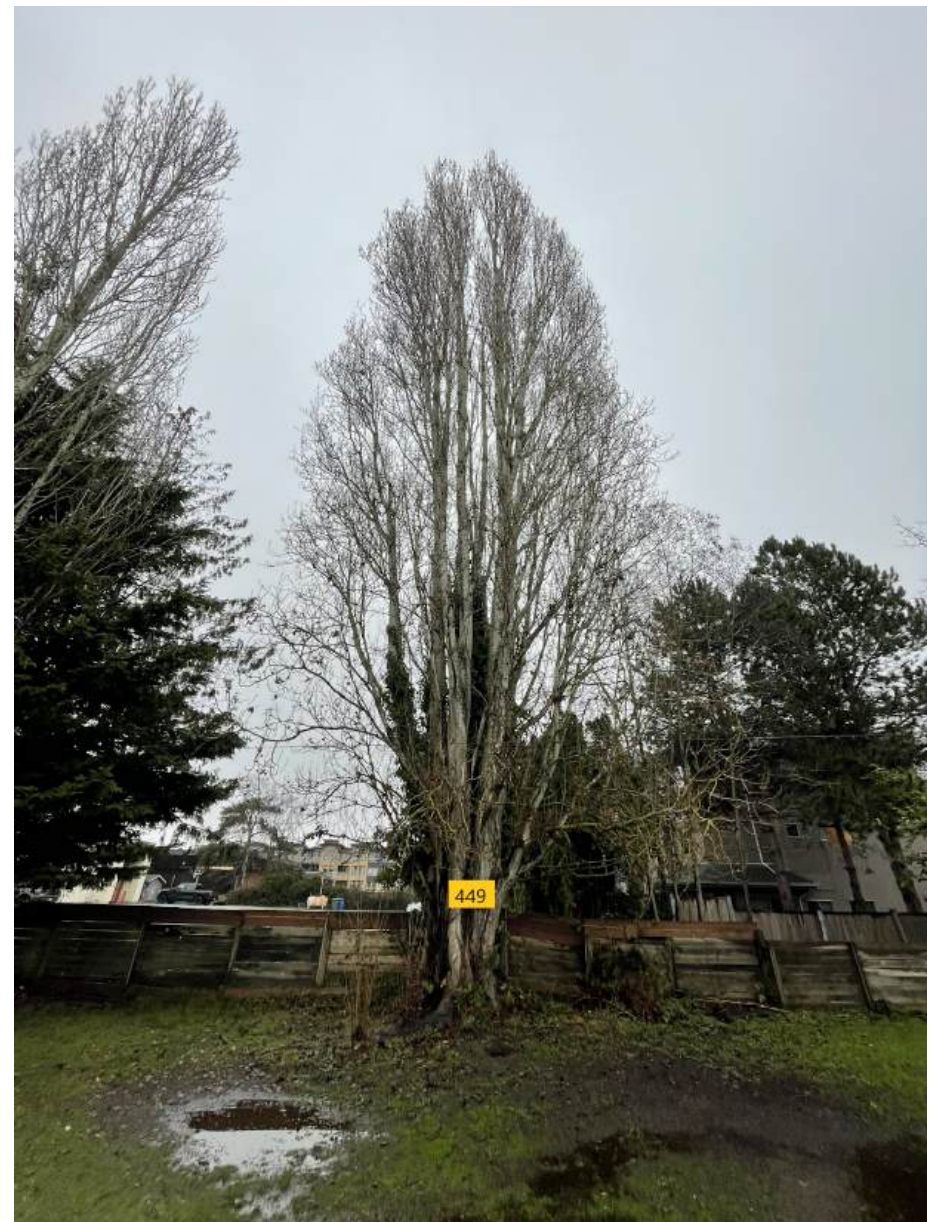
IMAGE 46-Tree 449- to be removed

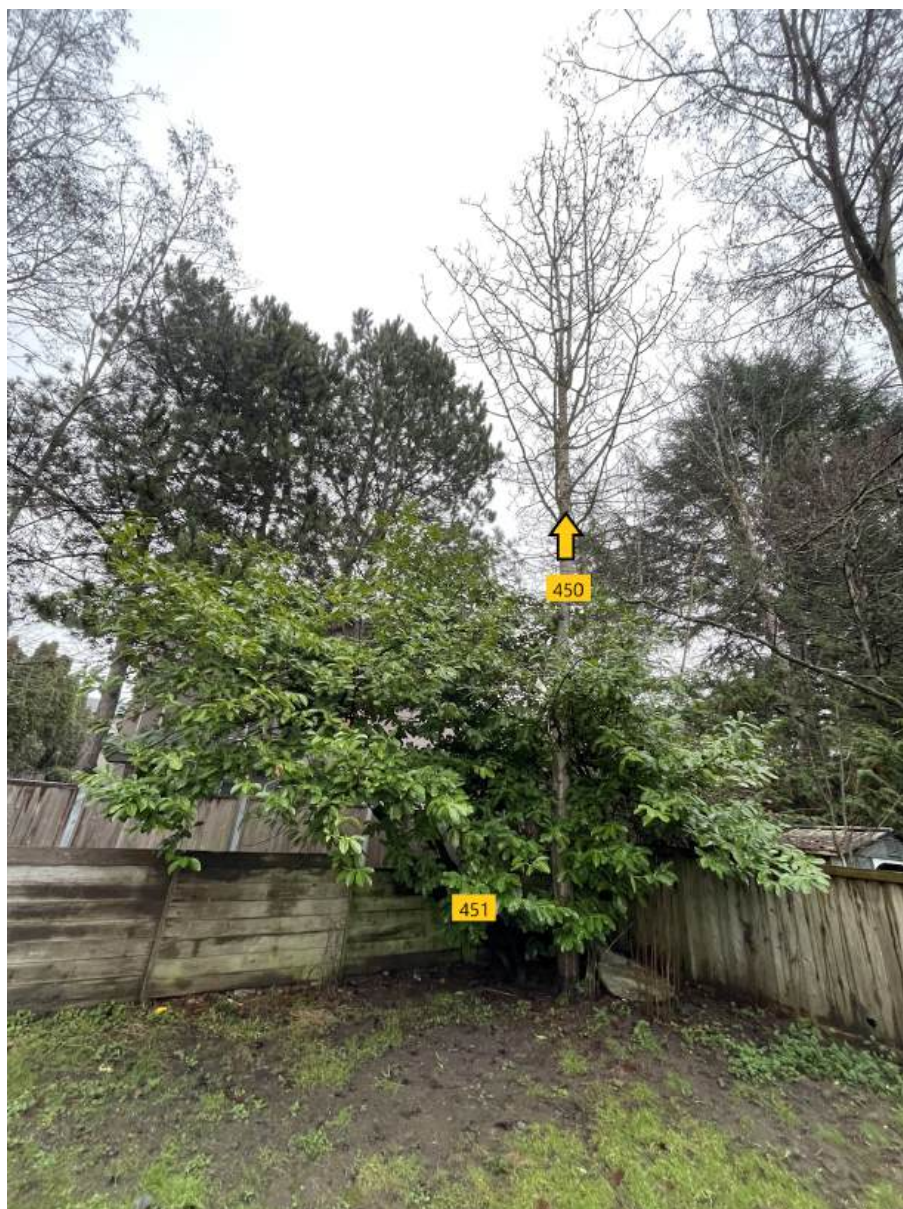
IMAGE 47-Tree 450 & 451- to be removed

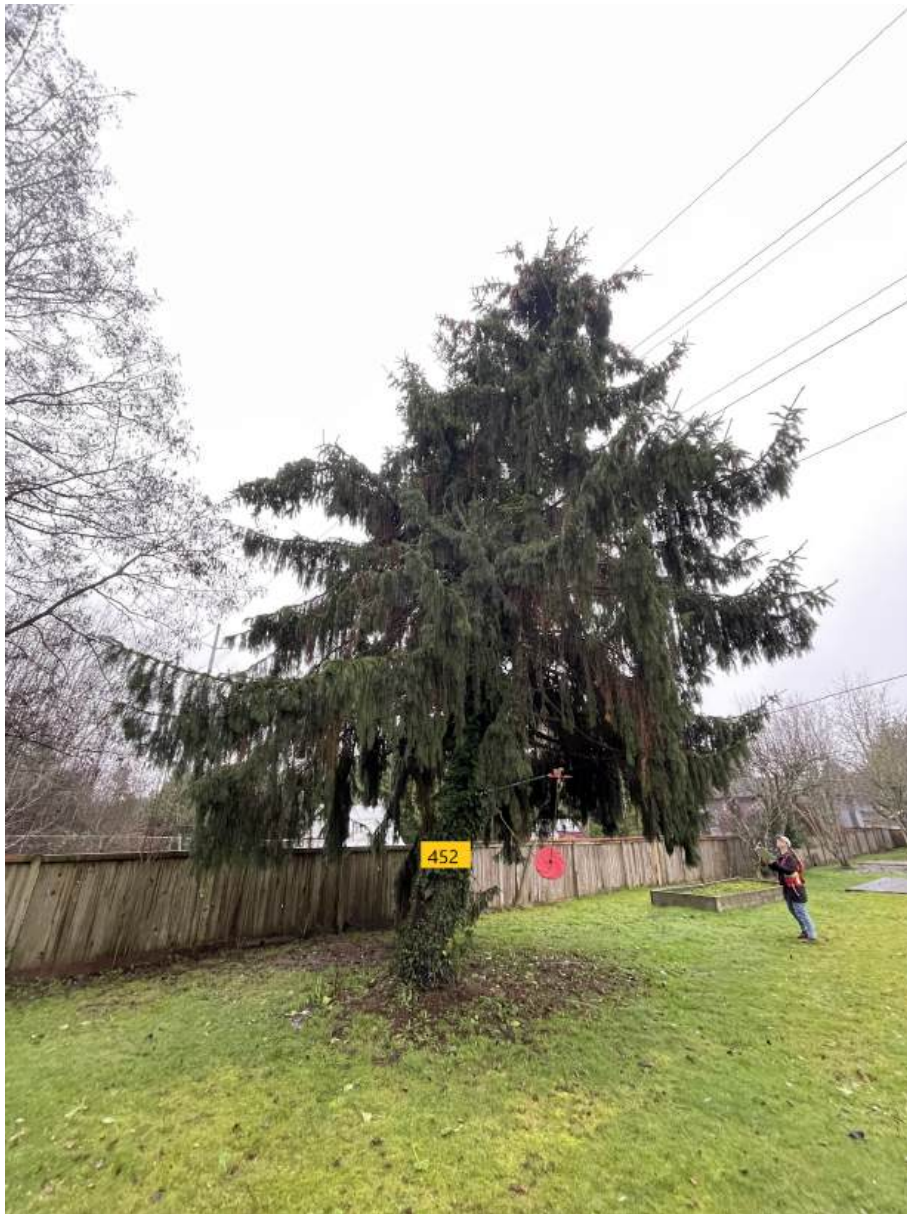
IMAGE 49-Tree 452- to be removed

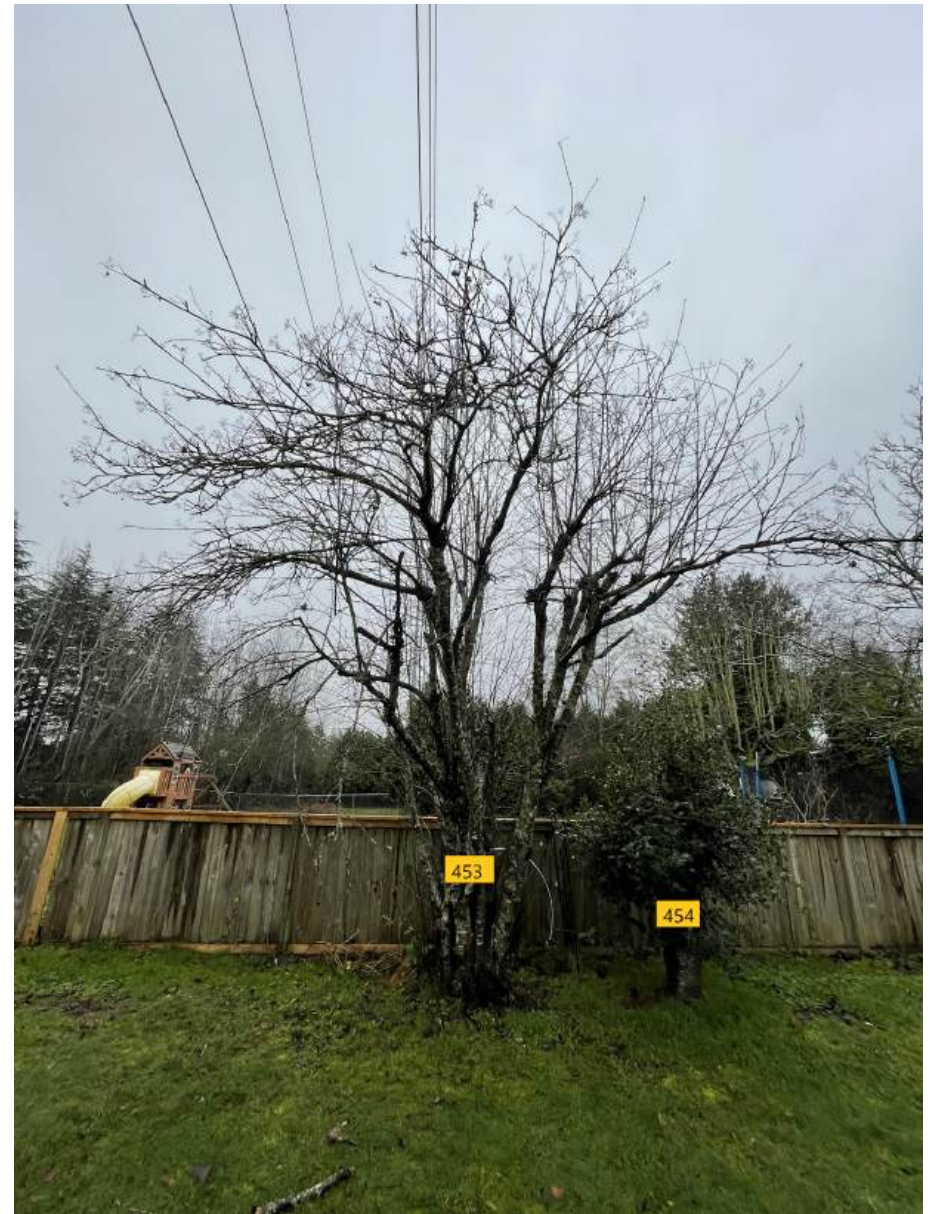
IMAGE 50-Tree 453 & 454- to be removed

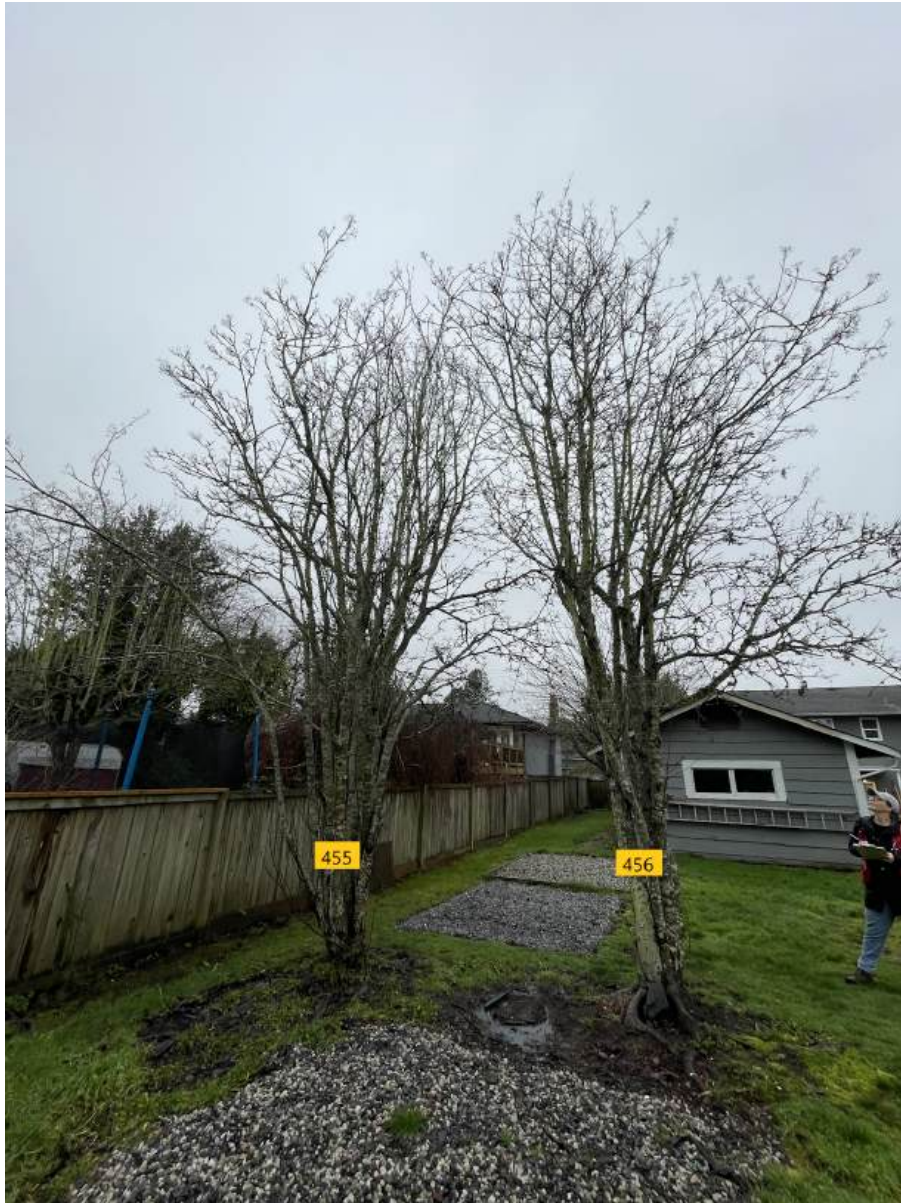
IMAGE 51-Tree 455 & 456- to be removed

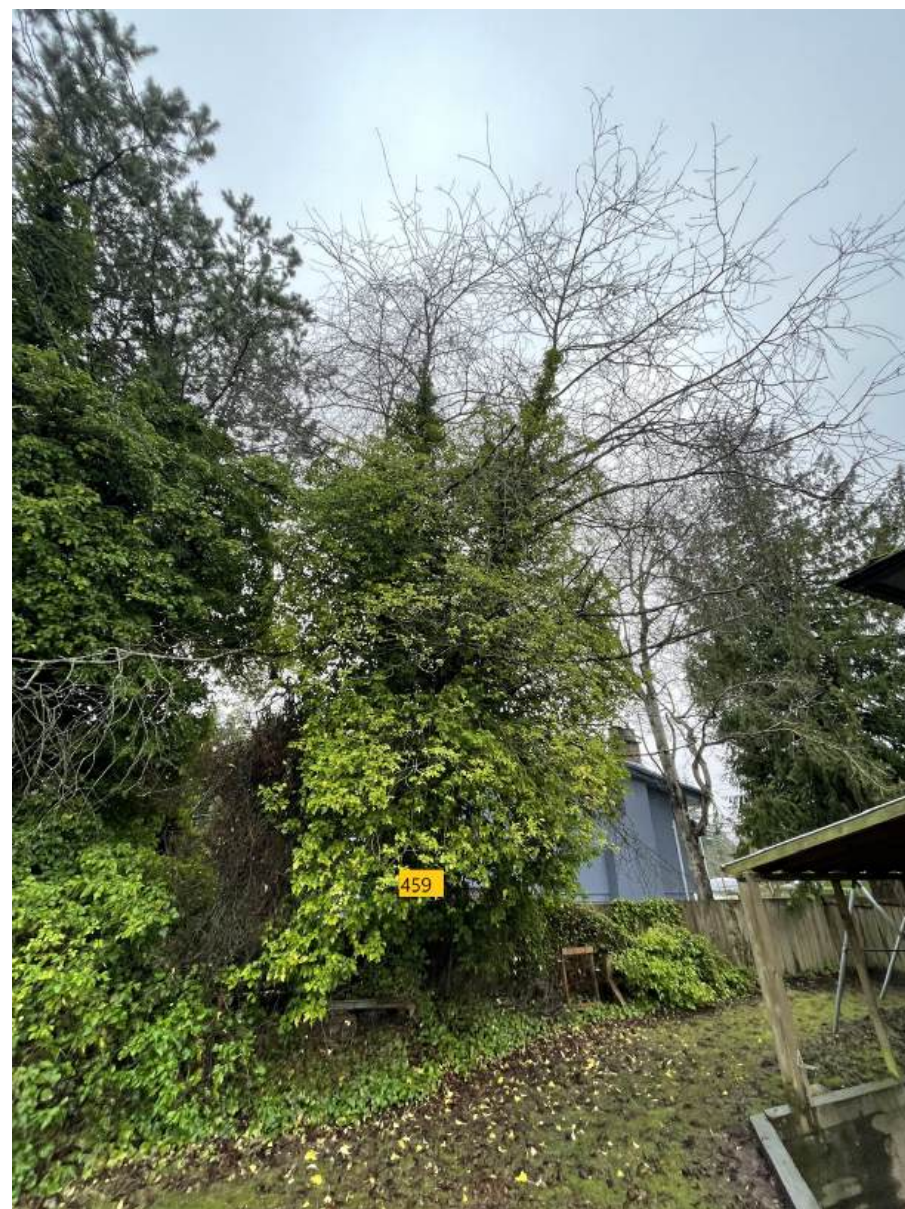
IMAGE 54-Tree 459- to be removed

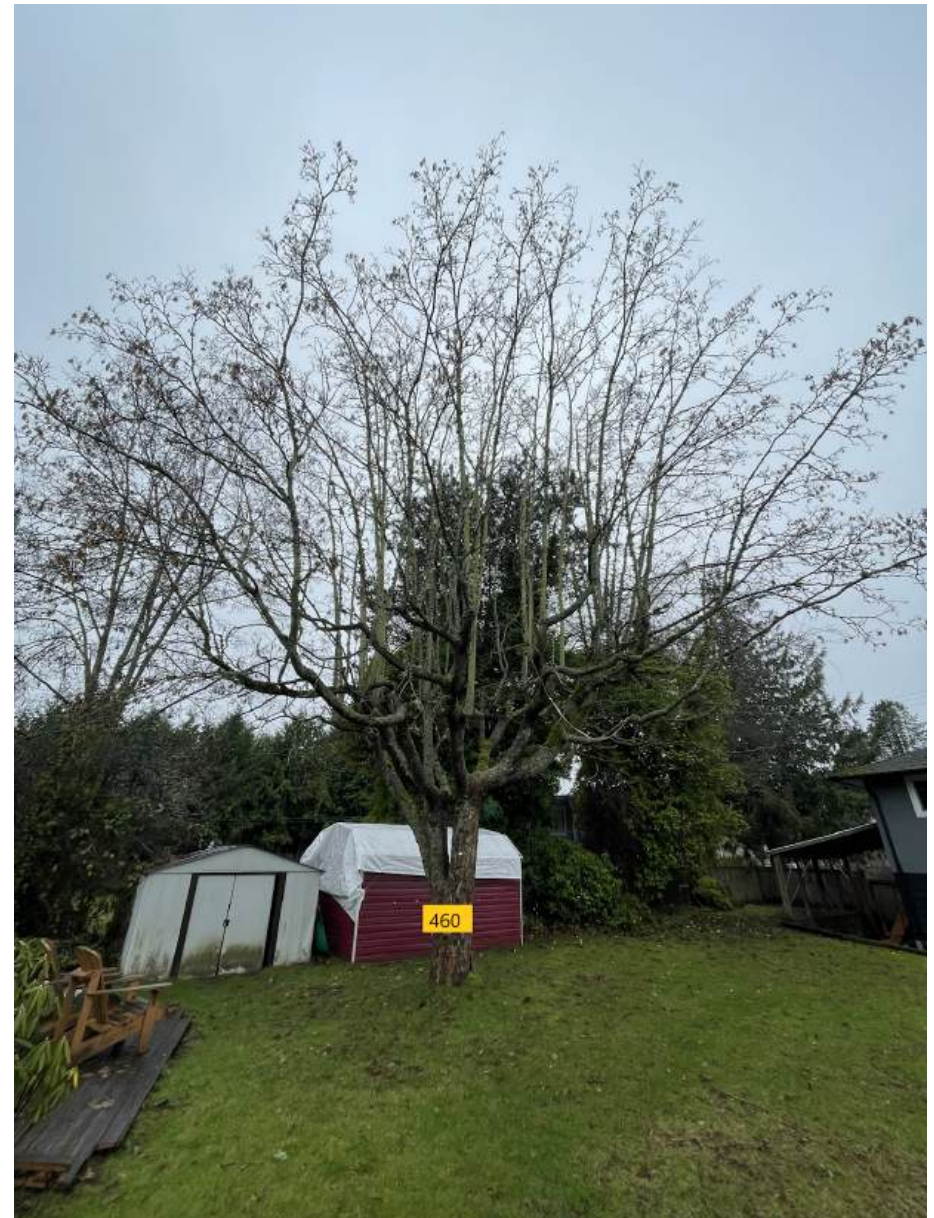
IMAGE 56-Tree 460- to be removed

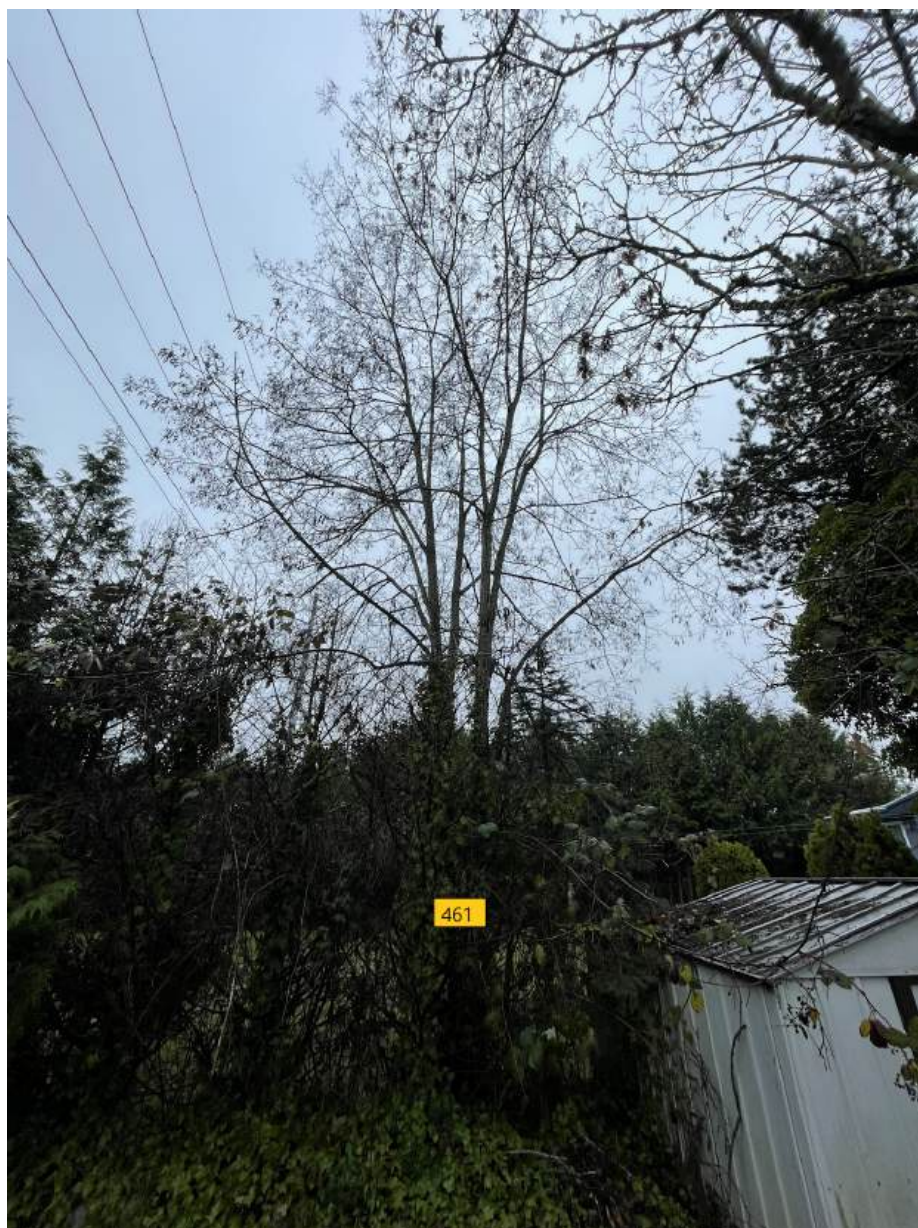
IMAGE 57-Tree 461- to be retained

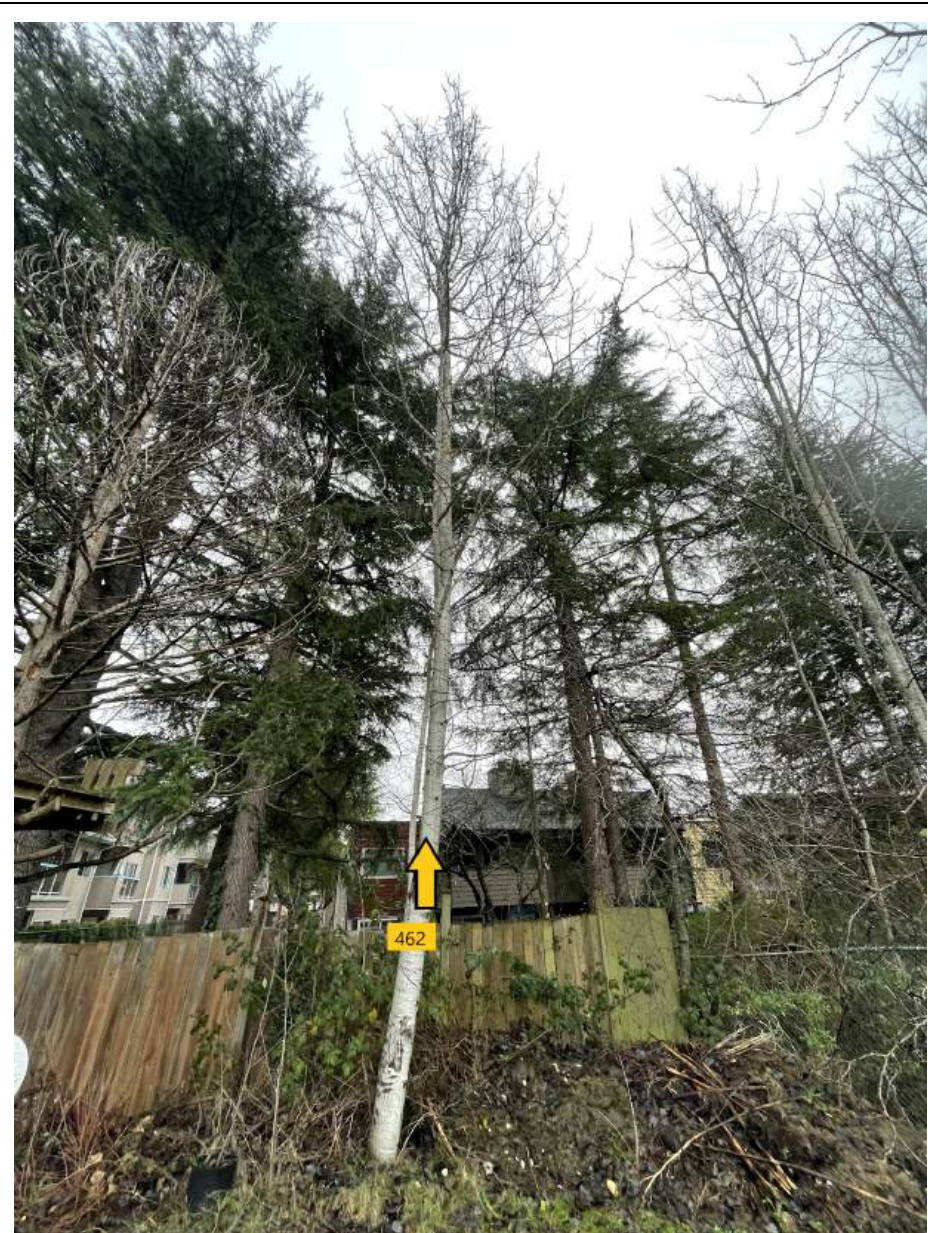
IMAGE 60-Tree 462- to be removed
