## Arborist Report

Inventory and Assessment of Trees Associated to Development at  
1170, 1156, 1146 53A Street and 5360 12 Avenue, Delta

Update April 21, 2025- Updated retention table

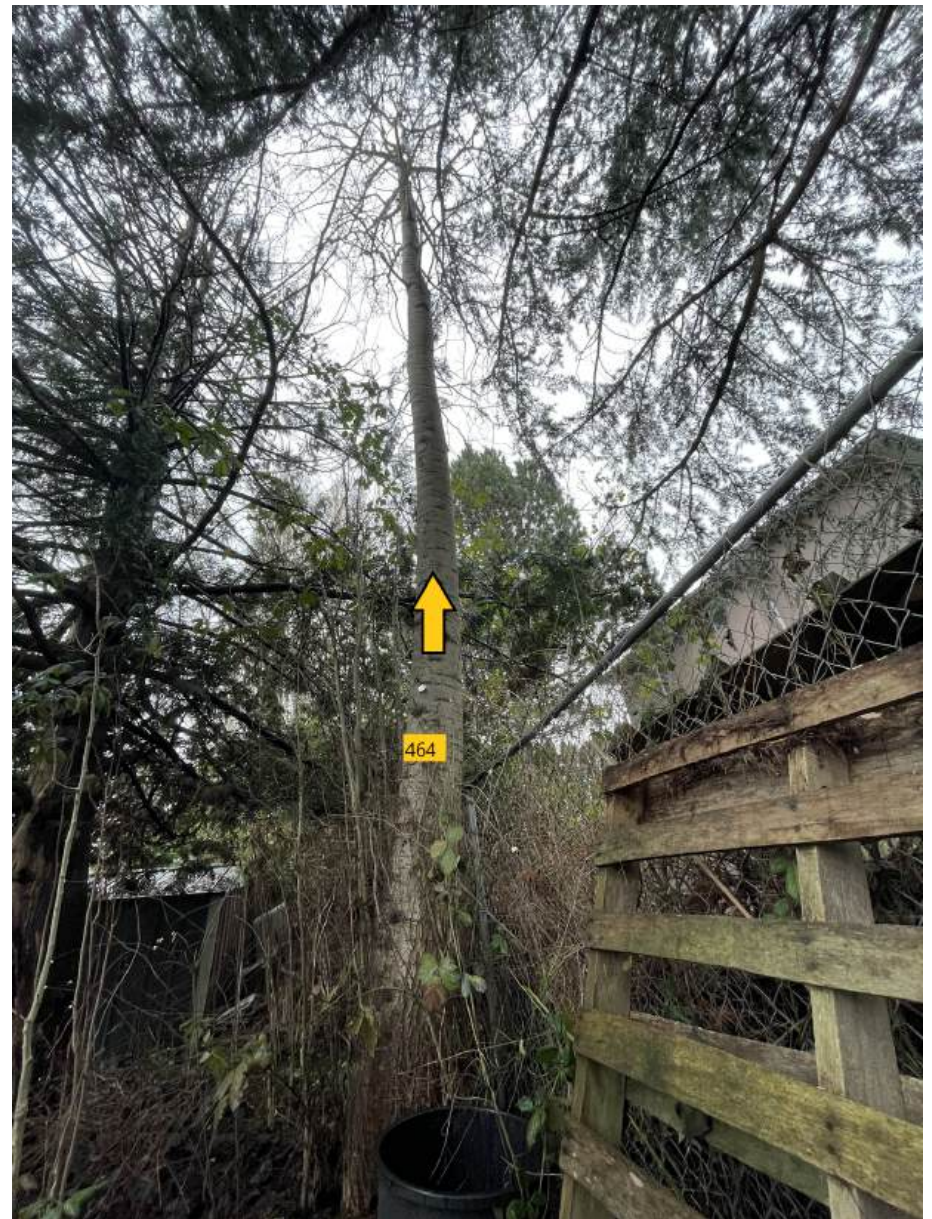
IMAGE 62-Tree 464- to be removed

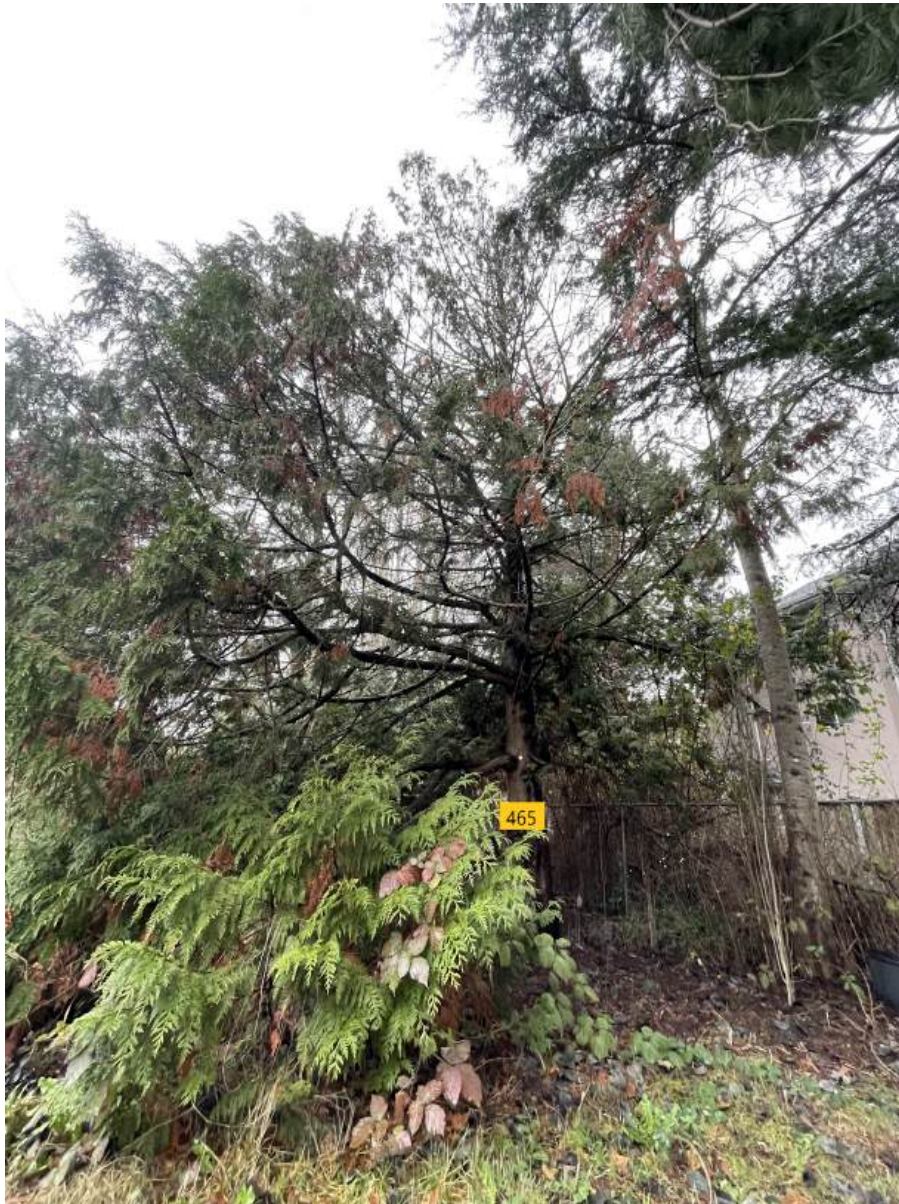
IMAGE 63-Tree 465- to be removed

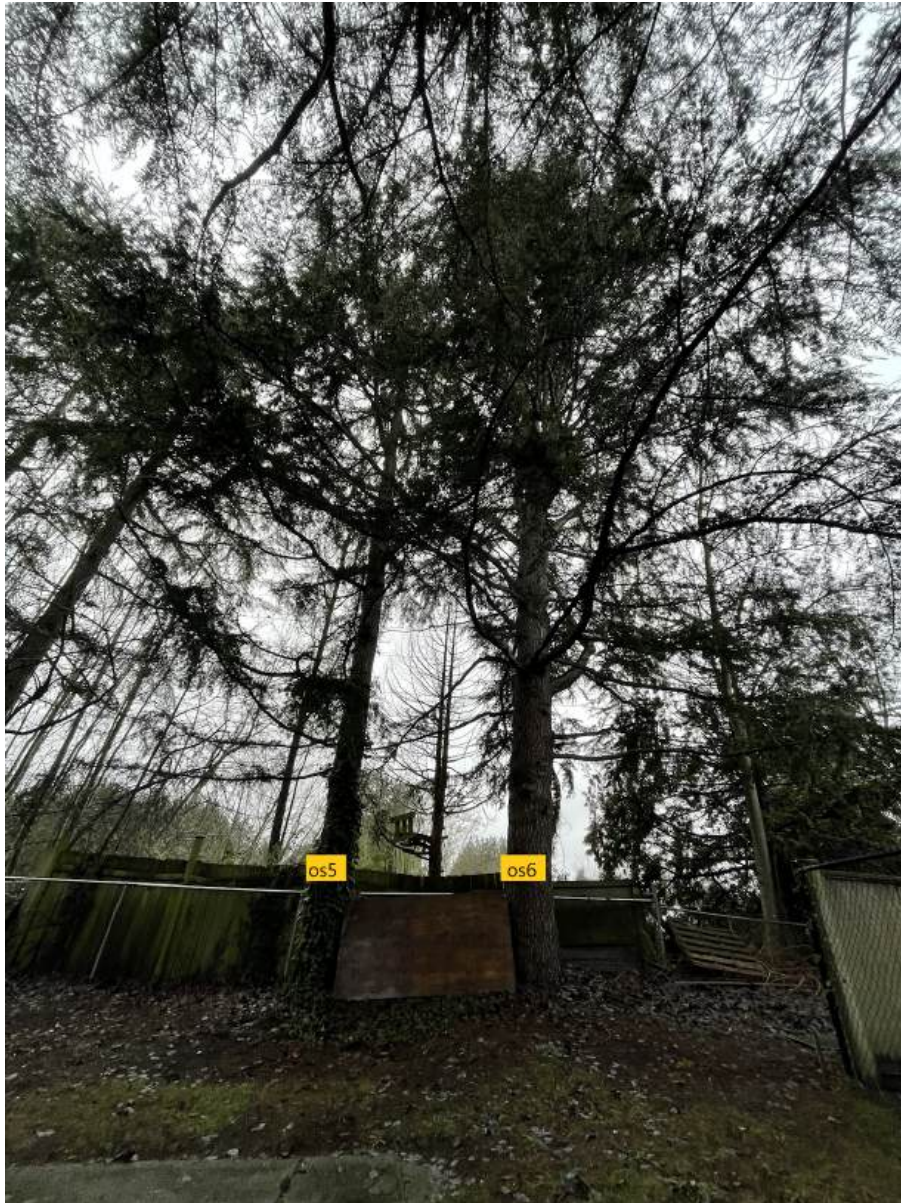
IMAGE 71- Tree os5 & os6- to be retained
